## 694 / PHO - Existing Photographs of Elm Lodge

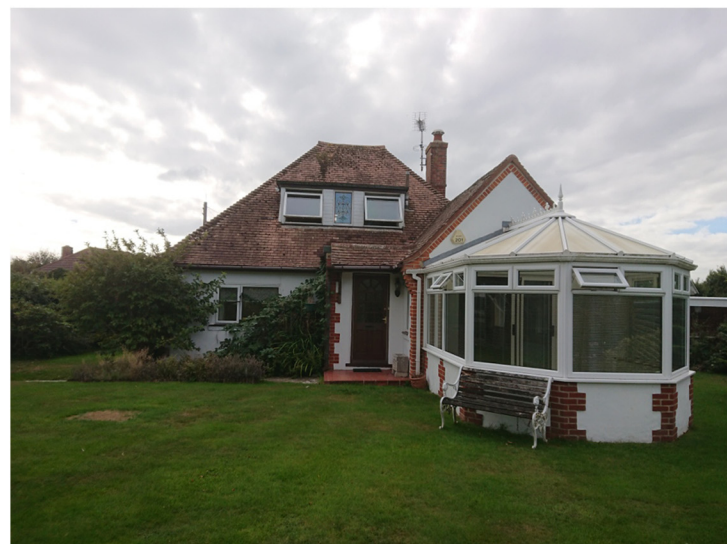
Existing side elevation

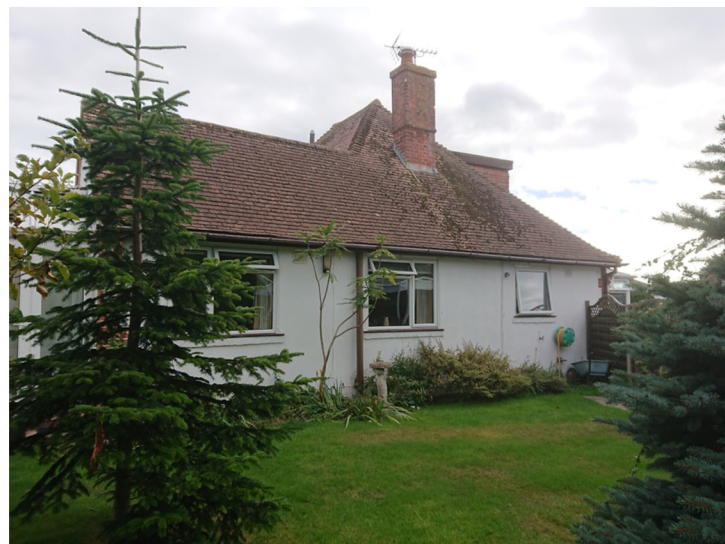
Existing rear elevation

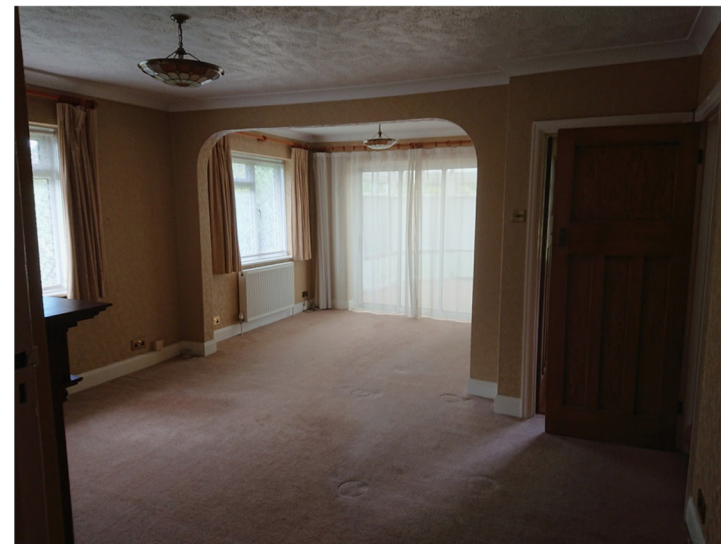
Existing living room

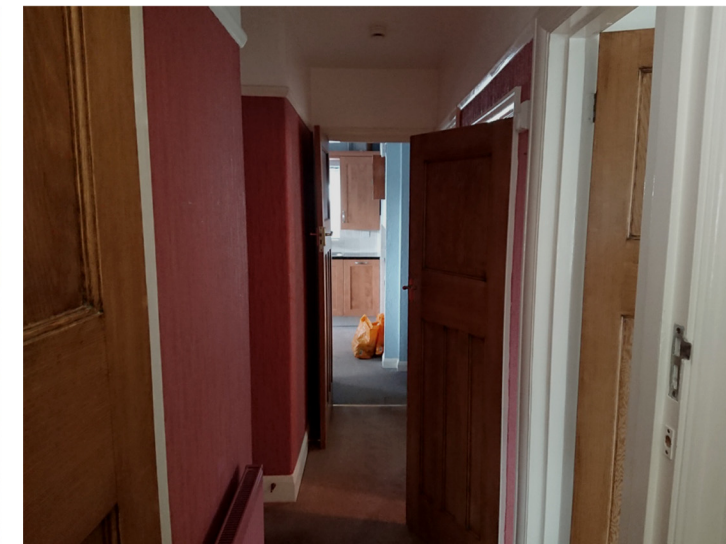
Existing hallway

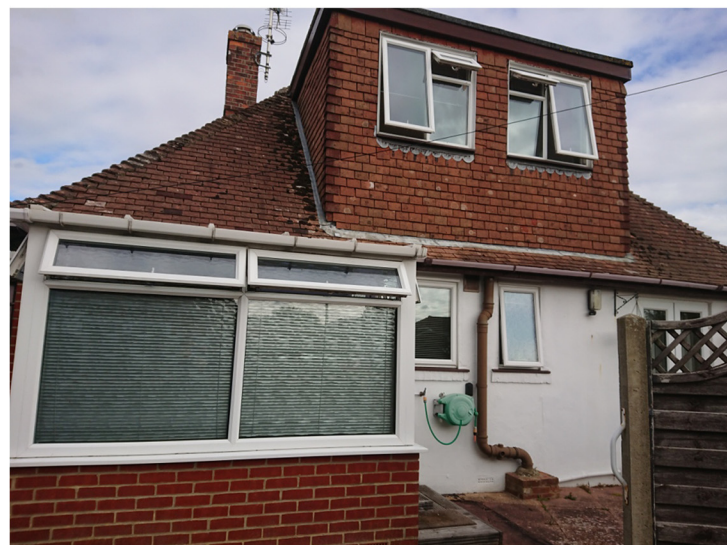
Existing side elevation

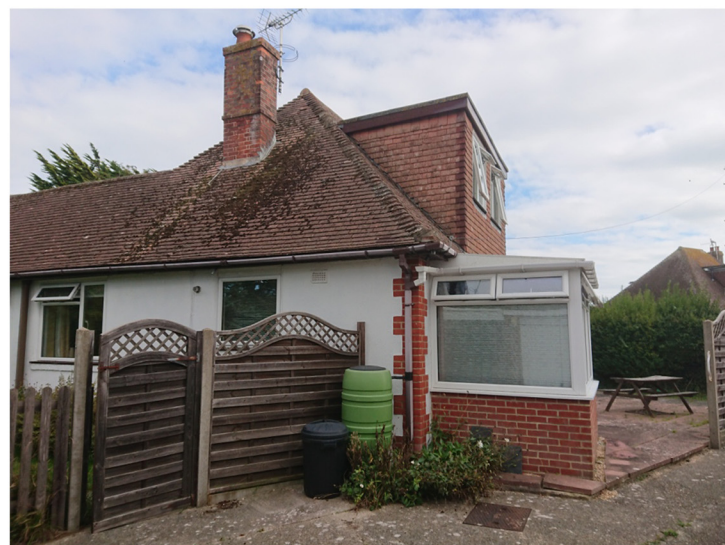
Existing rear elevation

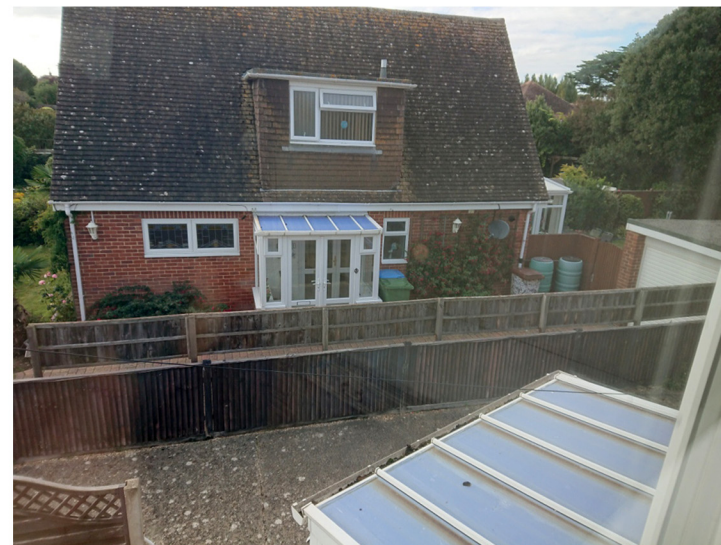
Existing view from bedroom 2 side dormer

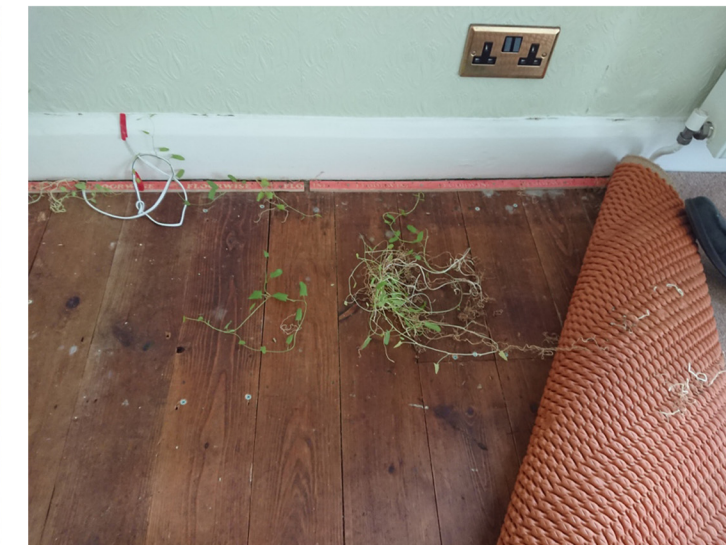
Existing condition of floors

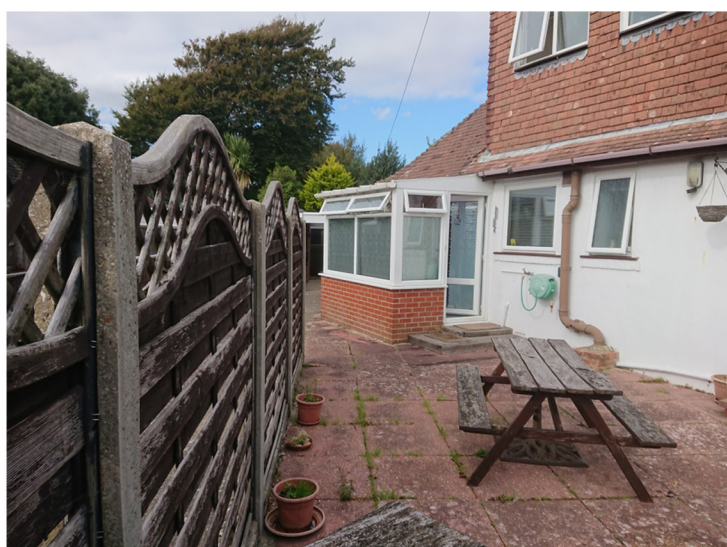
Existing front concrete paved area

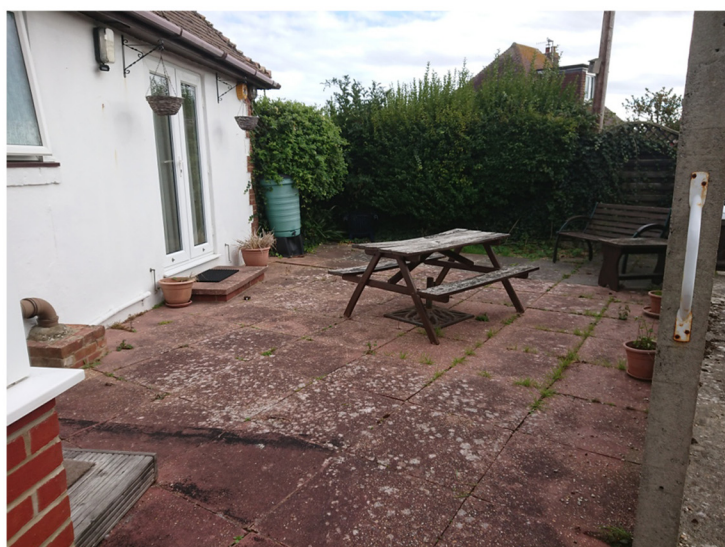
Existing front concrete paved area

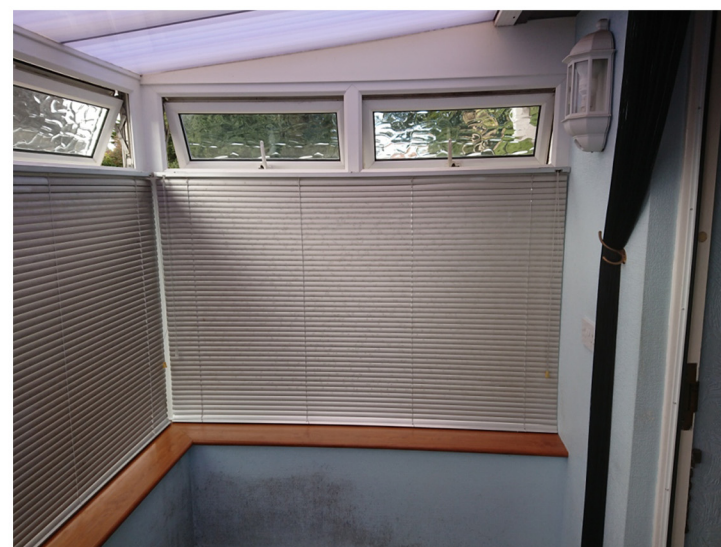
Existing porch (penetrating damp)

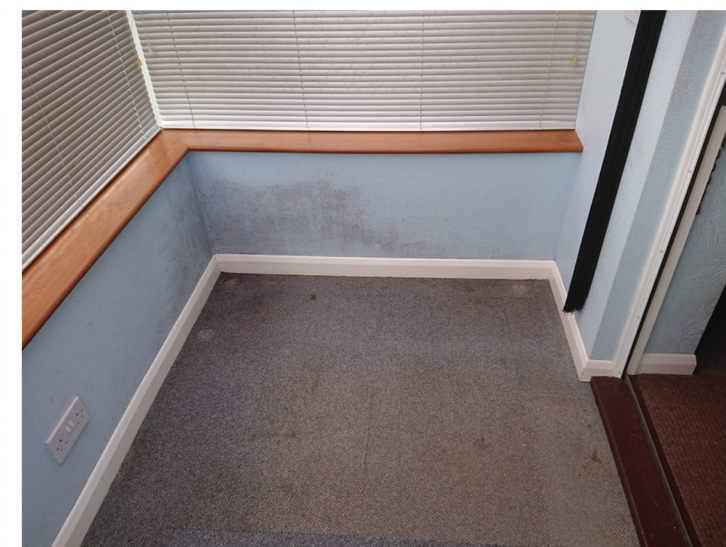
Existing porch (penetrating damp)
