## TREE REPORT

### *Little Paddocks Estate, Ferring*

*Professional inspection*

**Bournetrees**  
Consultancy

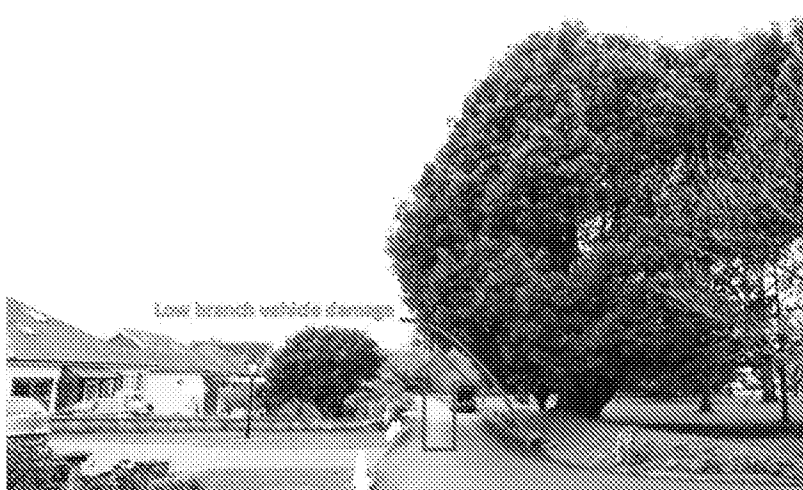
The ground beneath the tree canopy is mostly of grass with a good leaf mulch layer. No visible roots and mower damage was found amongst the leaf and grass. The road does encroach into the southern half part of the crown with evidence of bark damage caused by high vehicles passing beneath (Picture 3). The area appears to be relatively low occupancy and low usage and the report is based upon this site observation. Had the tree been located adjacent to the A27 for example then a different target/risk analogy would have been considered appropriate for the tree and of its future maintenance.

Picture 3, showing area impacted by the passage of high vehicles.

Branches which show bark damage caused by highway vehicle impacts should be reduced back to the edge of the road. It is recommended that all thin and flexible branches and twigs remaining unless they obscured road visibility for vehicle users.

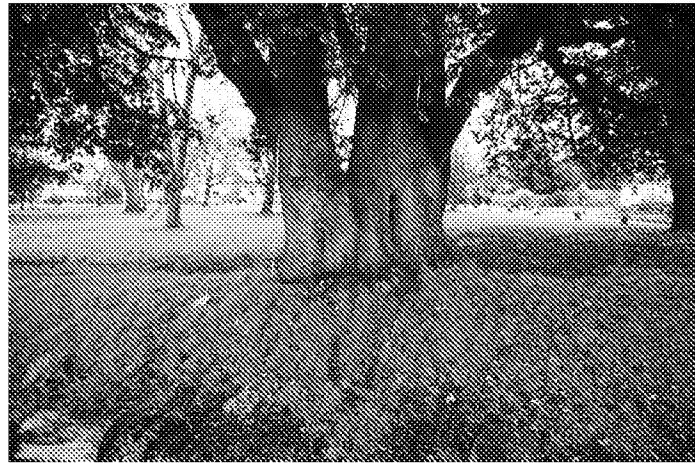
The main stem is unusually large and short (Picture 4). Initially the tree was thought to consist of several evergreen oak stems grown together as 'bunch planting'. On closer inspection there were no divisions, breaks or fissures. The bark has complete connectivity near its base surrounding the whole main stem circumference. The low stocky main stem with low continuous smooth crown periphery is advantageous. The aerodynamic profile can resist harsh winds from the south, with additional shelter provided by trees to the east, north and west.

*Picture 4, shows short and stocky main stem with low developed branch structure.*

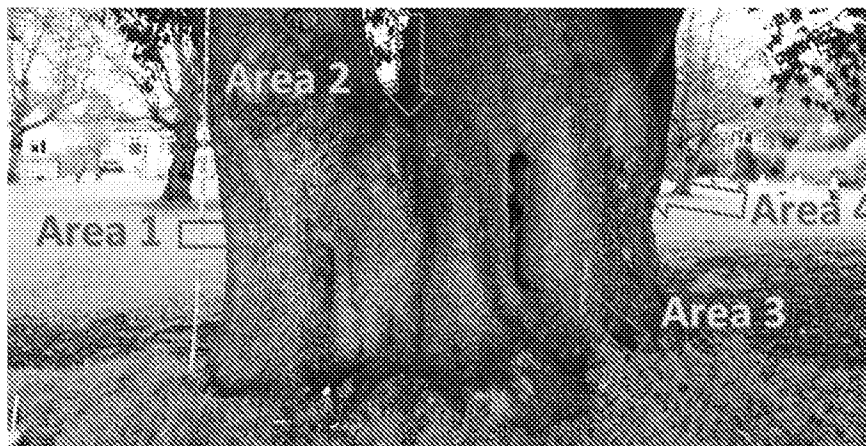
*Picture 5, showing areas identified as defects.*

The South facing main stem area showing 4 defects in picture 5 and further described below.

- Area 1; mottling gingering of bark, considered dysfunction.
- Area 2; a crease or ripple of bark with pronounce growth, caused by two opposing stem flexions. No separation, bacterial exudation or seepage found.
- Area 3; 50cm x 15cm open cavity with rolling thick cambium and healthy bark growth. The cavity extends into the heart of the tree in the location. Good healthy growth response surrounding the cavity wall. Potential habitation for wildlife.
- Area 4; small area of mottled bark below an old pruning wound which has now occluded (20cm x 15cm) indicates bark dysfunction which is localised. Regular monitoring will determine whether this area increases in size.

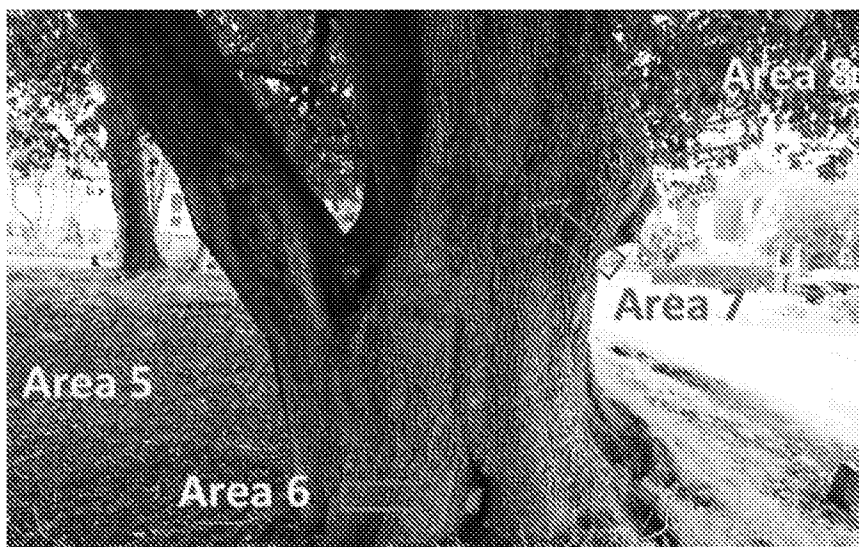
Picture 6, showing areas identified as defective.

The West facing main stem area showing 4 defects and fungal fruiting body in picture 6 and described further below.

- Area 5; mottling gingering of bark below a large cavity of a primary branch extending northwards. The branch cavity has possibly disrupted sap flow to cause cambial disruption/bark dysfunction.
- Area 6; Between two healthy buttress roots there is a shallow cavity and with the presence of a fruiting fungal body (see red arrow in picture 7 below). This is possibly a juvenile fruiting body of *Perennipora fraxinea*. The nature of decay causes an intense white rot at the main stem base of its host. Although it appears small the wood decay is likely to extend further into the centre of the main stem. It is not possible to determine how extensive this is from outward observation which a decay detection device should determine.

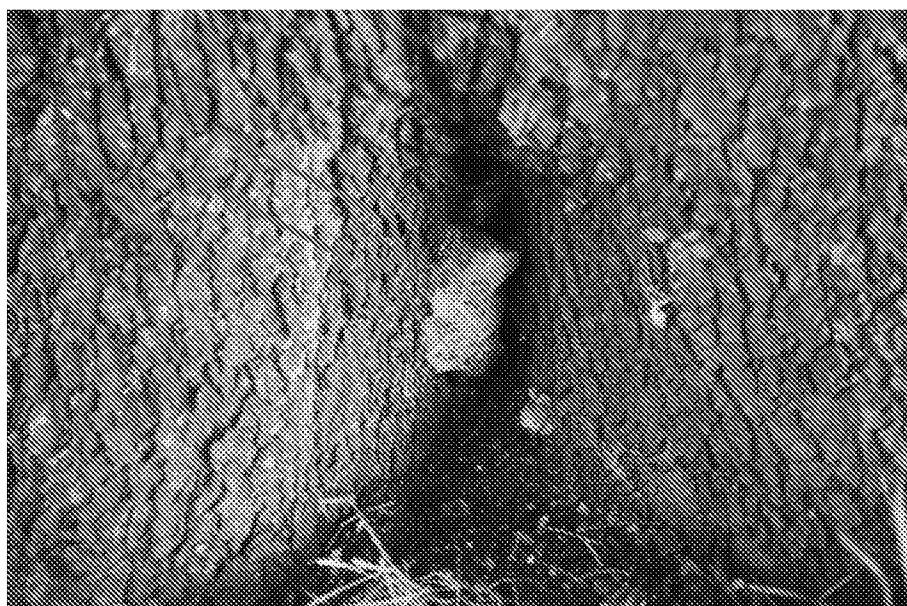
Picture 7, a fungal fruiting body between buttress roots facing west.

As demonstrated by using the steel probe, the main stem core has decayed. It is not possible to know how extensive the decay is and the wood quality forming the residual wall. Further tests using a decay detection drill is recommended to provide detail of the above, particularly in those areas near to the fruiting body, cavity and dysfunctional bark.

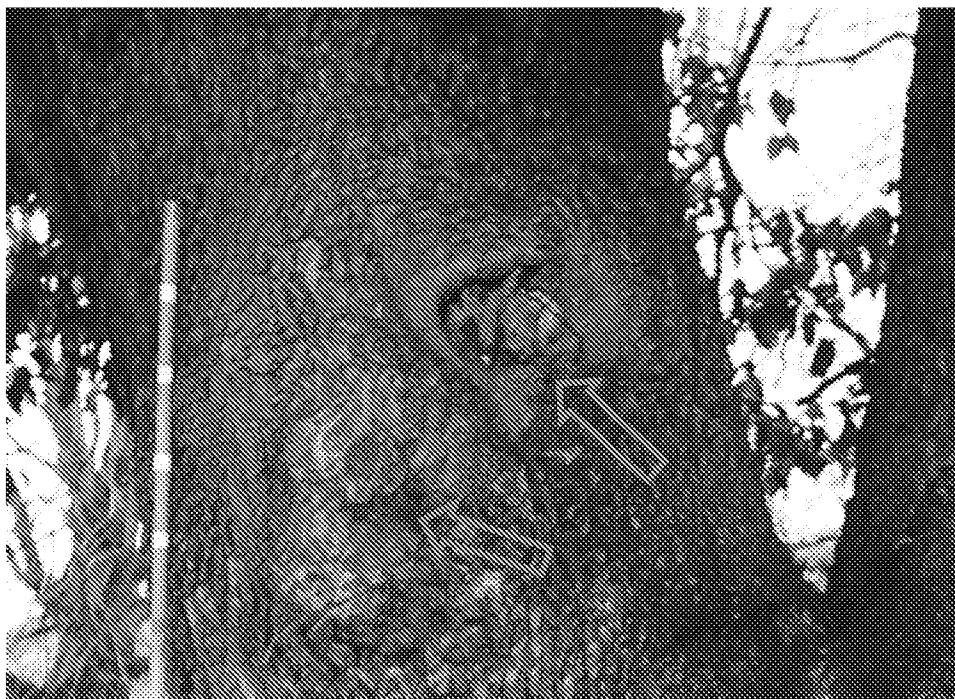
- Area 7; there is a narrow longitudinal girdling of bark running along the outside of the main stem approximately 3m in length. No separation, bacterial exudation or seepage from this area was found. The bark dysfunction is possibly linked with the fungal fruiting body and disruption of vascular cambium columns/vessels.
- Area 8; A pronounced bulge observed from this angle is the result of previous pruning of branches extending towards the road (Picture 8 and red arrows showing wound locations). One wound has healed, the other is becoming a cavity.

*Picture 8, previous poor reaction to historic pruning.*

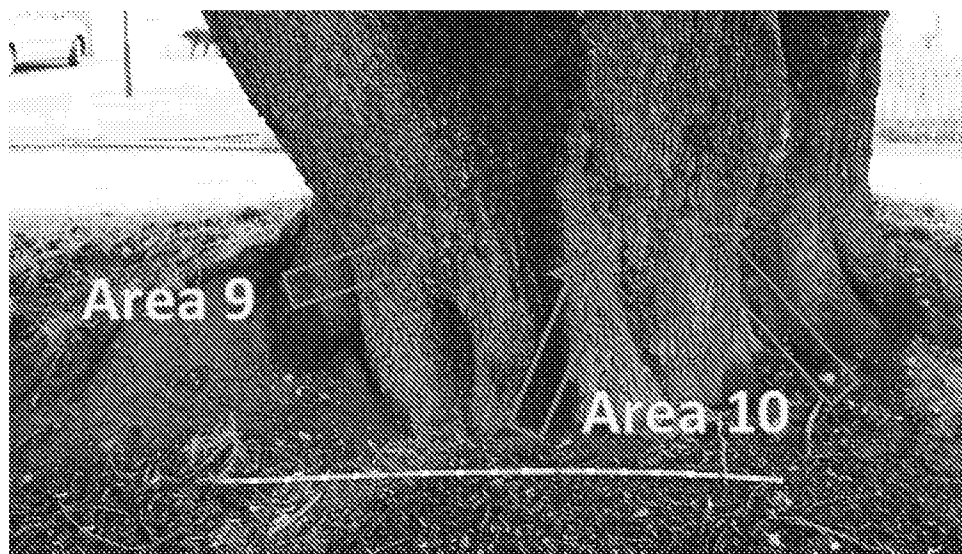
*Picture 9, showing areas identified as defective.*

The North facing main stem area shows 2 areas of bark dysfunction (Picture 9), described below.

- Area 9 and Area 10; show gingering dysfunctional bark and 'pitting' where buttress root formation has occurred below. This is a possible reaction strengthen an area becoming weak to the deterioration of wood tissue, and/or need to retain connectivity with the live crown portion and roots.

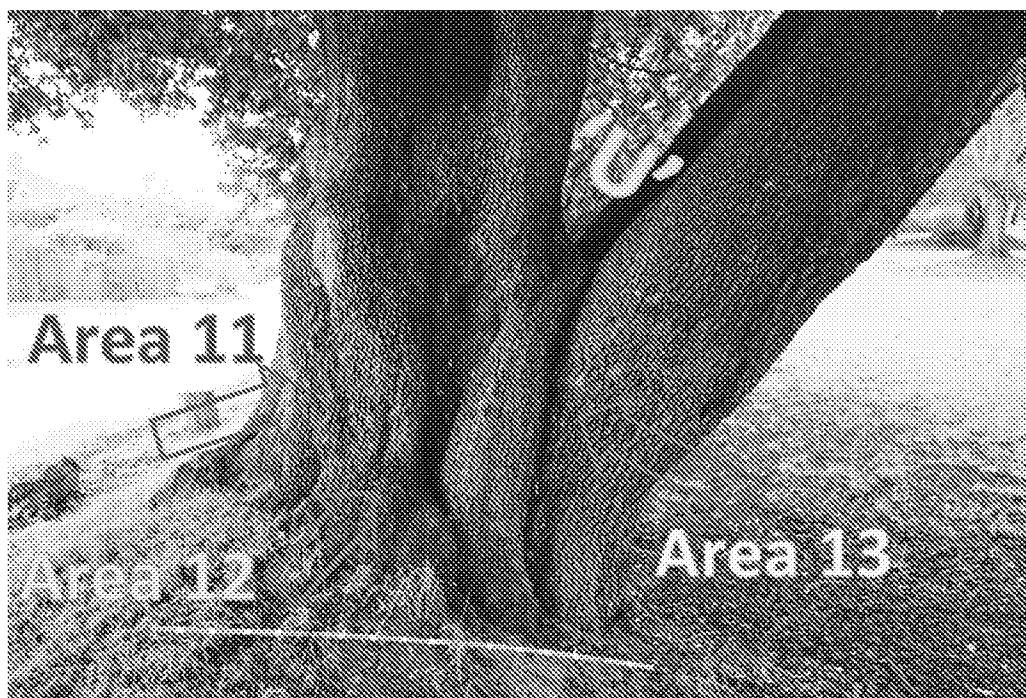
*Picture 10, showing 3 areas of concern and strong 'U' junction affected by bark fold anomaly.*

The East facing main stem area with bark dysfunction and 'folds', described below.

- Area 11; showing gingering dysfunctional bark. This is adjacent to Area 4, the occluded pruning wound and main stem cavity which faces north.
- Area 12; a deep fold formation with no decay but some minor bark dysfunction.
- Area 13; a deep fold, which appears to separate the primary branch (PB3) from its main stem. A closer inspection did not detect bacterial staining or decay, suggesting it is separating. There is some minor dysfunctional bark and this is one area to monitor. Fortunately, PB3 leans away from the road.
- 'U' Junction; this is an area described above a branch attaching to its parent branch/stem forming a strong union. The fold between both main stem and PB3 with additional weight is a concern and one to monitor for signs of separation. Reducing the branch should help lessen this possibility.

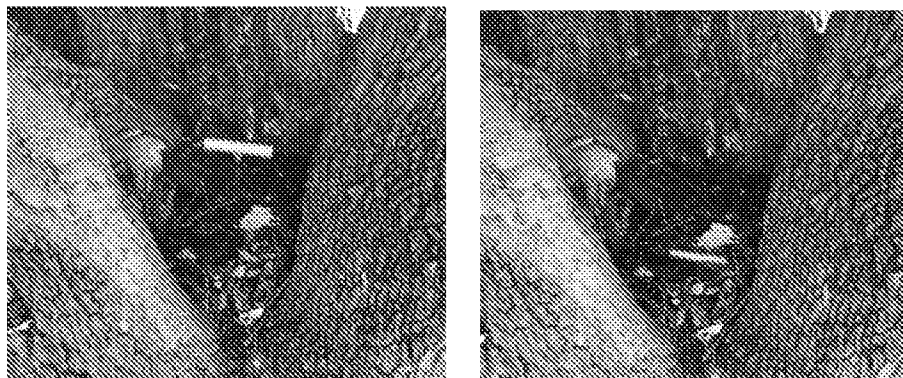
Soil has collected between the primary branches that divide from the main stem at 1.2m from the bank. Aerial roots from one primary branch has developed and has grown into the collected soil (Pictures 11 & 12).

Picture 11 and 12 above showing depth of steel probe into main stem cavity.

The steel probe (0.9m) was inserted fully into the soil. No resistance was found at this depth suggesting the central main stem wood core has deteriorate and not present. It is not possible from an outward visual inspection to determine the amount of the main stem core remains. This is important to determine what remain wood tissues remain to support the main branching structure. A decay detection device should help with this assessment and what remains of the residual wood shell, thickness and strength.

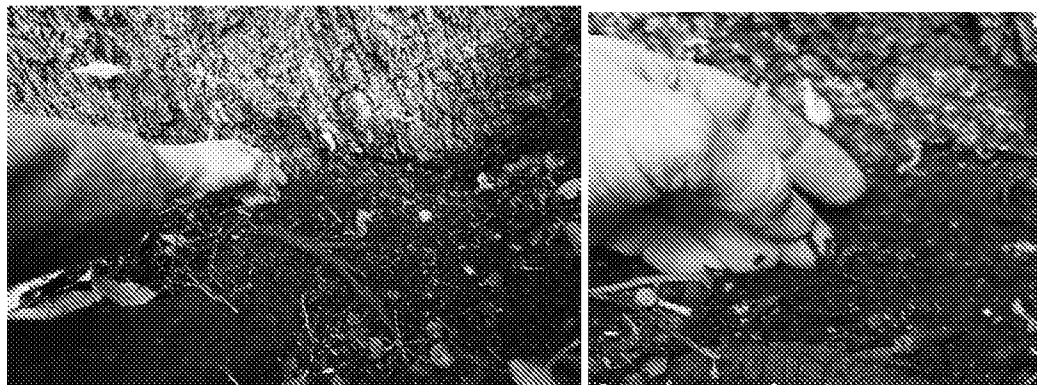
A large area of bark facing north from one of the primary branches (PB4) has become dysfunctional with 'gingering' mottled appearance (Picture 13 & 14). Fungal rhizomorph were found in the soil identified as *Armillaria spp.* This was confirmed by crushing the black structures between the fingers to reveal a 'mushroom' odour.

Picture 13 & 14 showing location of the fungal strands.

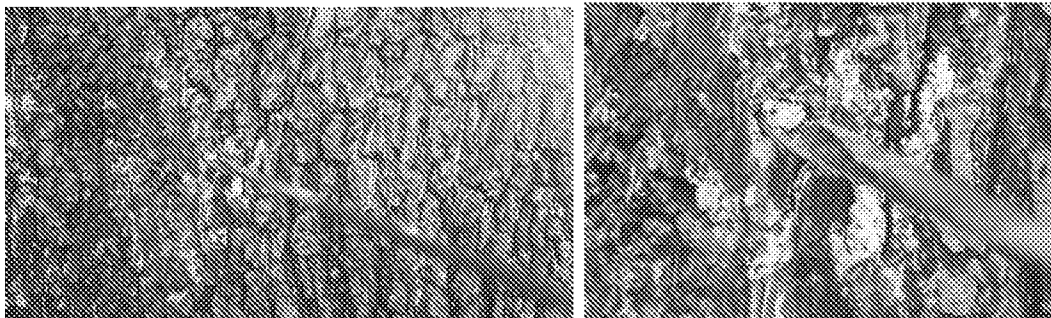
A steel auger shallow drilled into gingering mottle bark area above the location of the Honey Fungus rhizomorphs to reveal powdery dry wood 'shavings' (Picture 16 & 17). This was carried out to demonstrate why the gingering mottle bark areas are considered dysfunctional as no evidence of live, underlying sappy cambium was found. Similar gingering discolorations found in patches throughout the tree would likely produce the same results, hence why they are considered 'dysfunctional' as dead bark patches.

Picture 16 and 17, augured area to reveal dead non-living cambium beneath bark.

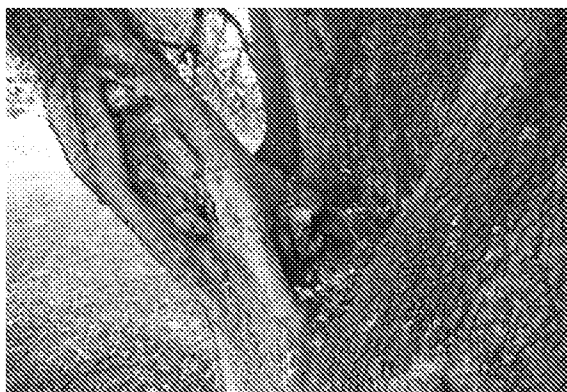
- PB1 Divides into two subsidiary branches. Its basal area appears healthy, the upper crown is sparse.
- PB2 has multiple old bark wounds where decay is present (Picture 19). Aerial roots have developed and is growing into the soil filled main stem cavity.

Picture 19, showing wounds and decay at base of PB2

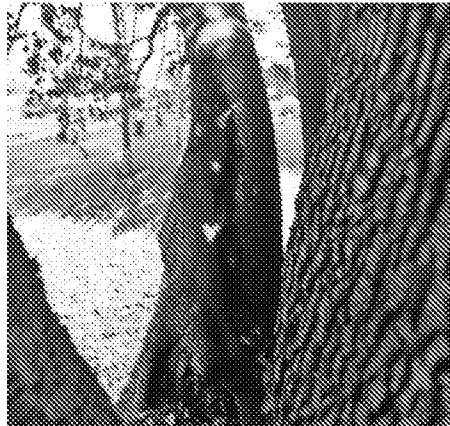
- The top of the PB2 shows a longitudinal cavity running at least 1m, having a diameter of 10cm (Picture 20). A ridge of reaction wood growth has formed either side of the cavity adding strength to an otherwise weakened branch.

*Picture 20, showing PB2 with ribbing of living wood tissue adjacent to decay cavity.*

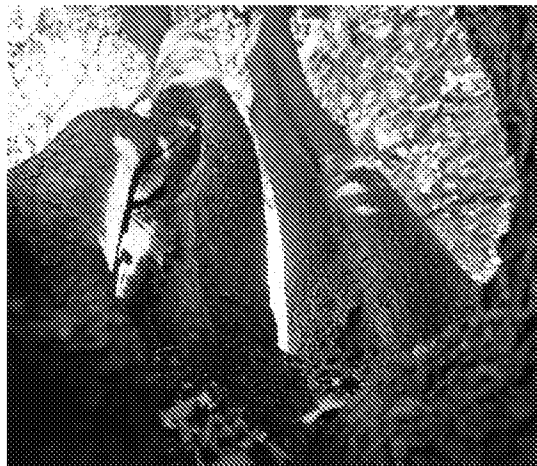
- PB3 is located close to PB2 (Picture 21) and smaller in size than PB1 & PB4. Both are similar in proportion to each other extending northwards. PB3 has no cavity formation but there is a slight pronounced double rib of supportive reaction wood running longitudinally.

*Picture 21, showing both PB2 (having decay) and PB3 (slight central dip and raised outer rib)*

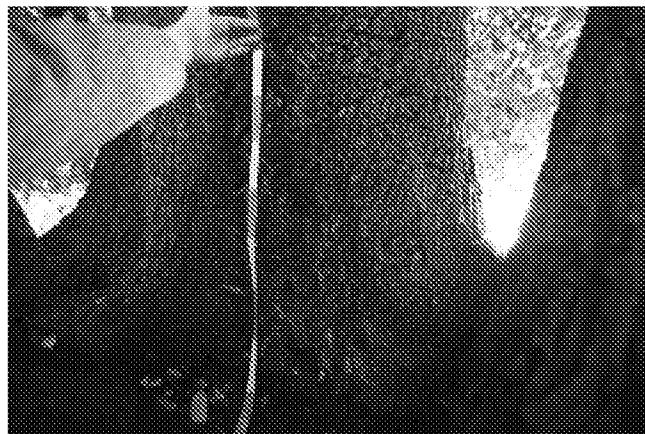
- PB4, Picture 22 below shows extent of dysfunctional bark affecting this primary branch and measures 80cm x 25cm. PB4 has a diameter of 60cm and further divides into three subsidiary branches to form the crown.

*Picture 22, extent of dysfunctional bark*

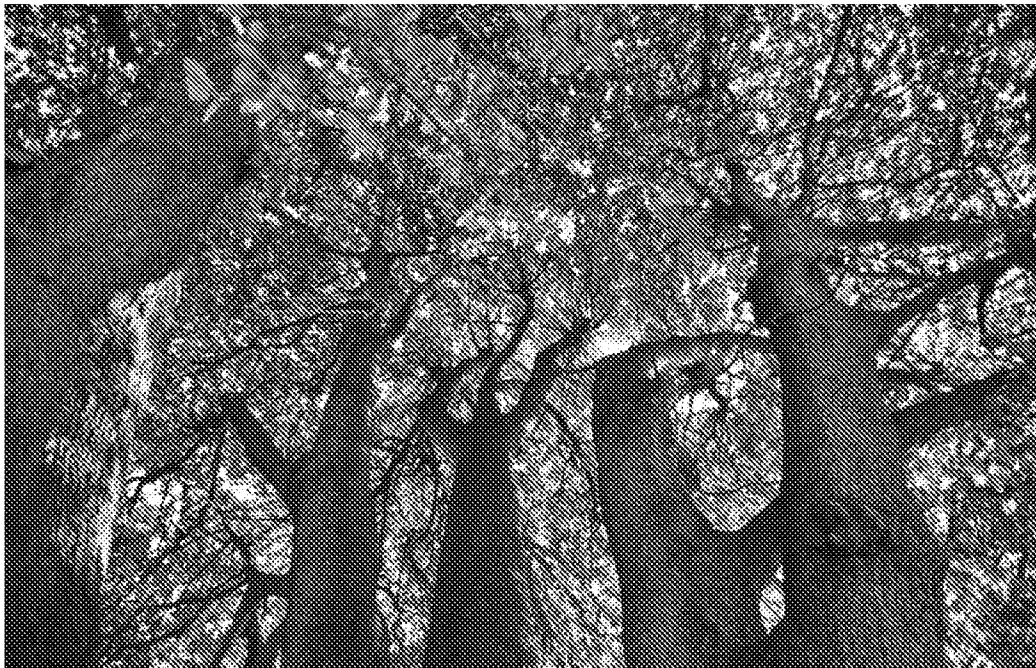
*Picture 23, showing sparse foliage of the crown*

- The crown shows the crown is sparse with 10-15% loss of foliage. There is also a large dead branch and dysfunctional bark which has been identified by the red arrows in Picture 23 and Picture 24.

**CROWN CONDITION:** The crown comprises previous lopped branches where multiple dense branch growth occur around a height of 12m. the crown foliage has grown from a previous lopping of branches at approximately 12m from the ground. Deterioration in the form of sparse foliage and large dead branch has occurred suggesting a decline in the health of the tree.

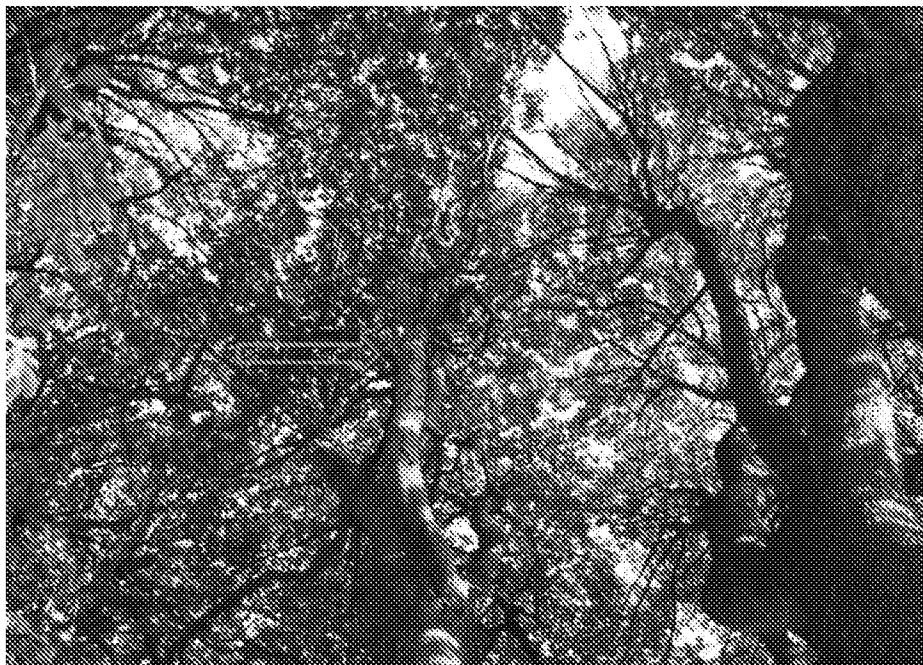
*Picture 24, identifies the large dead limb from PB4.*

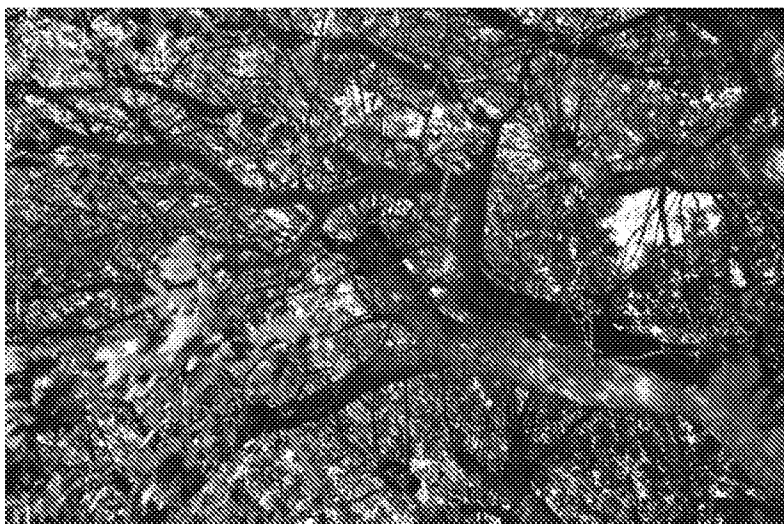
*Picture 25, The upper crown part which grows toward the south.*

The reduction should begin in the 1<sup>st</sup> phase by removing a select proportion of branches in the upper crown to leave a minimum 5cm proud of the 'target cut' (Picture 29). The following pictures (25-28) provide examples marked as a Red Bar of where to carry out the initial cuts. These pruning points will then be monitored to determine favourable growth response from the area of dormant buds (5cm protuberance) before the next phased branch removals commence in 3 years.

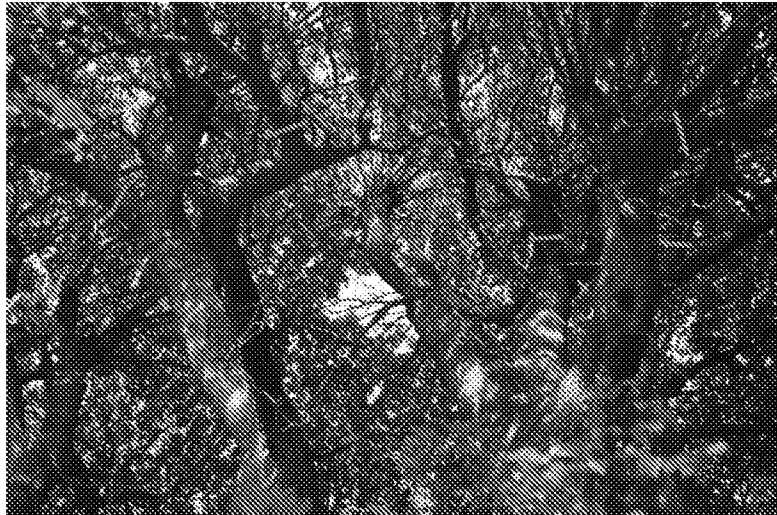
*Picture 26, crown area on the south side*

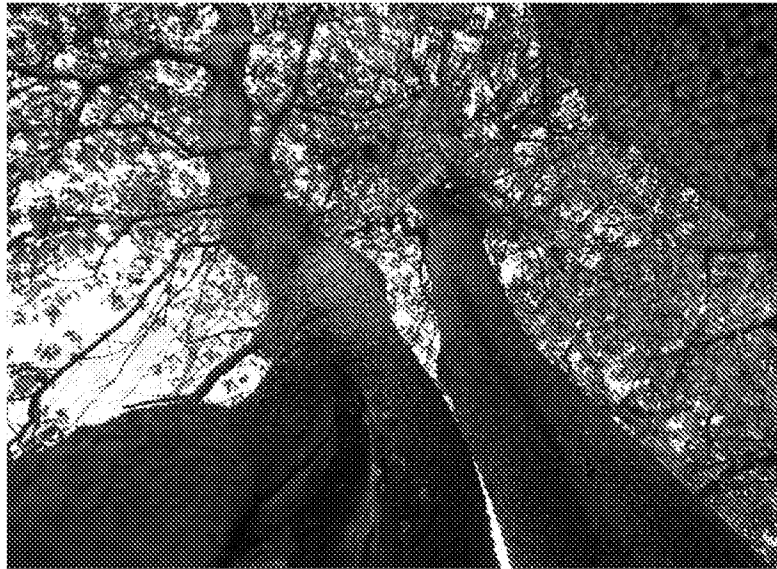
*Picture 27, crown areas of PB2 and PB3*

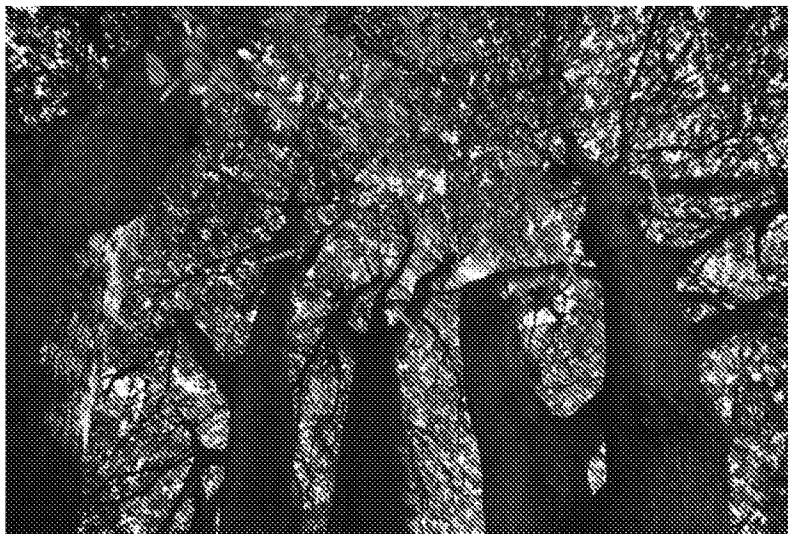
*Picture 28, crown area of PB4 and PB1*

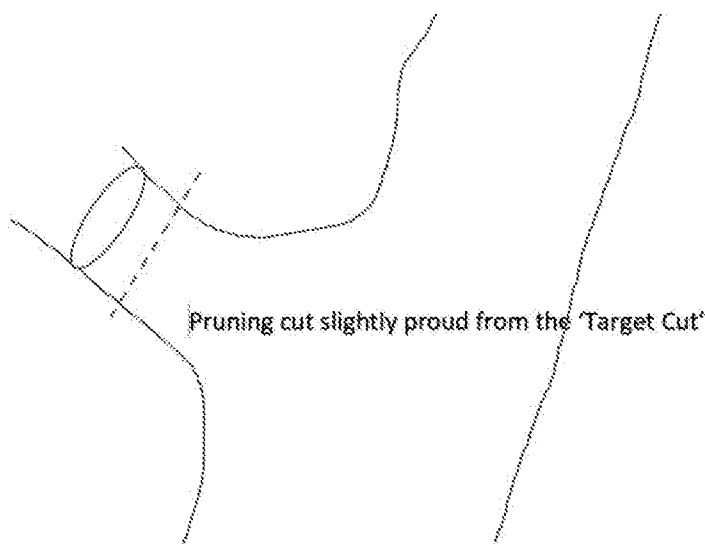
Picture 29, showing the dashed target cut and the desired 5cm protuberance.

The final cutting of each selected branch should provide a minimum 5cm stub in order to allow dormant buds to grow. The minimum stub length should be at least 5cm proud of the 'Target Cut'. At this stage there should be no selective removal of branches within the lower half of the crown.
