## **Tree Inspection Report**

**Little Paddocks Estate, Ferring**

**April 2021**

**Our reference:** TIR/0421/1

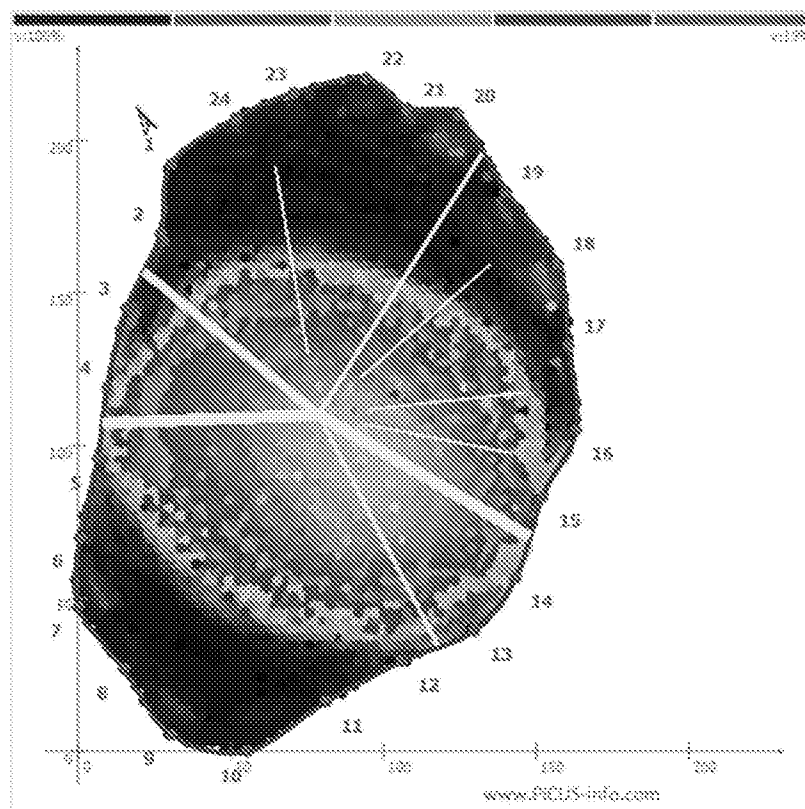
The completed tomogram is shown below; measuring point number one (MP 1) was placed on the north side of the stem, for reference:

The image indicates a large central area of low sonic velocity, coloured maroon/blue, suggesting the presence of significant deterioration within the stem. However the analysis software has overlaid broad yellow lines on the image, which indicate the presence of very distinct differences in sonic profile between adjacent measuring points. This can occur when radial cracks or other sonic barriers are present in the stem that can have the effect of exaggerating the extent of apparent decay and/or the actual shape of the decayed area.

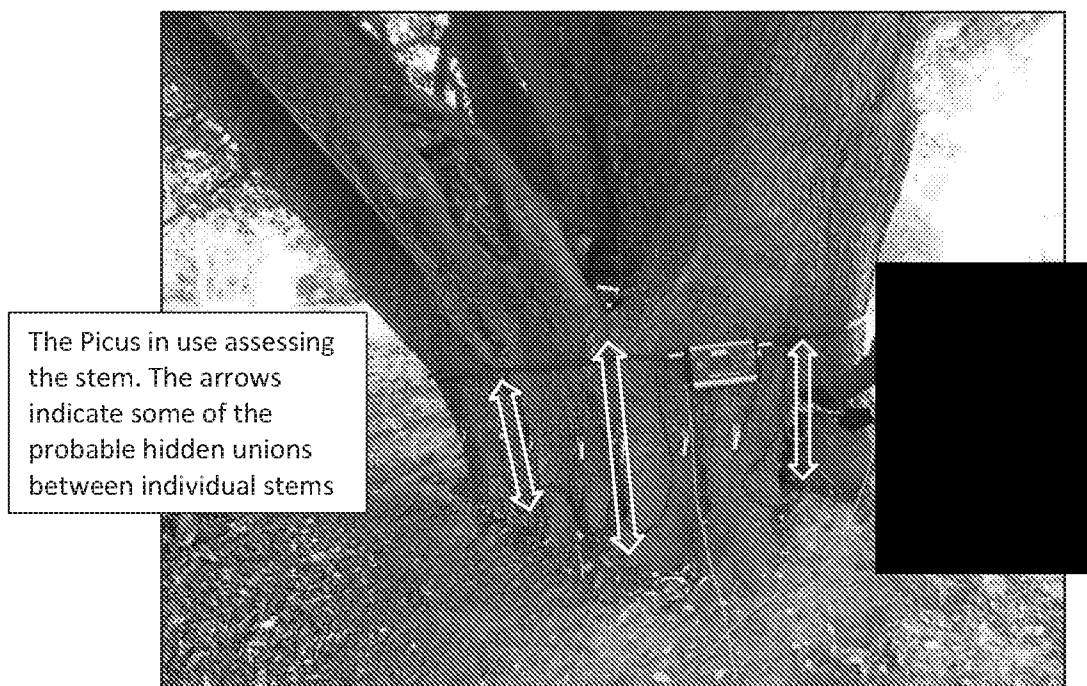
In this instance it is likely that bark layers compressed within the stem between the original component stems making up the base are acting as partial sonic barriers (see photo below). In view of possible inaccuracy in the result a second instrument, the Treetricon was used via the same measuring points.

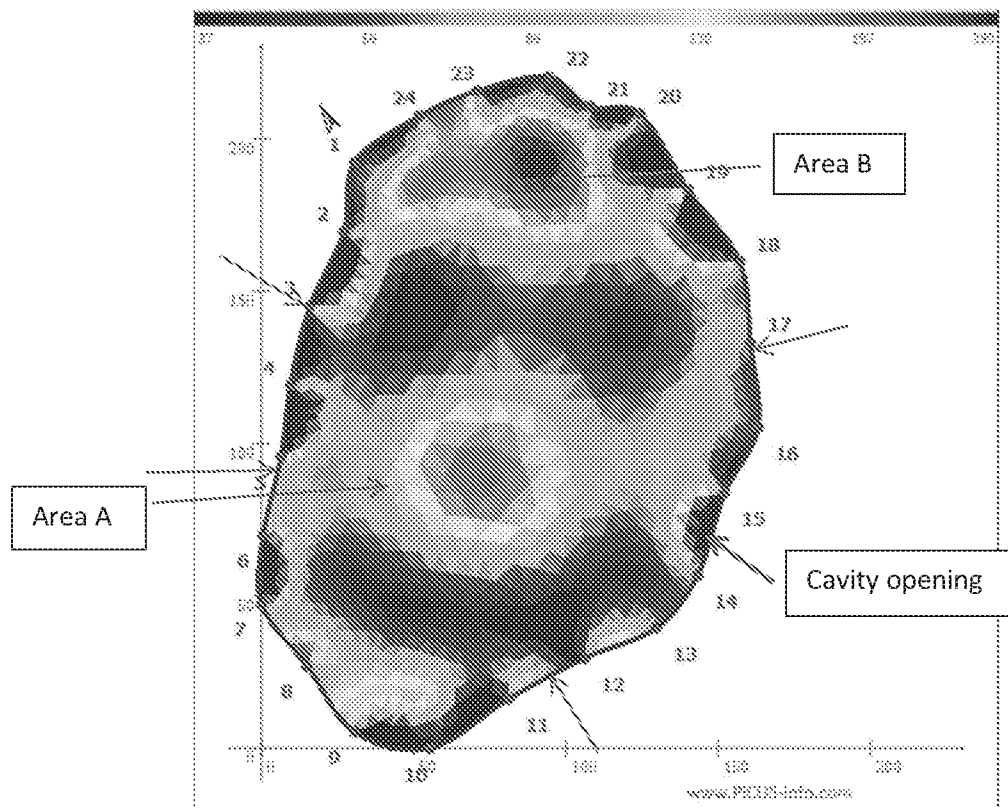
The result with the Treetricon is shown below:

In this instance, the most significant results on the tomogram are the areas of high relative electrical resistance, marked Area A and B on the tomogram. The former indicates a distinct area of decay and hollowing which accords with visual observation of the base (see below):

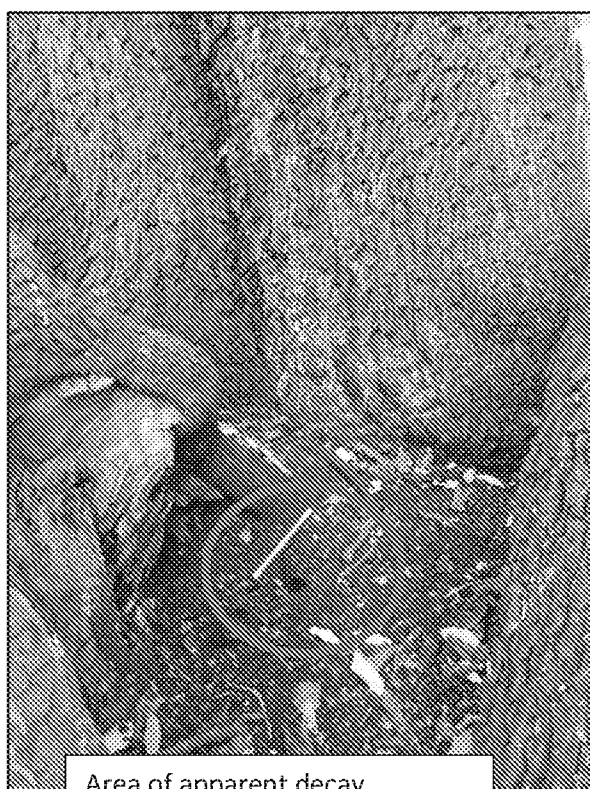
Area of apparent decay between stems, marked A. Note the 90cm long steel rod inserted up to the handle

As shown by the photos above, Area A includes the soil-filled area between ascending stems towards the west side of the base and the cavity at MP 14-15. Area B appears to indicate deep concavities in the stem shape between MP 18-19 and MP 20-21, presumably marking the base of a stem that originally arose from ground level. See photo below.

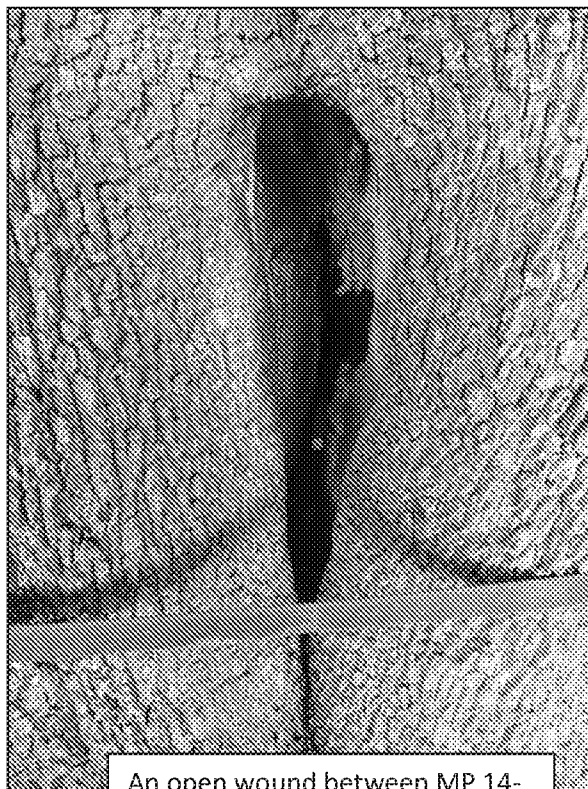
An open wound between MP 14-15, leading to a large irregular cavity

The open cavity to the east side of the stem base was probed with the steel rod to assess its depth and shape, as much as its irregular form would permit. It is apparent from the results that its presence has been incorporated into the sonic tomogram. This may not reflect the actual shape of both features but structurally they may certainly be regarded as one area, in my view.

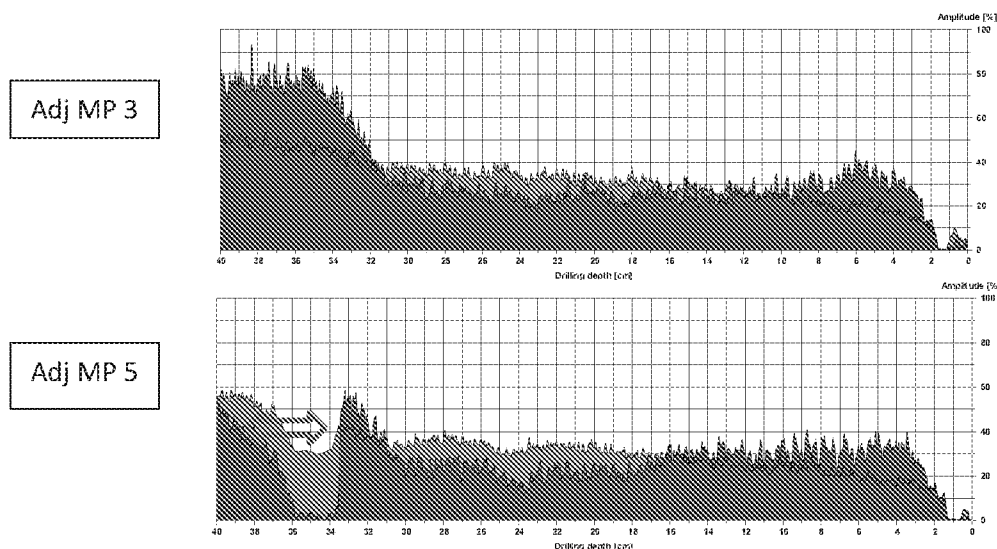
The Resi was used at the same level as the other instruments in four positions, equivalent to adjacent MP 3, 5, between MP 11-12 and adjacent MP 17 to confirm the extent of apparent decay in Area A. These points are also marked by small arrows around the edge of the Treetric image, for information. The results are shown in this order below; drilling direction is shown right to left:

The first result, adjacent MP 3 does not indicate the onset of decay within the maximum drilling depth of 40cm; indeed drilling resistance increases significantly from a depth of 32cm onwards. The second result at MP 5 only records a brief drop into decay/hollowing at 34-36cm although resistance is likely to drop again just beyond the maximum drilling depth. The final two measurements both record decay, at depths of 26 and 35cm respectively.

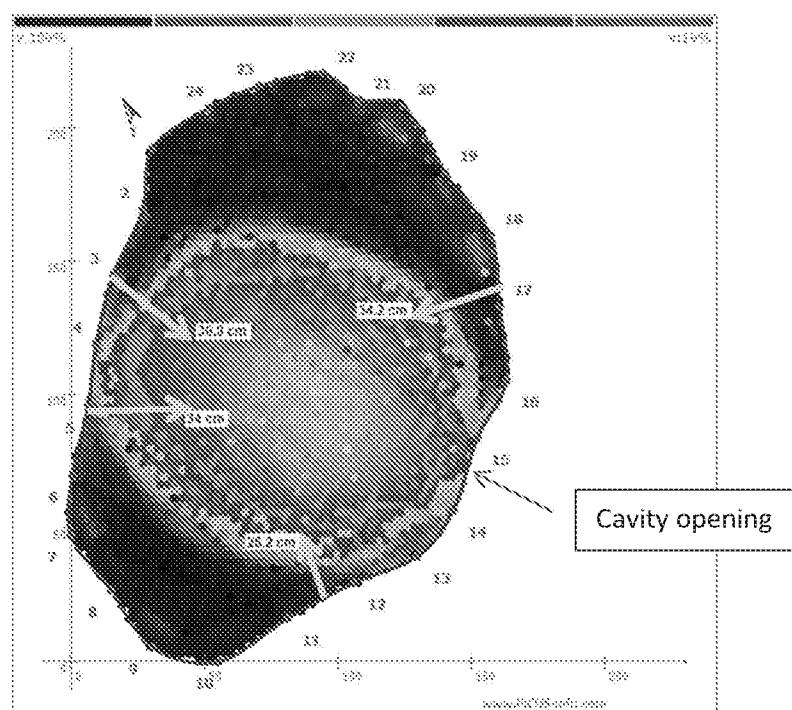
The result at MP 5 did not enter the decayed area but is likely to have been very close. However it still provides some indication of the minimum depth of sound wood at this point. For clarity the depths of sound wood are represented by scaled lines overlaid on the Picus image below:

It is apparent from this view that exaggeration in the extent of decay/hollowing has occurred on the northwest side.

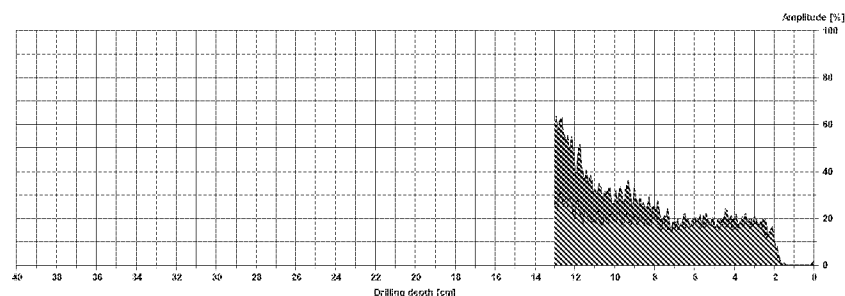
A final Resi measurement was made at the base of a large ascending limb which exhibits an area of bark dysfunction; the result does not indicate any deterioration on the outer stem and drilling was stopped at a depth of 13cm due to rapidly rising drilling resistance:

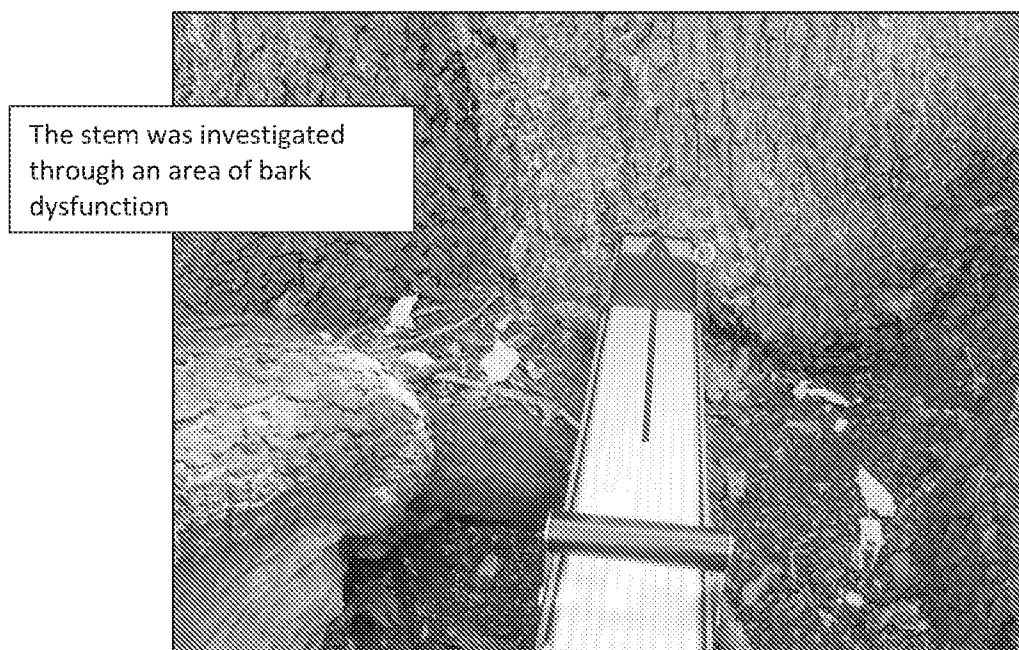
The location of this drilling is shown in a photo overleaf:

Mr Brewster's report notes the presence of Honey Fungus rhizomorphs within the soil-filled cavity that appeared to be associated with bark dysfunction at the base of the ascending stem that was investigated using the Resi.

If Honey Fungus is the cause it is likely that further loss of functioning bark will develop in this and possibly other parts of the base. It will be important going forward that those on site inspect the lower stem for indications of this and possibly other species of fungal species. Identification of these will assist the future management of the tree. Although Honey Fungus may be associated with the bark disorder above the soil-filled cavity, it is not likely to be responsible for other discrete areas of bark discolouration.

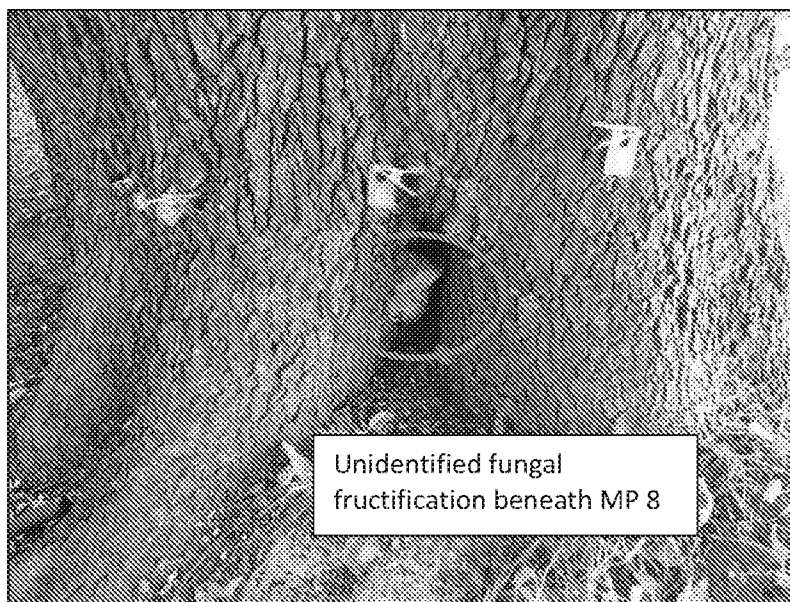
I originally suspected that the area shown above, in the deep fork between stems, may be composed of organic material (subsequently forming soil-like material); however the results of this investigation and the presence of an emergent fungal bracket nearby, in a concavity below MP 8, suggest that active decay is likely to be present.

In view of the tree's position within an area of domestic housing, it is obviously prudent to ensure the size of the crown does not exceed the structural strength of the lower stem. Accordingly I support the recommendation in Mr Brewster's comprehensive report to carry out staged reduction and advise that this is commenced as soon as practicable (following receipt of any necessary consents).

- Carry out crown thinning and reduction as informed by Mr Brewster's report
- Ensure the tree is subject to periodic visual inspection by those on site and professional assistance sought if any indications of decline in vigour or structural condition are noted
- Repeat an assessment of decay and hollowing in the combined lower stem in 3-4 years
