# TREE RISK ASSESSMENT REPORT

43 Ferringham Lane, Ferring, West Sussex, BN12 5NB

| <b>Document<br/>reference:</b> | MDJAC-AM25111-TRAR-01 |
| <b>Date:</b> | 5 January 2026 |

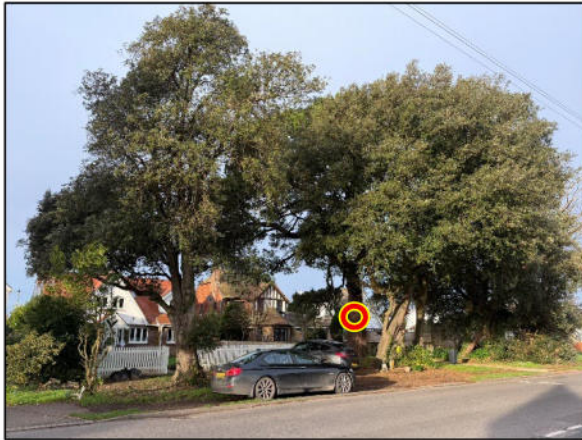
*Photograph 1: below left, looking westwards across Ferringham Lane towards the subject pine tree [red circle on trunk], screened by other Holm oaks in the foreground; and*

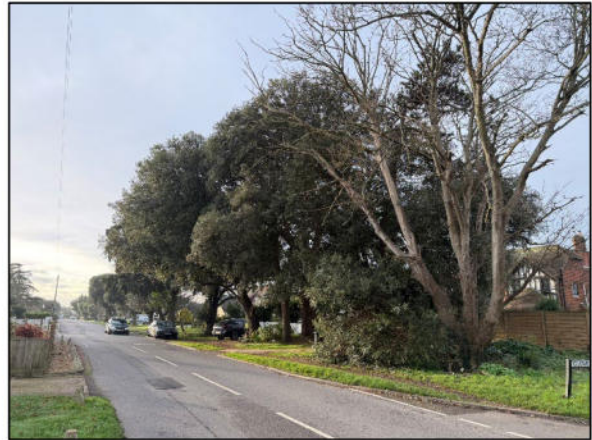
*Photograph 2: below right, looking south-westwards across Ferringham Lane, demonstrating the lack of prominence of the subject tree from the street scene.*

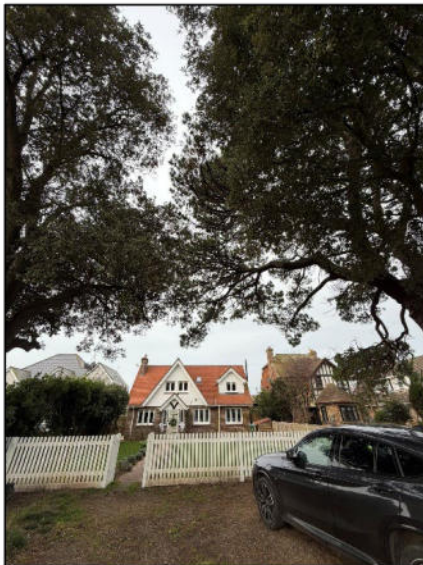
*Photograph 3: below left, looking westwards towards the picket fence and subject property; and*

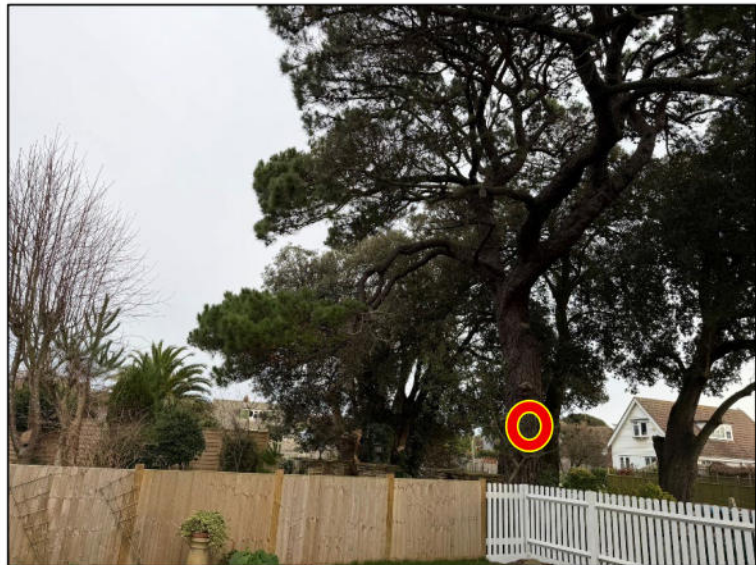
*Photograph 4: below right, looking northwards towards the subject tree, showing the boundary fencing between the subject property and the adjacent plot.*

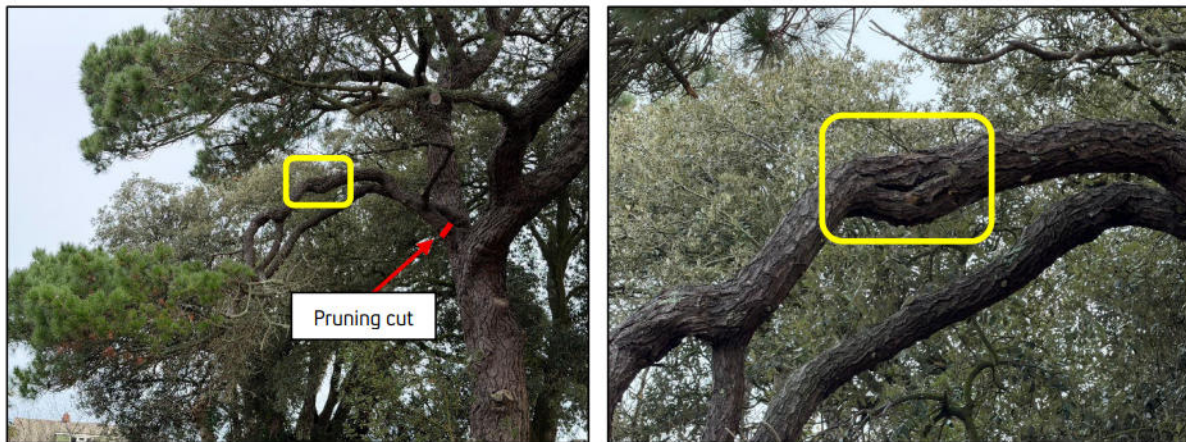
4.1.4. My assessment identified what appears to be a 'hazard beam' (see glossary of arboricultural terms) associated with a heavy, pendulous branch located at approximately 6m on the western side of the trunk. While failure of this limb is unlikely to pose a material risk of injury to my client at No. 43 Ferringham Lane, it does present a risk of injury to the adjoining landowners. Given the limited occupancy and low levels of pedestrian activity beneath the canopy on the neighbouring side caused by the adjacent owner's age and lack of mobility, the likelihood of personal injury is low. Consequently, damage to the boundary fencing would be a more probable consequence should the branch fail. In any event, it would be prudent for this branch to be removed as part of the tree's proactive risk management.

Photograph 5: showing the branch in question. Defect shown in yellow, pruning cut location to remove branch shown in red; and

Photograph 6: below right, showing a close up of the 'hazard beam' formation.

| Tree No. | Species | Risk Rating | Recommendation |
|---|---|---|---|
| T1 | Monterey pine | <b>Moderate</b> | <p>Remove all deadwood;</p> <p>Remove 1no. 'hazard-beam' at 6m on west side;</p> <p>Remove 1no. branch at 8m on south side (100mm dia.), overhanging garden of No. 43; and</p> <p>Reduce the remaining south-west and south sections by 1-1.5m.</p> |

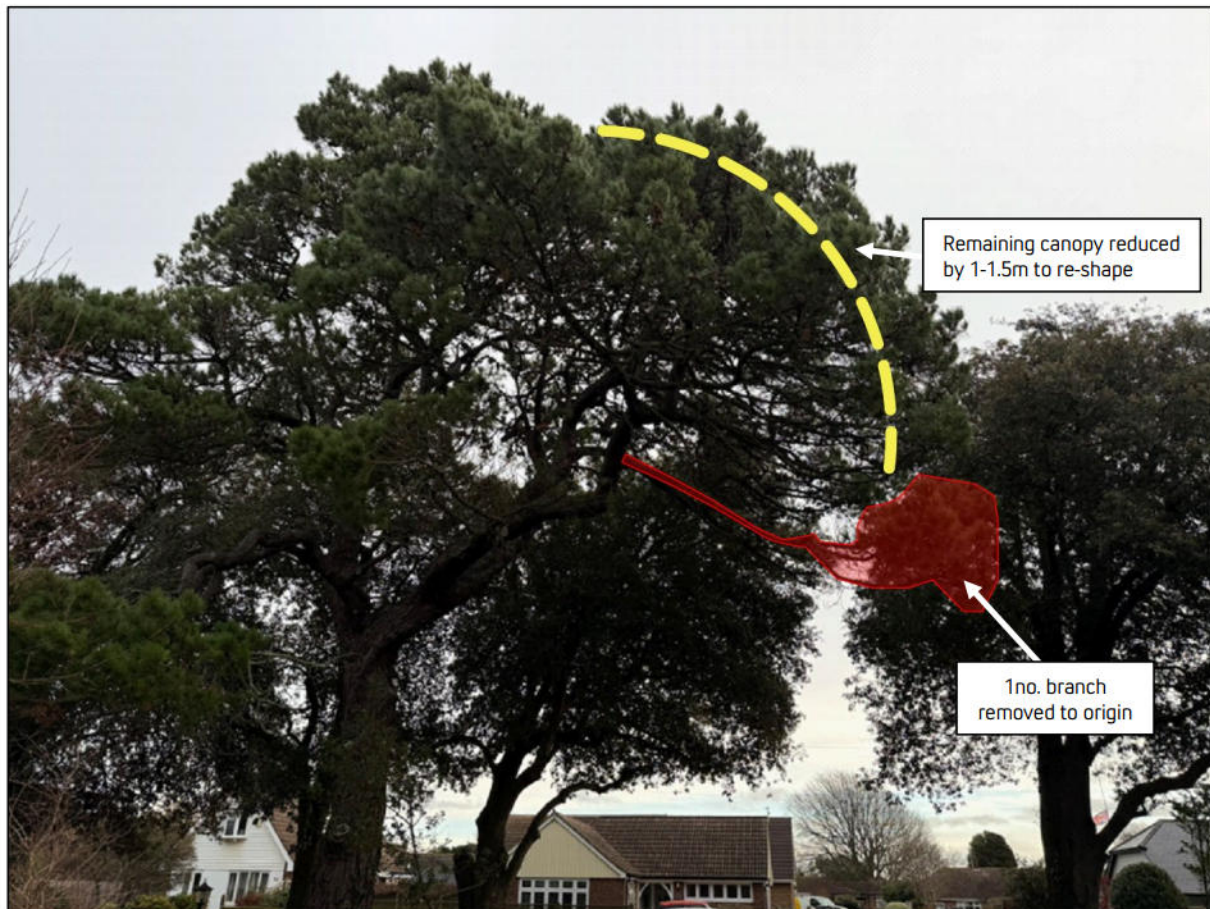
4.1.6. A species-specific consideration in this instance is the frequency of cone fall from the tree, which has occurred on several occasions in the past. This has resulted in damage to vehicles, and on one occasion a falling cone struck the hand of the owner of the subject property at 43 Ferringham Lane, while he was working in his garden.

4.1.7. Monterey pine (*Pinus radiata*) produces large, heavy, woody cones, which can pose a foreseeable hazard where trees overhang occupied areas. The cones typically measure in the region of 8–15 cm in length and can weigh in excess of 300g when dry, and considerably more when wet. They are formed in clusters and are retained on the tree for many years, often falling unpredictably due to wind, decay of the attaching structure, or disturbance from wildlife. When shed from height, these cones can generate sufficient force to cause injury to people or damage to vehicles, roofs, and other property beneath the canopy. In locations where public access or regular occupation occurs below the crown spread, the presence of mature cones materially increases the risk profile of the tree, providing reasonable justification for targeted pruning to reduce overhanging growth and manage foreseeable risk.

*Photograph 7: showing pruning requirements to reduce the likelihood of cone fall causing further damage or injury to 43 Ferringham Lane.*

4.1.8. Accordingly, it would not be unreasonable for the specific removal of branches and the cutting back of lateral branches overhanging 43 Ferringham Lane, to be undertaken in the interests of risk mitigation. Pine does not readily tolerate heavy pruning, and so this element would have to be undertaken sensitively by removing 1no. branch back to its origin, and reducing the remaining lateral foliage by 1-1.5m, as shown below.

4.1.9. The proposed canopy reduction works can be undertaken in accordance with BS3998:2010 *'Tree Work - Recommendations'* and will be largely screened from the public realm by the canopies of the adjacent evergreen Holm oaks fronting Ferringham Lane. While the works will be partially visible from Clover Lane, the tree is not a prominent landscape feature from this viewpoint, and as such, the resultant impact on the character and appearance of the site and the wider area will be minimal.
