**Project Name:** 40 Little Paddocks, Ferring, Worthing, BN12 5NJ

**Project Description:** Condition and Connectivity

**Inspection Standard:** MSCC5 Sewers & Drainage GB (SRM5 Scoring)

The survey was carried out to ascertain connectivity.

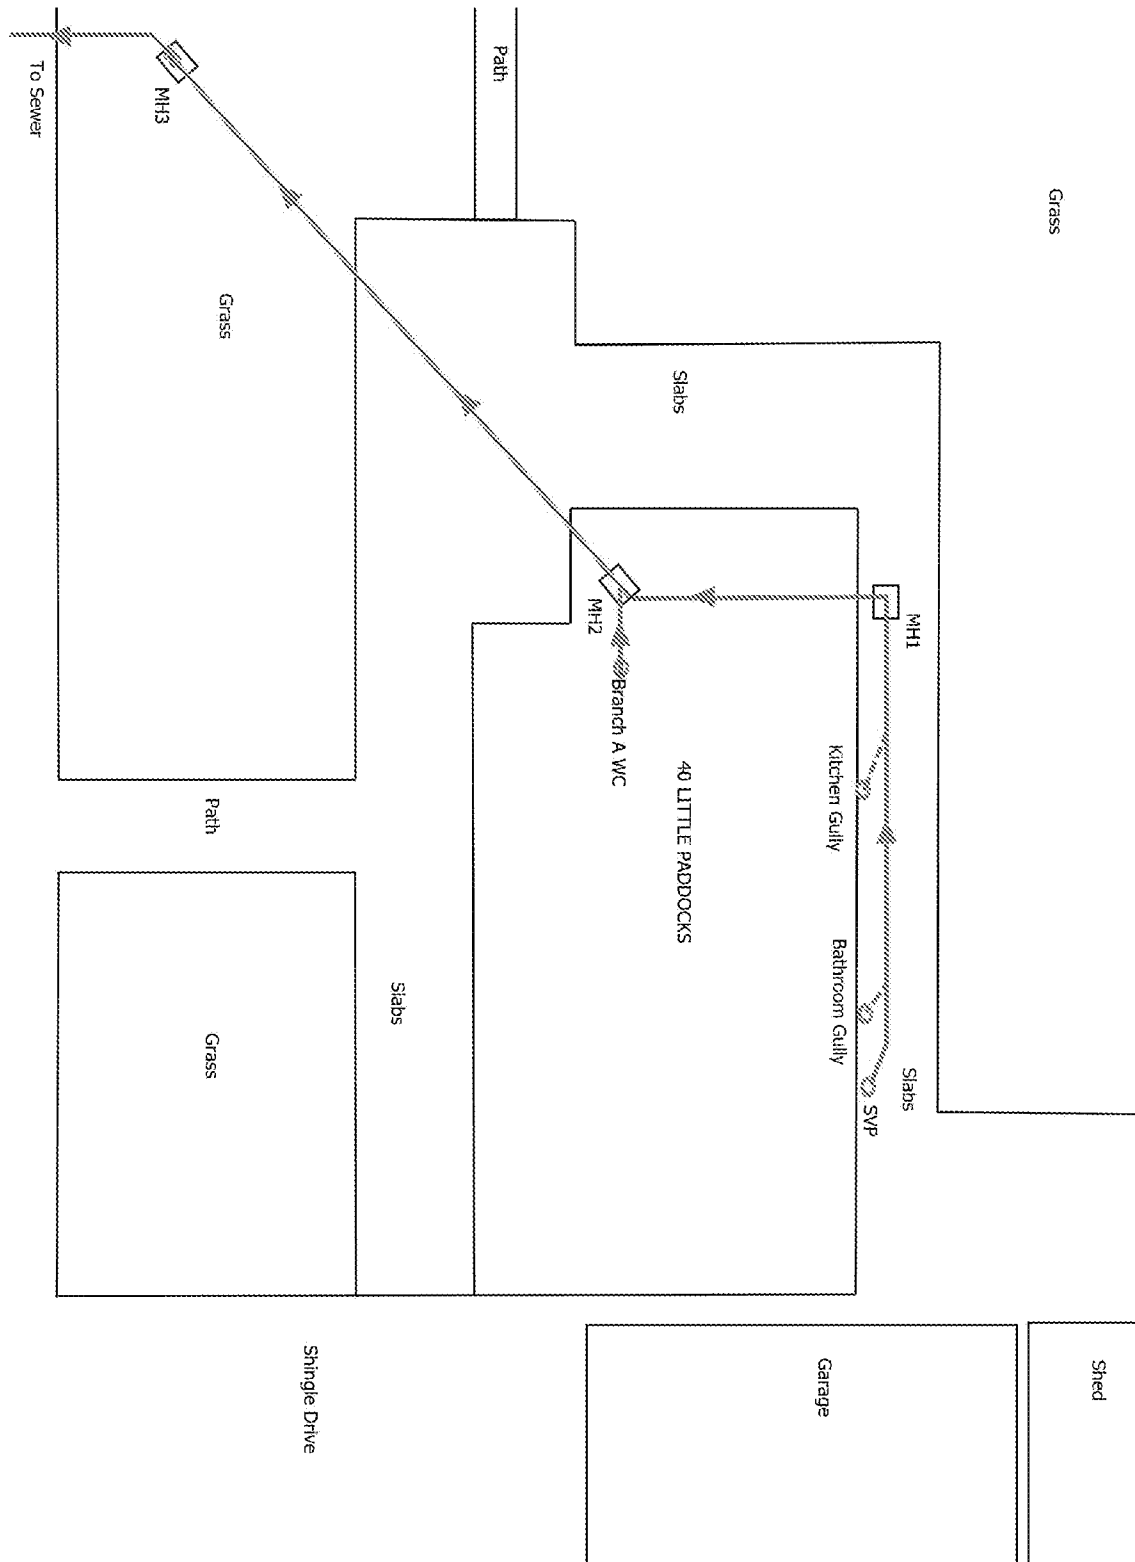
## Project Drawing, Page 40 Little Paddocks, Ferring, Worthing, BN12 5NJ

The pipework is being removed and replaced/reconfigured due to building works. Please see attached plan for layout.

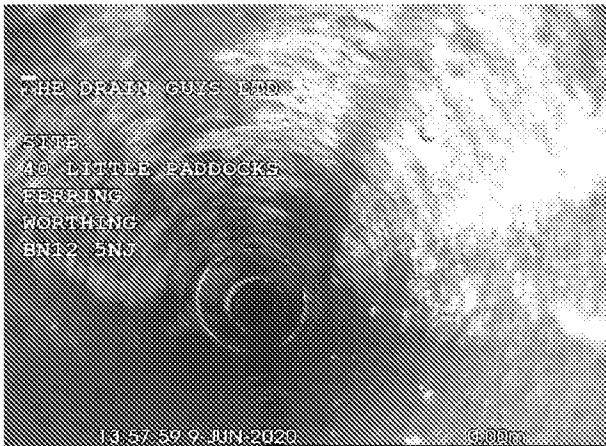
INLET

Start node type, manhole, reference number: MH1

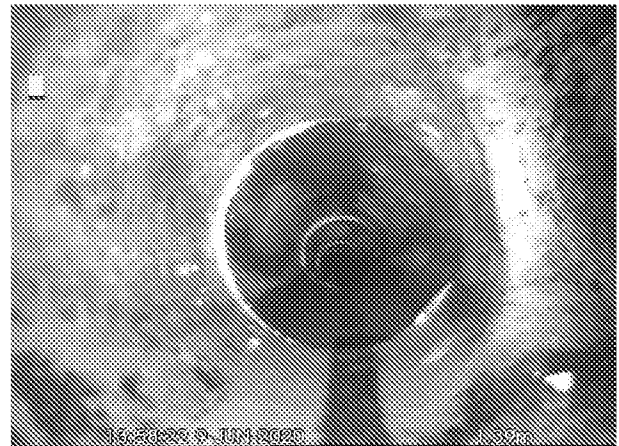
INLET

Junction at 3 o'clock, diameter: 100mm: Kitchen Gully

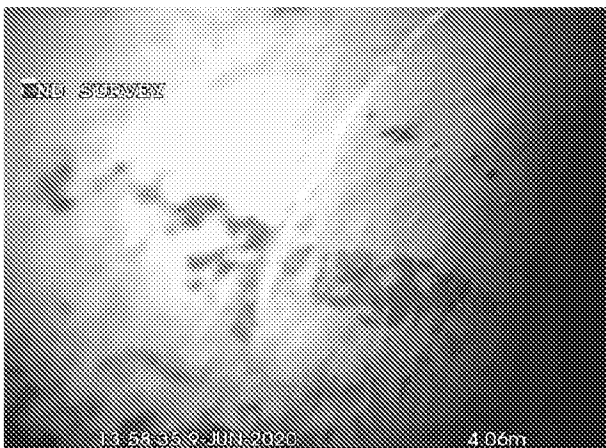
INLET

Finish node type, other special chamber, reference number: INLET: SVP

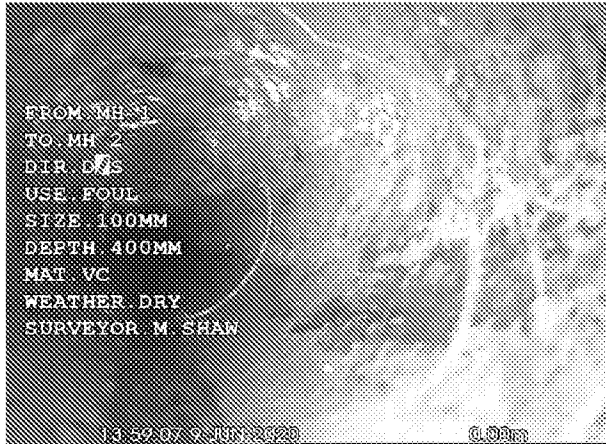
MH1X\_e81b9753-9b49-4e68-bae3-f0b6decfb0e\_20200612\_123833\_203.jpg, 00:00:00, 0.00 m  
Start node type, manhole, reference number: MH1

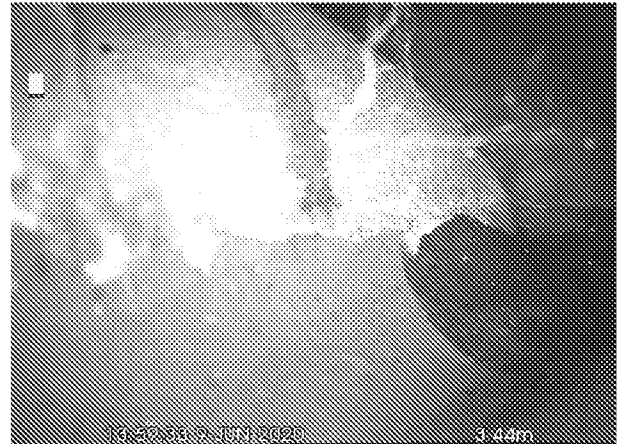
MH1X\_3ad51c90-37eb-496d-8c27-056d4efdce8d\_20200612\_123910\_992.jpg, 00:00:25, 3.44 m  
Finish node type, manhole, reference number: MH2

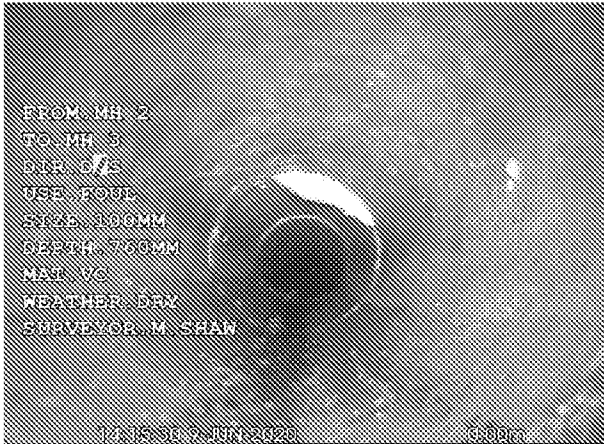
MH2X\_1afa7fa6-f4ad-498c-8581-4f24decbee1f\_20200612\_124158\_865.jpg, 00:00:00, 0.00 m  
Start node type, manhole, reference number: MH2

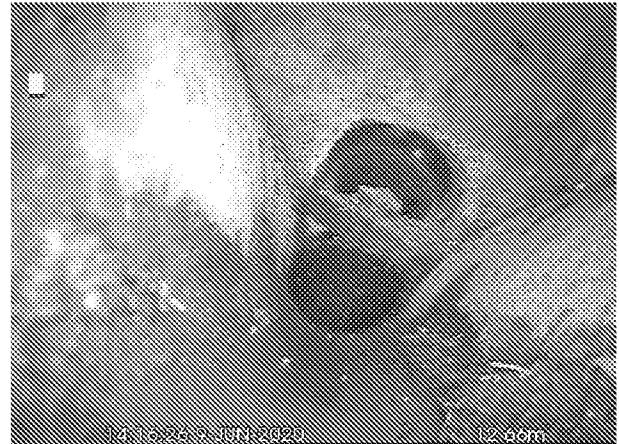
MH2X\_3dc4050a-39bf-4292-a0d1-a05d6bbe9c05\_20200612\_124302\_265.jpg, 00:00:57, 12.66 m  
Finish node type, manhole, reference number: MH3

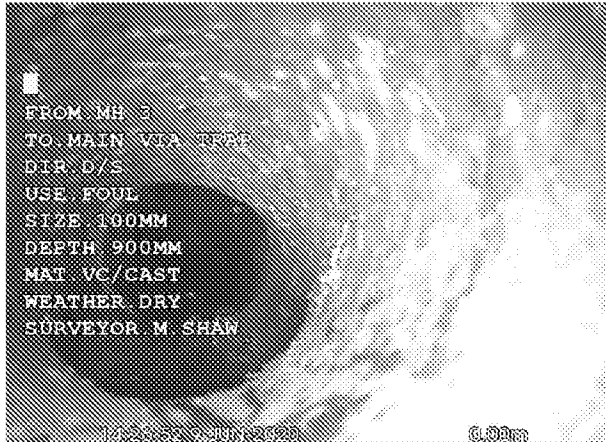
General remark: SURVEYING THROUGH INTERCEPTOR TRAP

MH3X\_aaf487c7-fc8a-443a-9460-26c2c92f19c2\_20200612\_1  
24409\_604.jpg, 00:00:00, 0.00 m  
Start node type, manhole, reference number: MH3

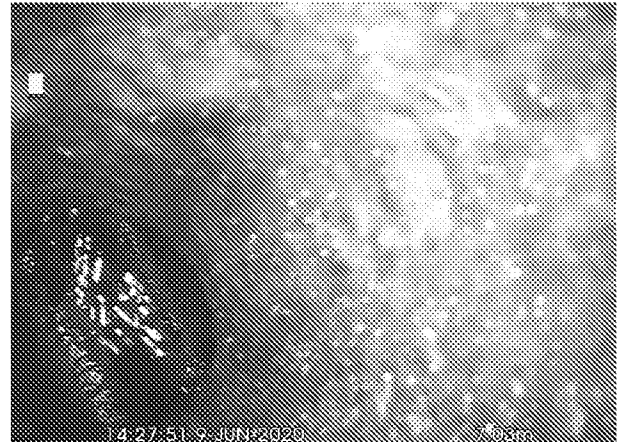
MH3X\_b41864fa-301f-4edc-bf7f-dcfacde1cd7c\_20200612\_12  
4546\_390.jpg, 00:01:00, 7.03 m  
Finish node type, major connection without manhole, reference
