## **REASONS FOR PROPOSED TREE WORK**

### **T1 Horse chestnut along the west fence line:**

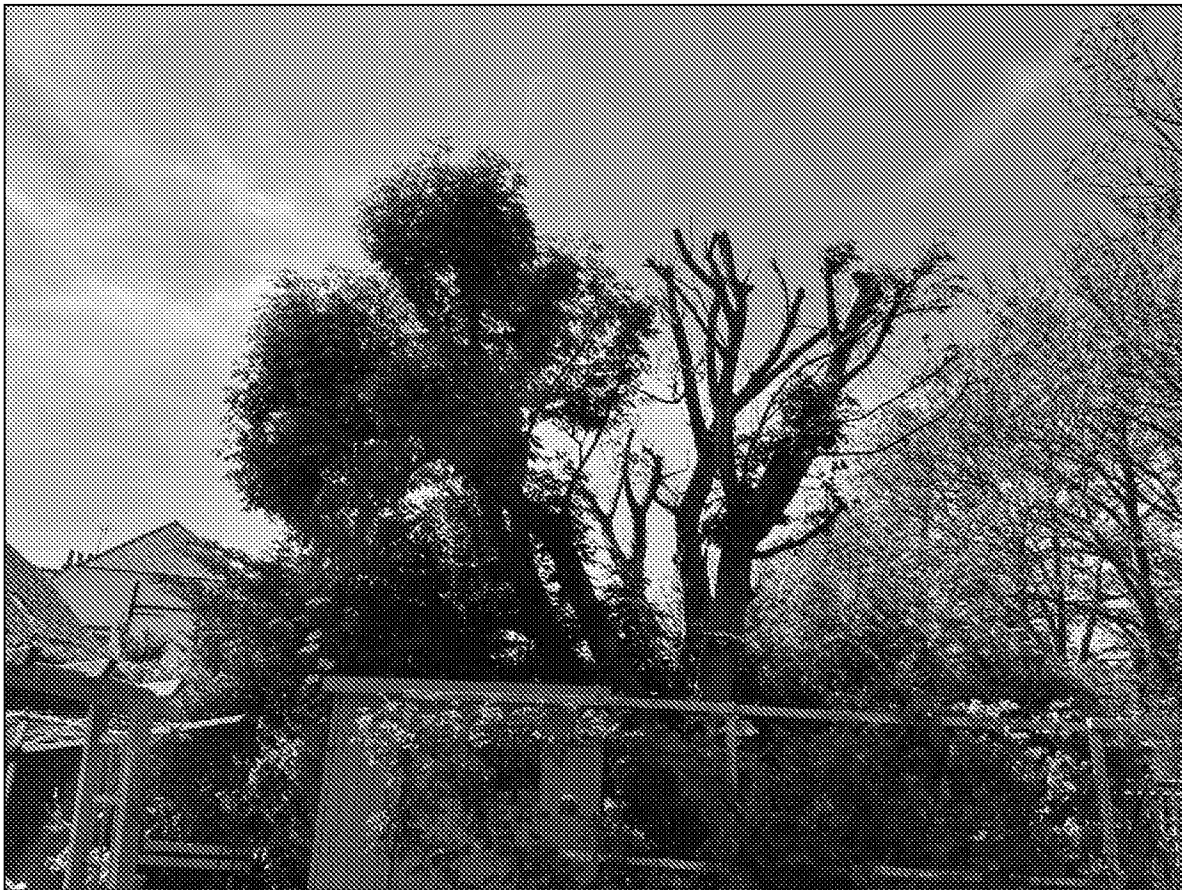
*The tree is in terminal decline with only c.35-40% live crown remaining.*

*Fructifications of the decay fungus *Ceriporus squamosus* are present along the main stem indicating decay is present and with Horse chestnut's poor ability to compartmentalise decay, further deterioration of the stem is inevitable*

- Sectional fell

*The intention is to remove the tree, grind out the stump and make ready for a replacement tree – the species of which has yet to be decided*
