Photos to show examples of existing condition of the interior and exterior of 30 Limmer Lane

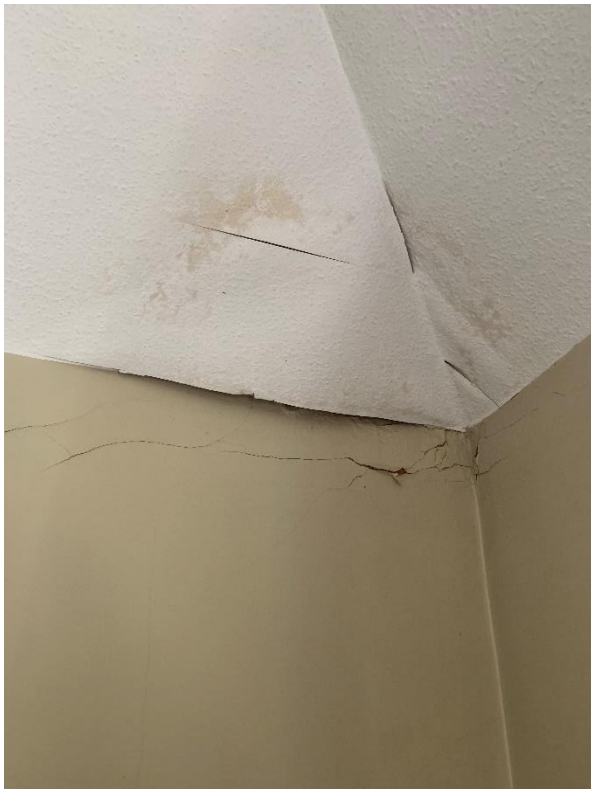
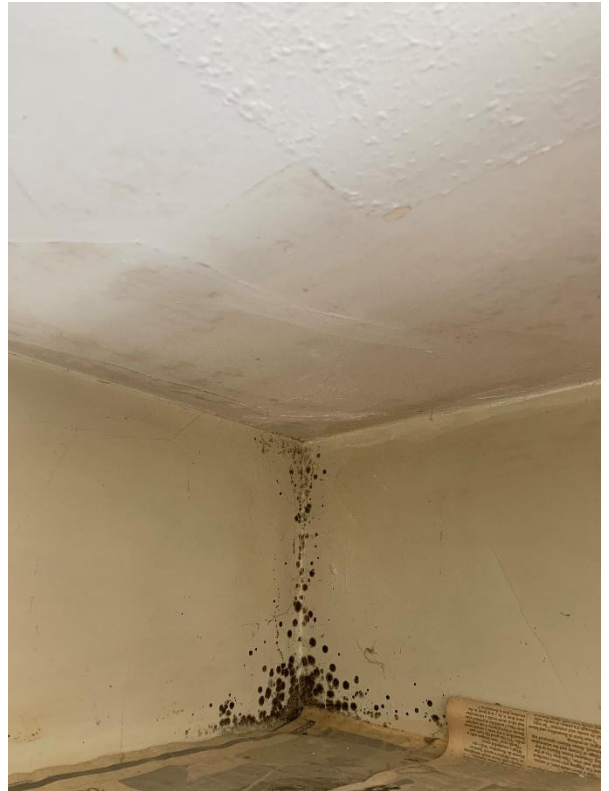
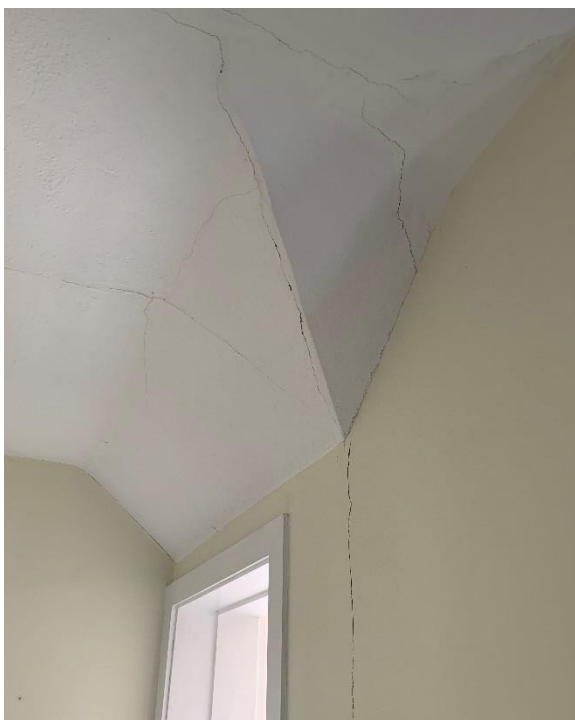
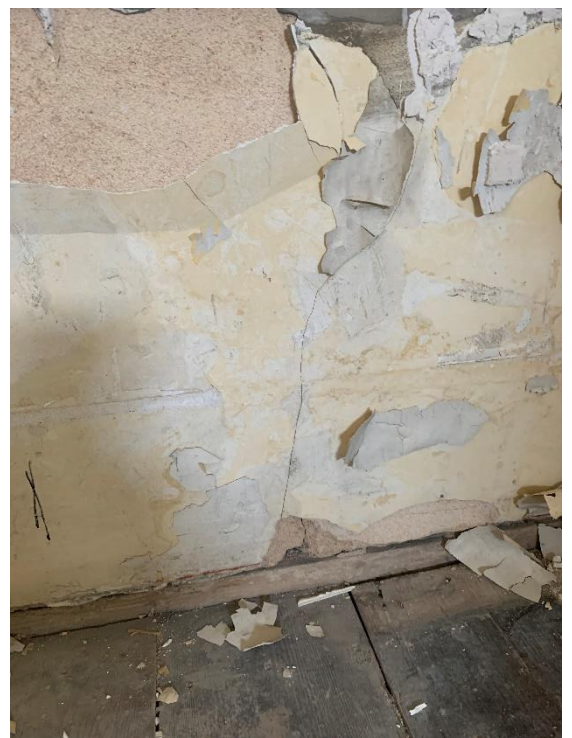
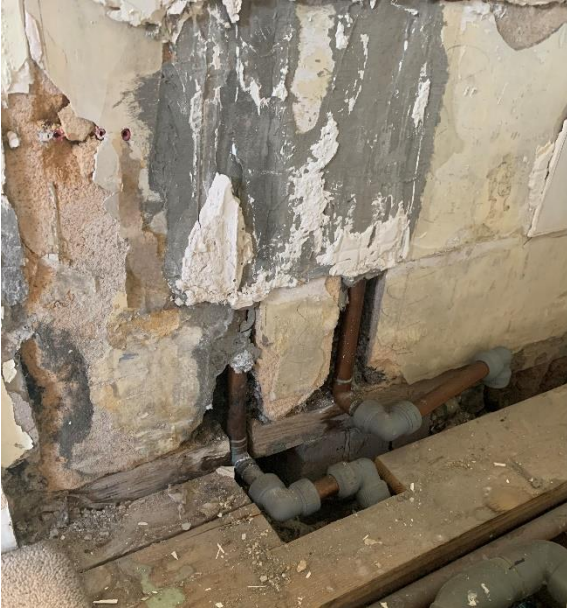
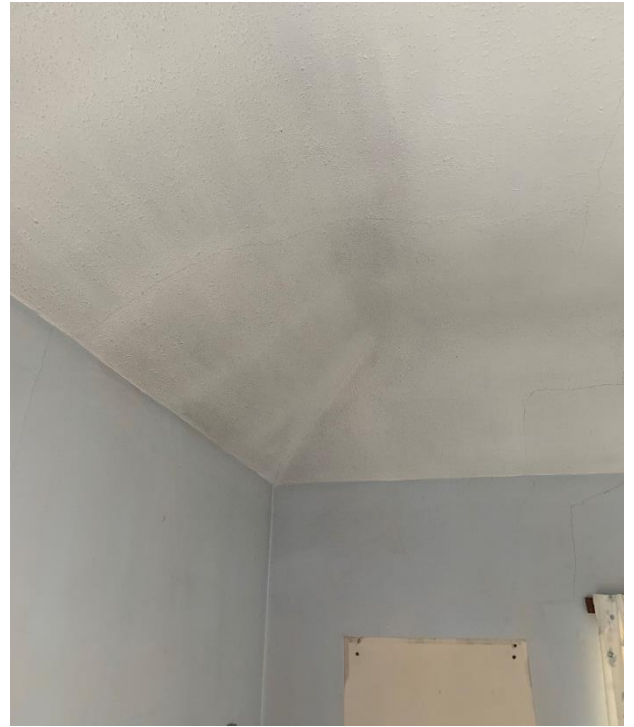
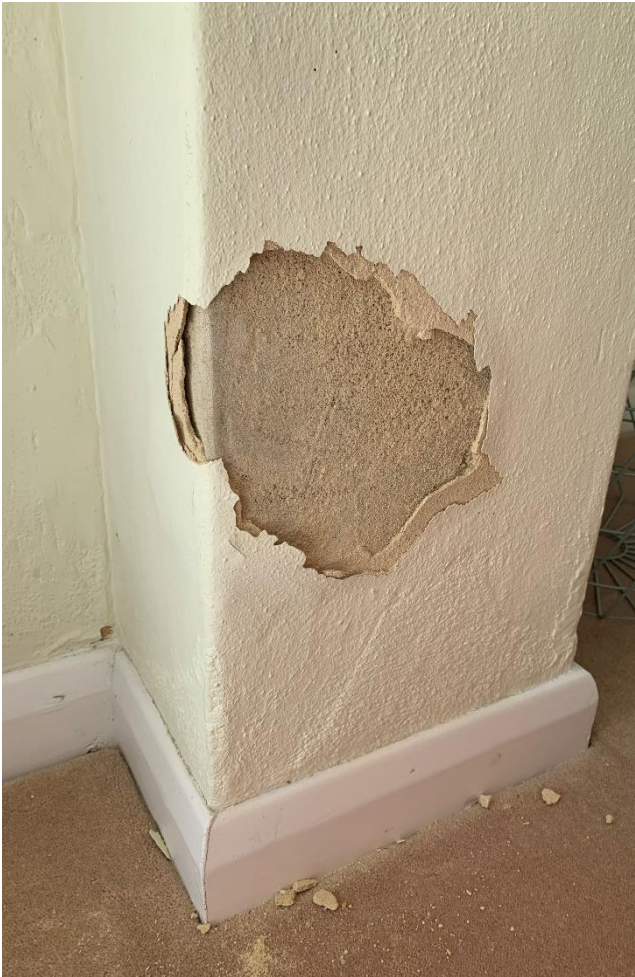
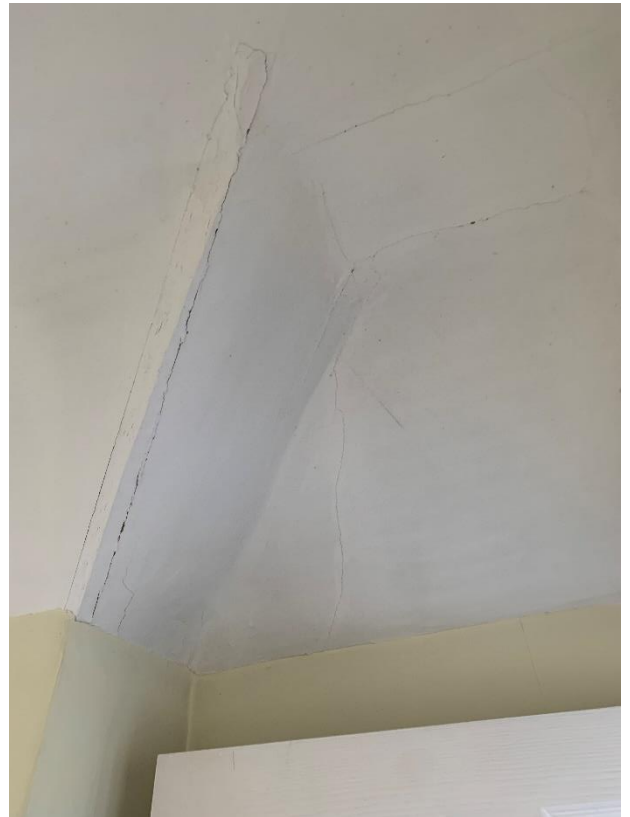
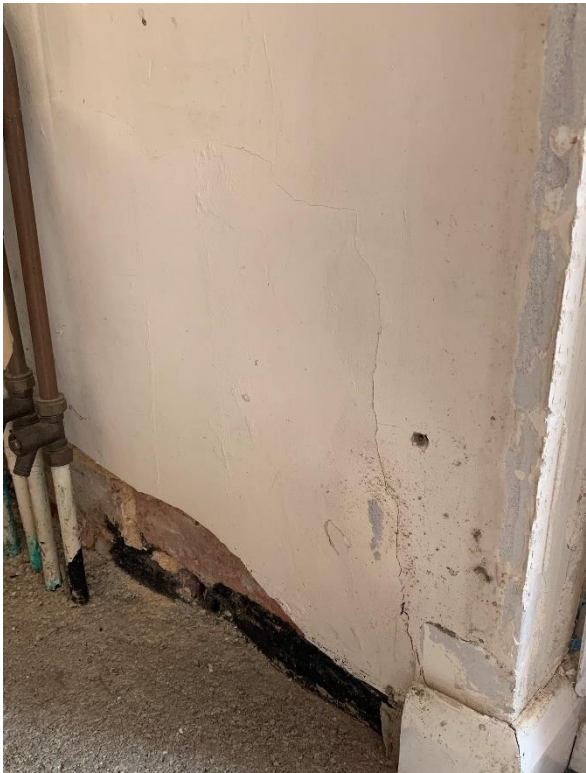
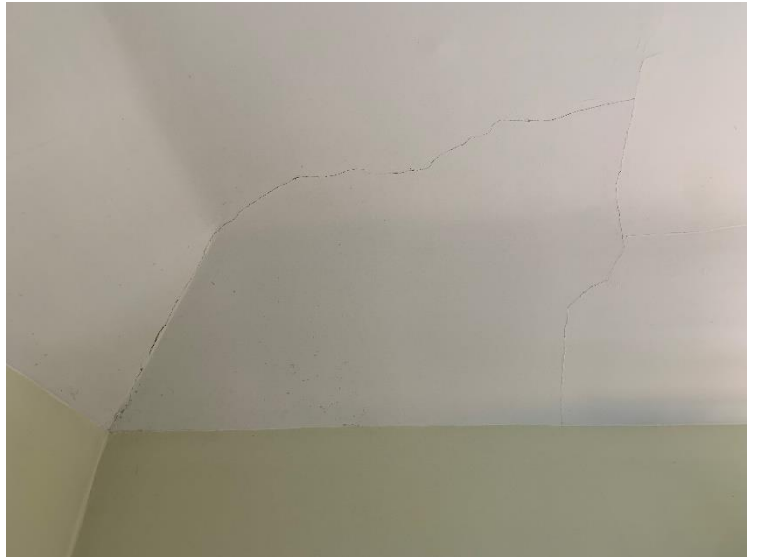
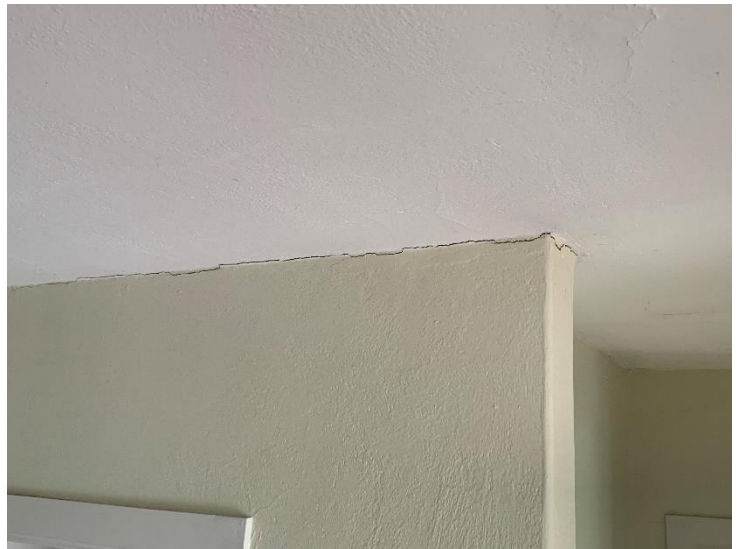
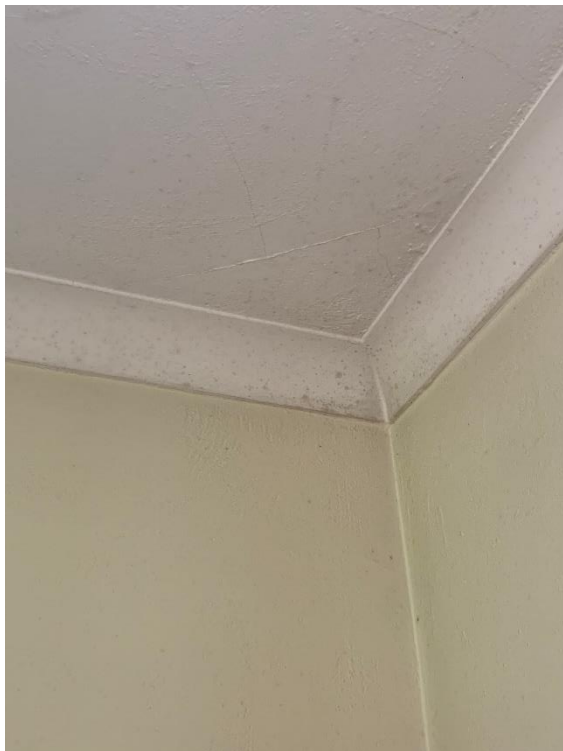
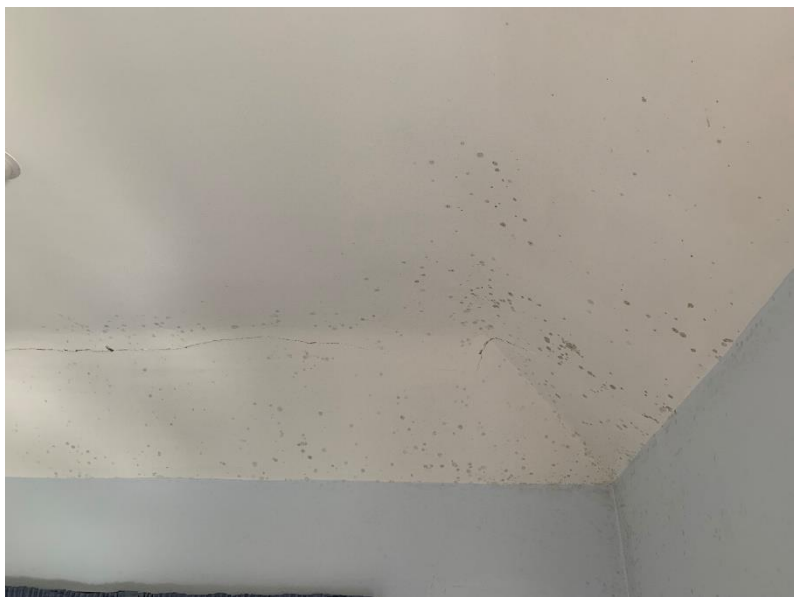
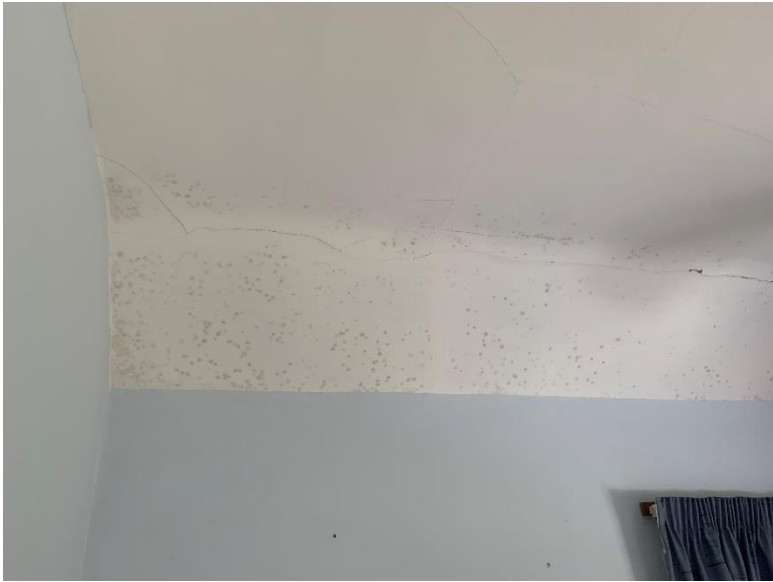
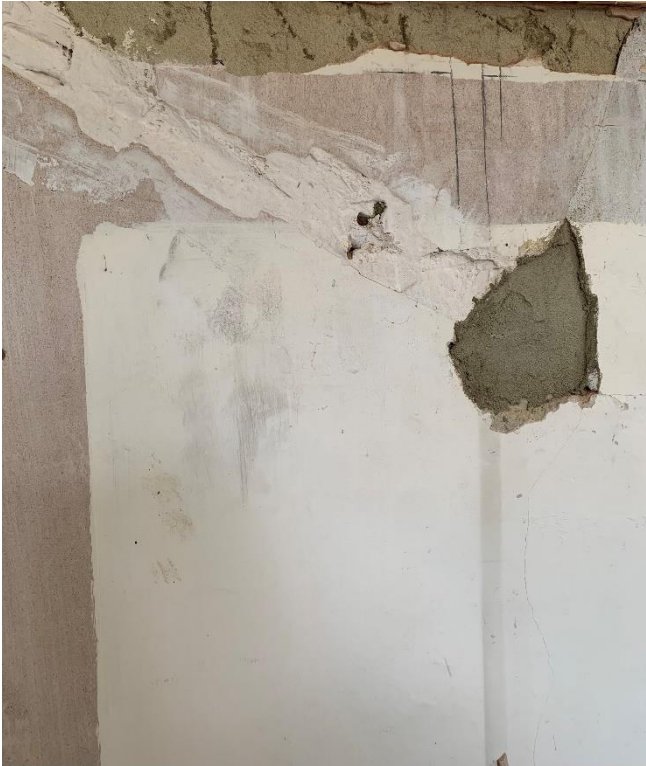
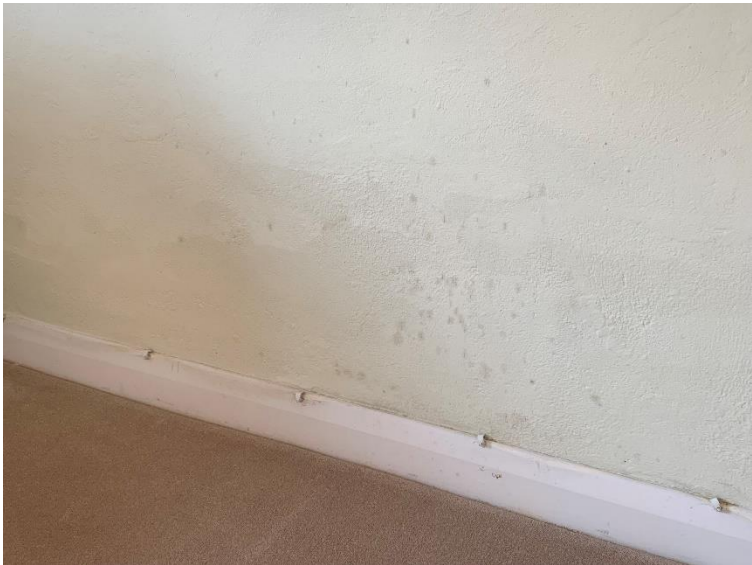
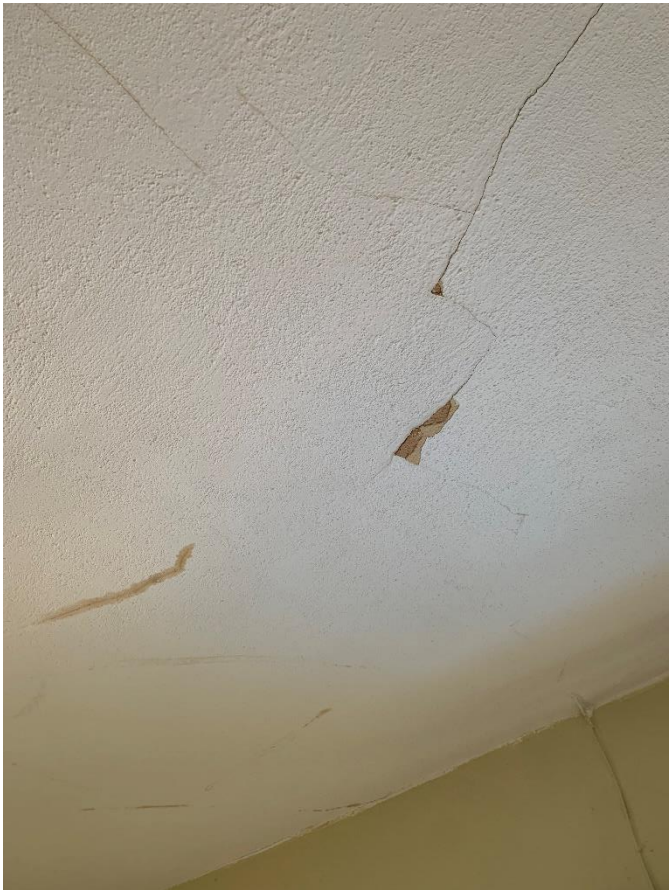
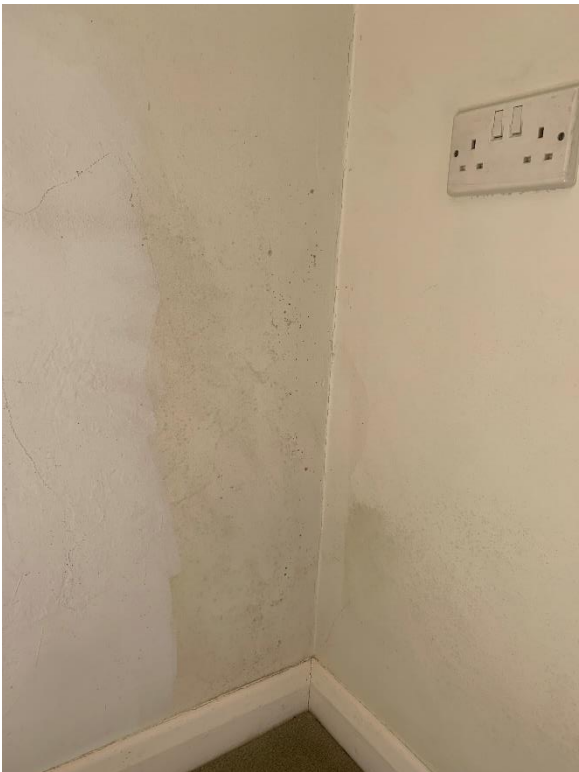
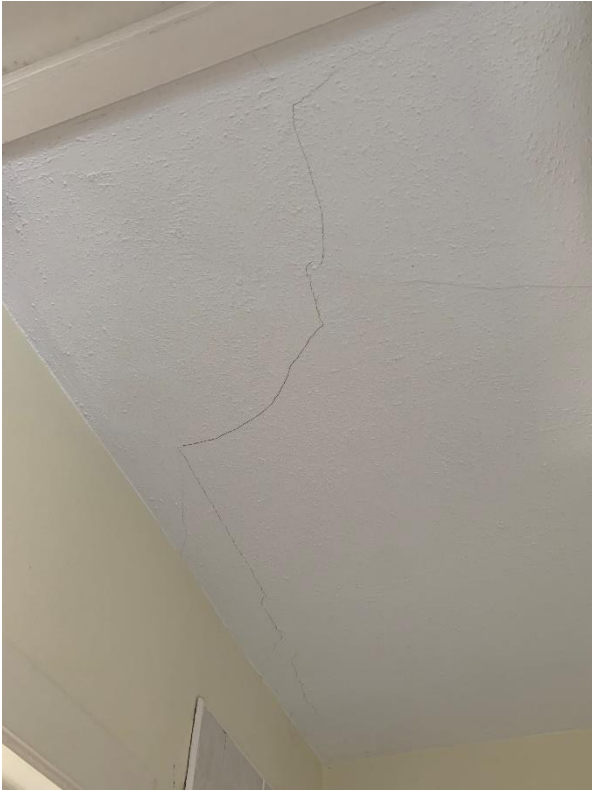
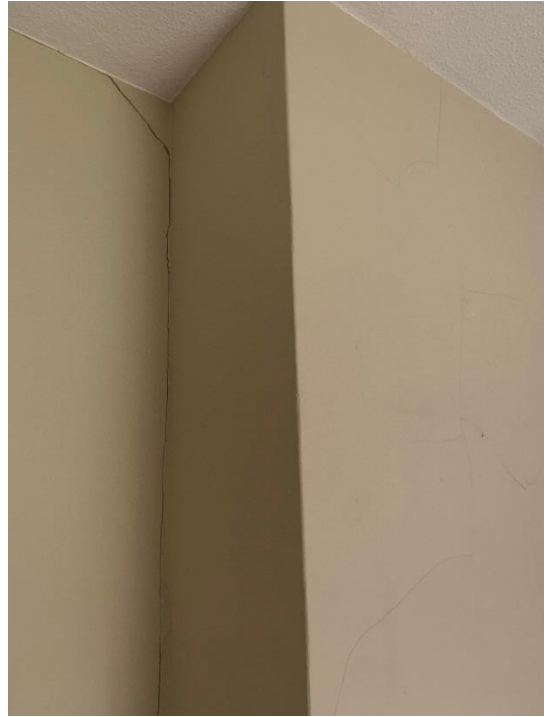
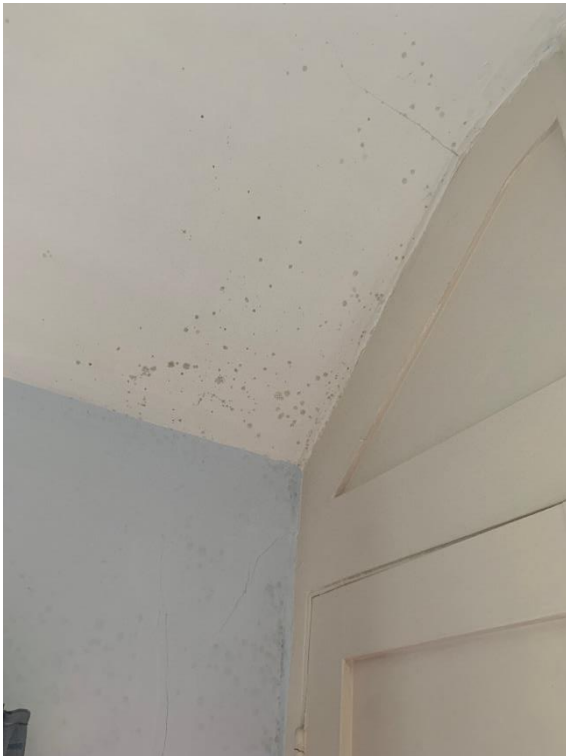
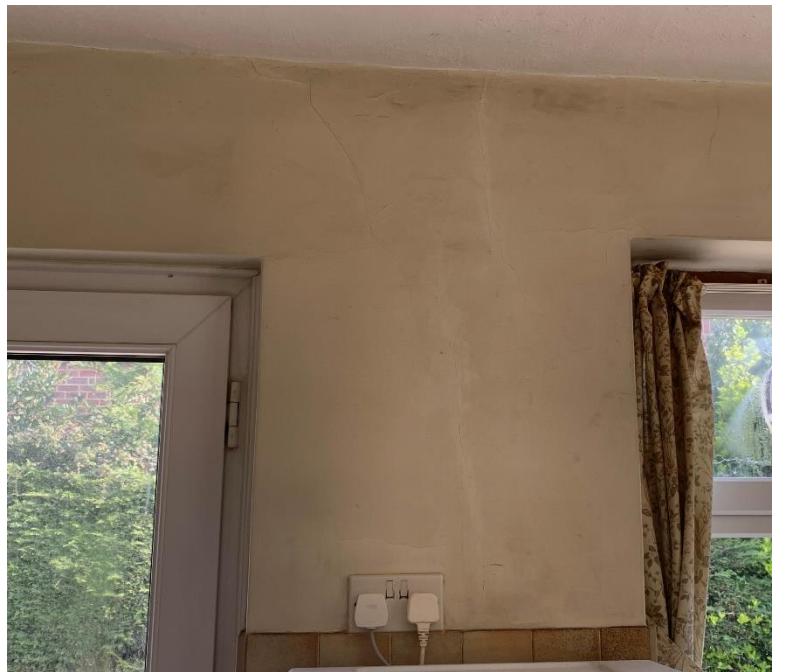
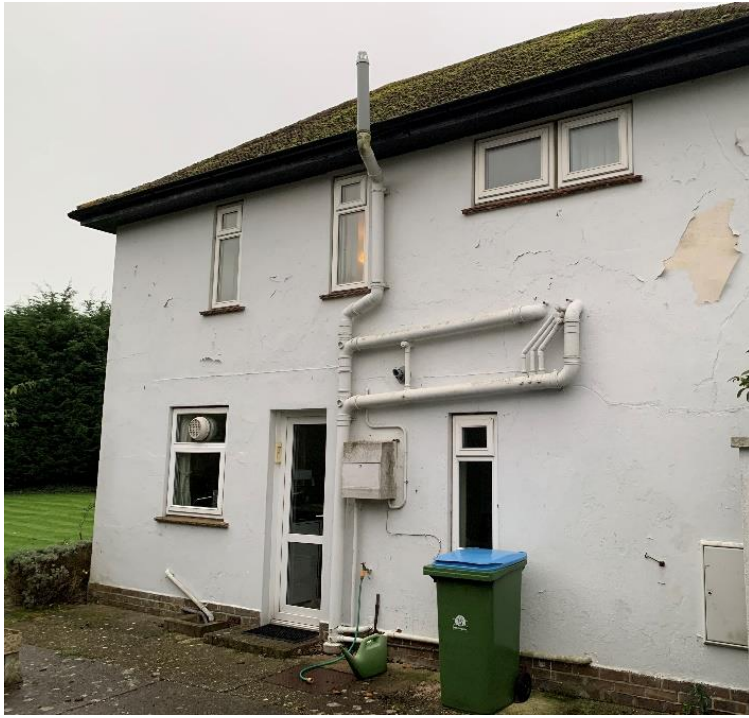
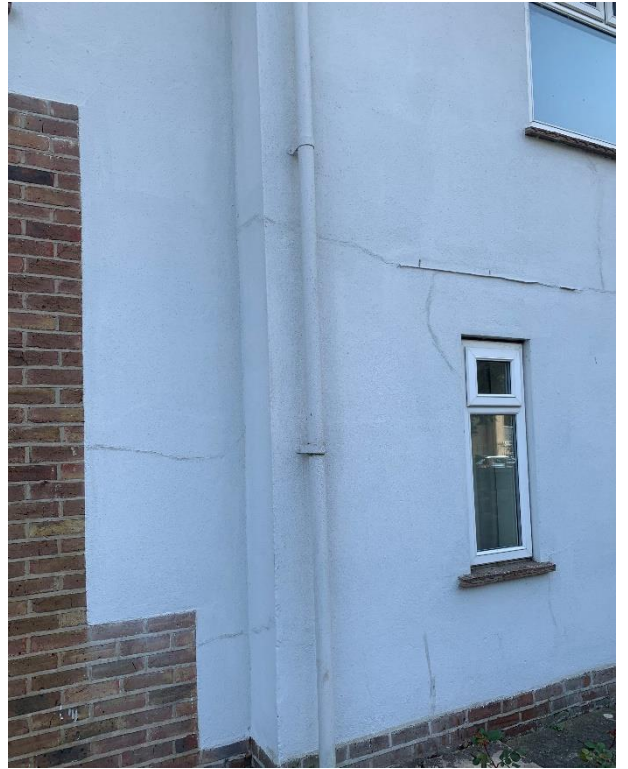
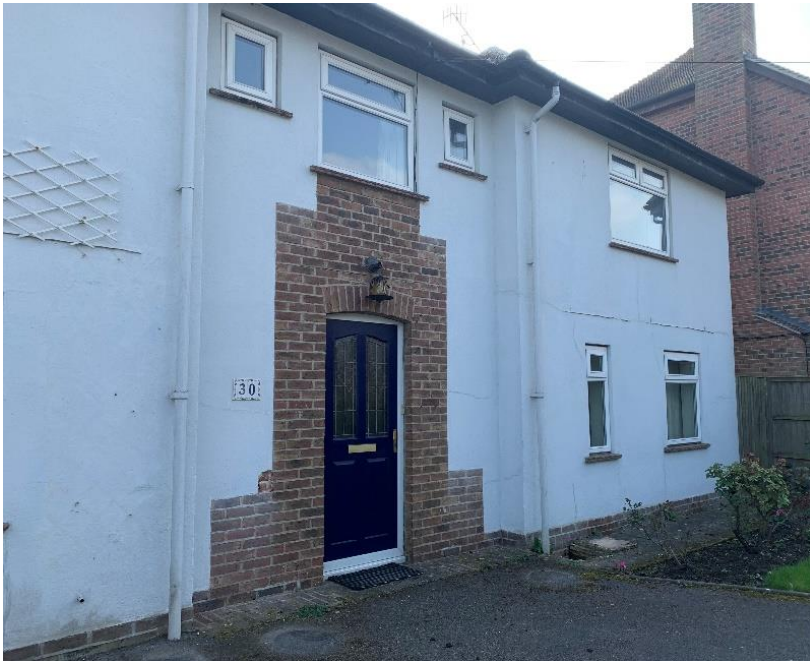
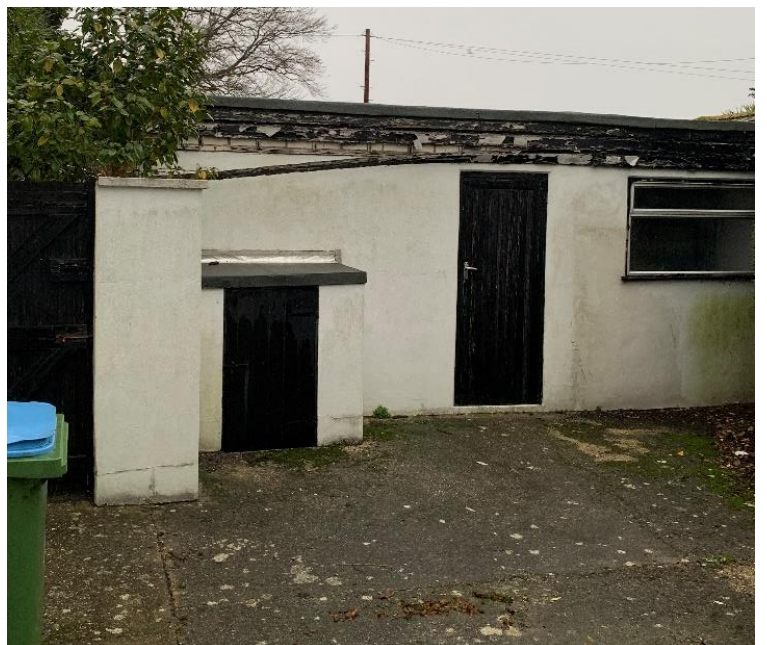
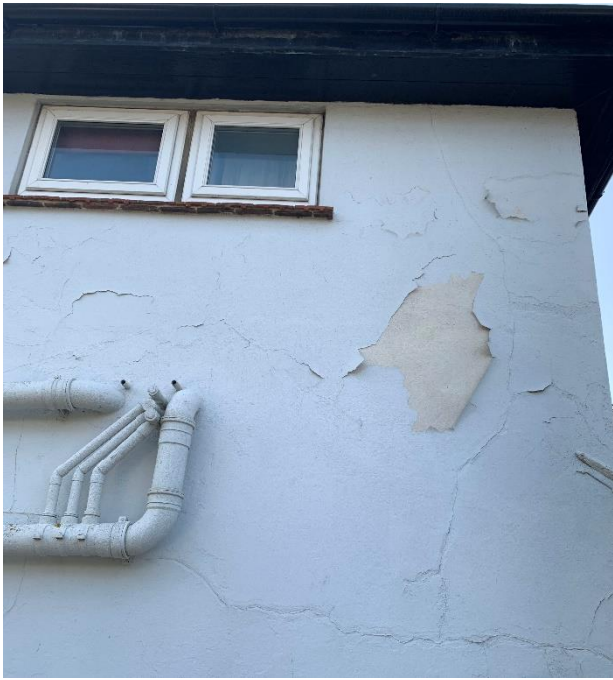
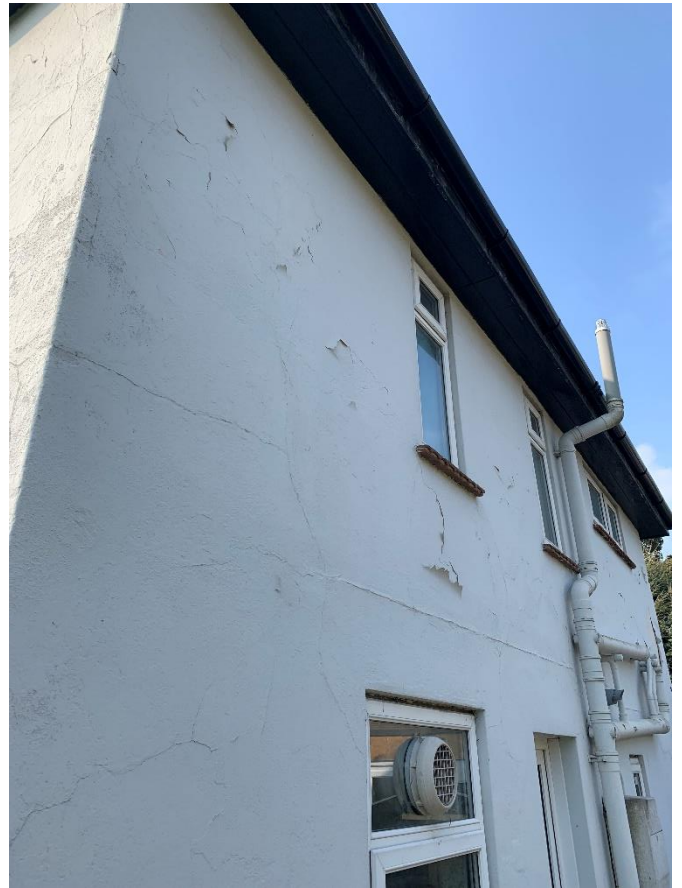
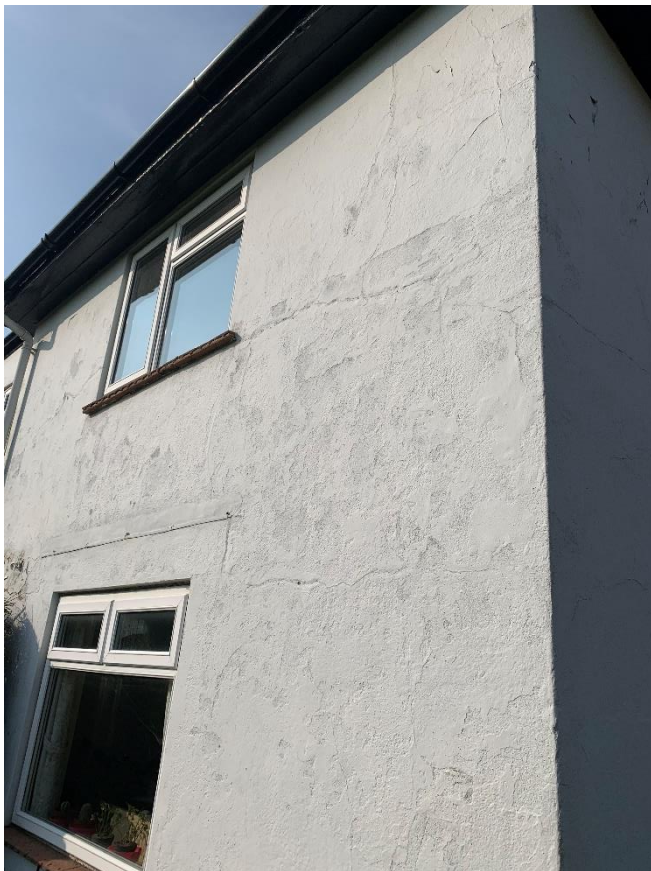
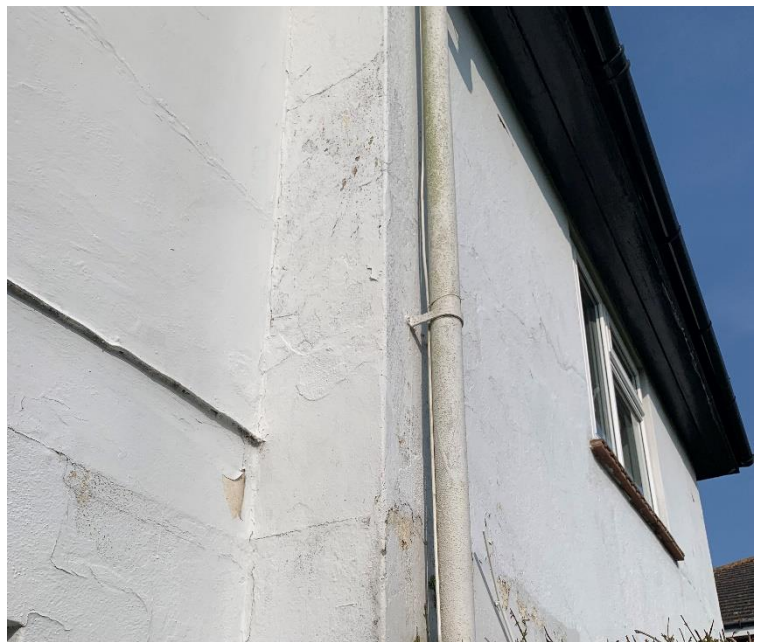
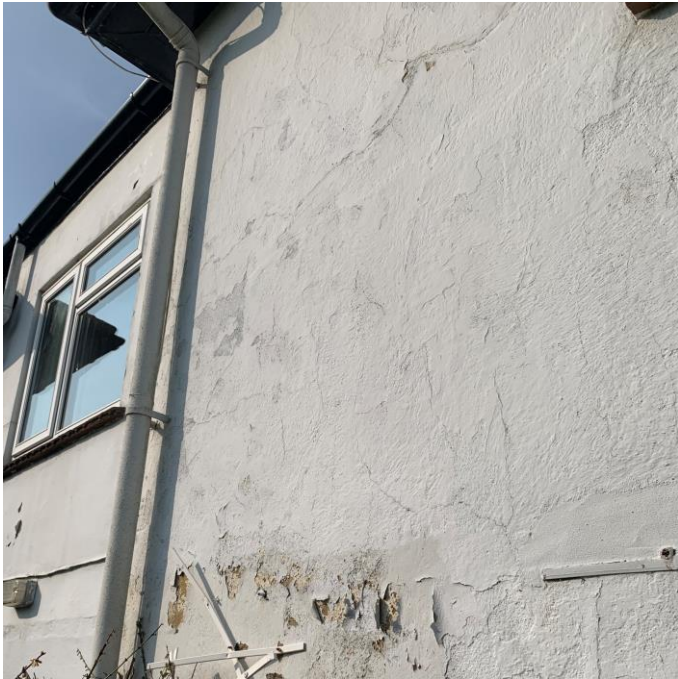
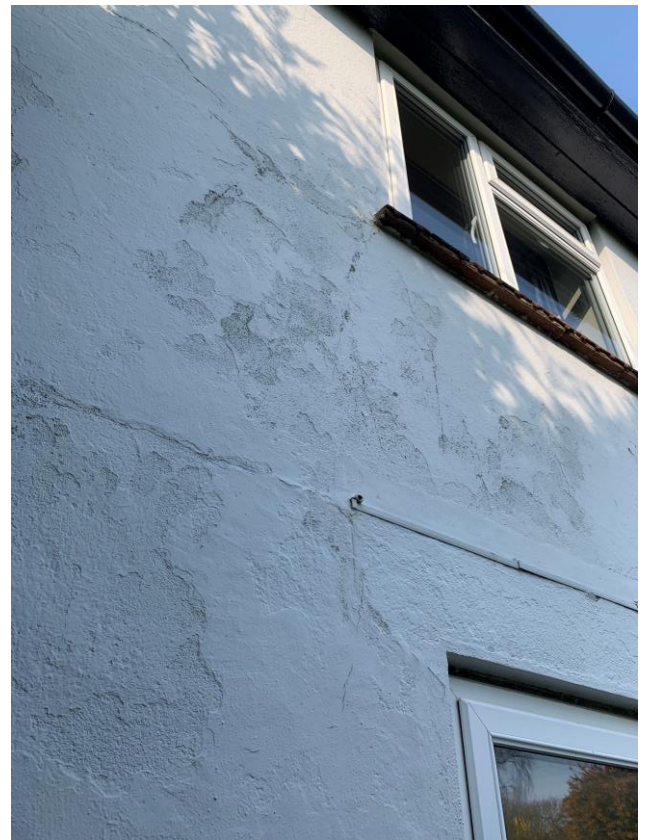
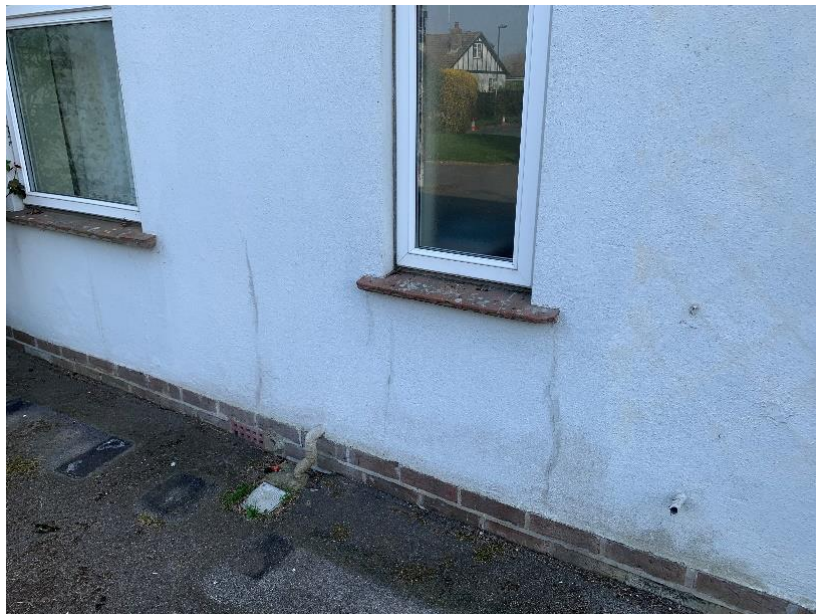
Main points identified include (but not limited to):

- Mould and damp on majority of internal walls
- Cracking of many internal walls and ceilings
- General dilapidated condition
- Crumbling interior finishes
- Water ingress
- Cracking of many areas on external walls
- Damaged roof
