# TREE REPORT AT 46 OUTERWYKE ROAD, BOGNER REGIS

COMPILED BY CARLOS DALY (Arbor A Tech.Cert, NCH Arb)

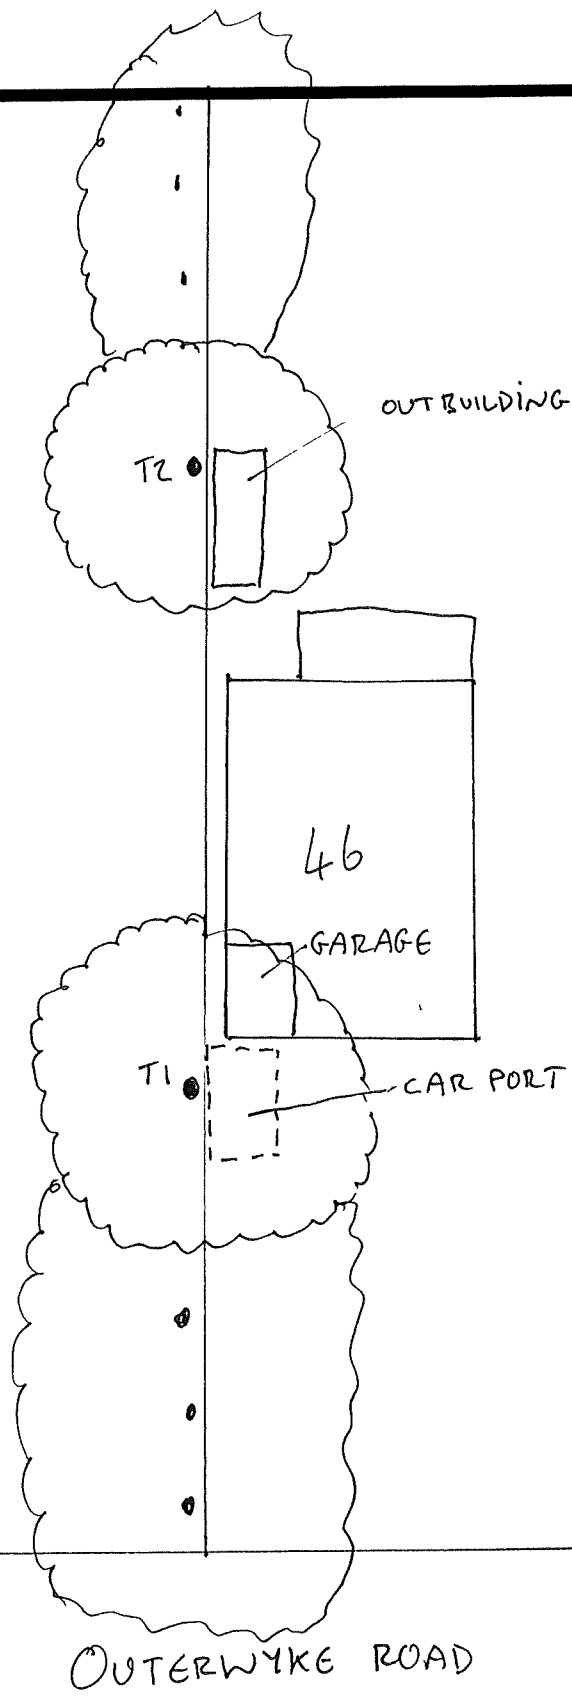
- 2.1 (SEE FIG 1 & PIC 1, 6 & 7) The 2 number Monterey cypress' are located on the Western boundary of 54 Outerwyke Road. This boundary is adjacent to 46 Outerwyke Road. The 2 number trees are part of a row of Monterey cypress that runs along the length of the boundary between the two properties.
- 2.2 Number 46 Outerwyke Road was built in 1934. The trees in question are approx. 60-70 years old.
- 2.3 The two trees in question are part of a group Tree Preservation Order (TPO) No. 5 (1963) confirmed by Arun District Council. The two trees in question are not within a Conservation Area.

- 3.1 (SEE FIG 1) T1 and T2 are both Monterey cypress (*Cupressus macrocarpa*). They are approx.14m tall and have a crown spread of approx 11m. They are situated so close to the boundary that the some of the trunk and root flare of both trees are trespassing into 46 Outerwyke Road. The upper crowns overhang 46 Outerwyke Road by approx 5-6m.
- 3.2 Both trees seem to be in reasonable health with no obvious defects spotted from ground level.
- 3.3 The trees were 'topped' by approx one third in 2005 as a result of local authority intervention.
