**Barratt Homes****Felpham**

**Inspection Date: 10 Apr 2013**

**Inspection Type:** Post Install Inspection

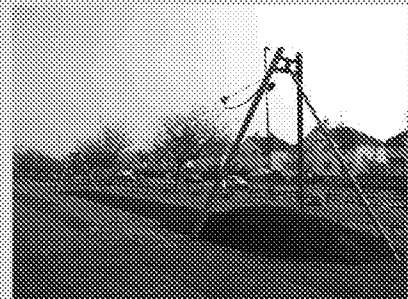
### Aerial Runway

- ❖ Standards Compliance – Yes
- ❖ Surfacing Area Compliance – Yes
- ❖ Surfacing Type – Grass Mats
- ❖ Manufacturer - Lappset
- ❖ Defects/Issues - Yes

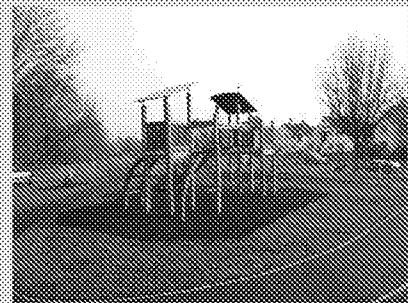
### Multi Play Unit

- ❖ Standards Compliance – Yes
- ❖ Surfacing Area Compliance – Yes
- ❖ Surfacing Type – Grass Mats
- ❖ Manufacturer – Lappset
- ❖ Defects/Issues - Yes

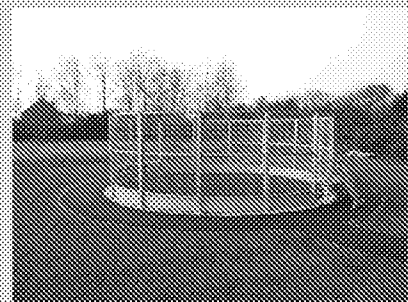
### PANNA

- ❖ Standards Compliance – N/A
- ❖ Surfacing Area Compliance – N/A
- ❖ Surfacing Type – Tarmac
- ❖ Manufacturer - Lappset
- ❖ Defects/Issues - Yes

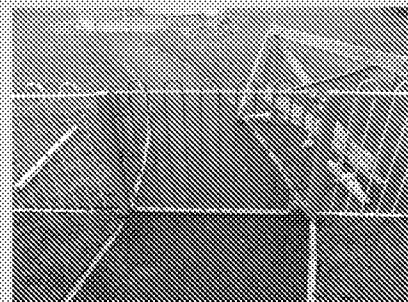
### Single Gate x 3

- ❖ Standards Compliance – N/A
- ❖ Surfacing Area Compliance – N/A
- ❖ Surfacing Type – N/A
- ❖ Manufacturer - Steelway Fencecore
- ❖ Defects/Issues - Yes

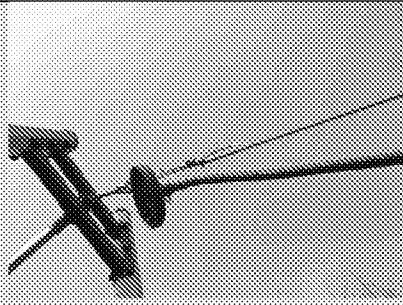
| <p><b>Aerial Runway</b></p> <p>There is excess cable hanging from the launch end of the runway</p> <p>Risk (2) Very Low</p> <p>Ensure the cable is secured in place or trimmed back</p> | |

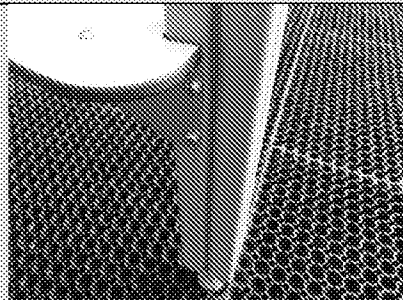
| <p><b>Multi Play Unit</b></p> <p>There is minor splitting to one of the posts, where a climbing step has been attached to it</p> <p>Risk (4) Low</p> <p>Consider replacing the damaged post</p> | |

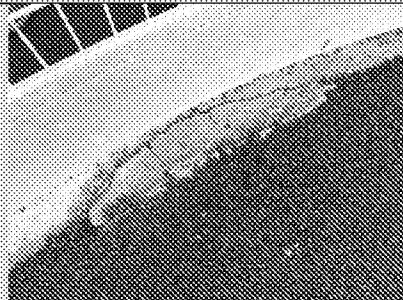
| <p><b>PANNA</b></p> <p>The concrete surfacing inside the PANNA is breaking up</p> <p>Risk (4) Low</p> <p>Ensure any loose pieces are removed and the area refilled to ensure a level surface.</p> | |

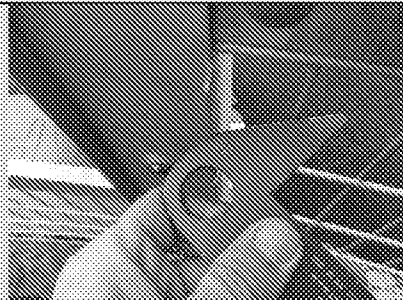
| <p><b>Cradle Seat Swing</b></p> <p>One of the post covering plates has been fitted the wrong way round and as a result edges with a radius of less than 3mm are evident</p> <p>Risk (6) Low</p> <p>Ensure the facing plate is re fitted correctly.</p> | |

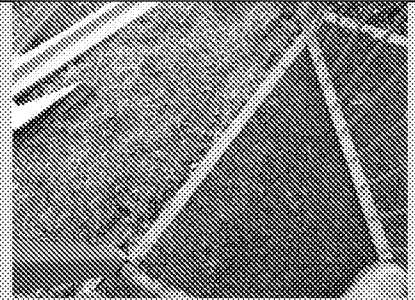
### Gate (Nearest the main Road)

There is a trip point between the PCC edges and the grass surfacing.

Risk (8)

Ensure the trip point is removed

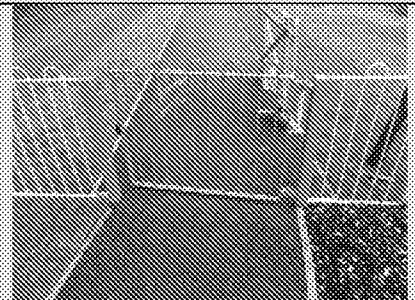
### Gate (Nearest the aerial Runway)

The gate fails to close correctly

Risk (4)

Ensure the gate is tensioned and operates correctly
