**Barratt Homes****Felpham**

**Inspection Date:** 10 Apr 2013

**Inspection Type:** Post Install Inspection

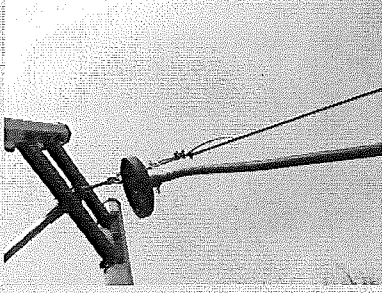
| <p><b>Aerial Runway</b></p> <p>There is excess cable hanging from the launch end of the runway</p> <p>Risk (2) Very Low</p> <p>Ensure the cable is secured in place or trimmed back</p> | |

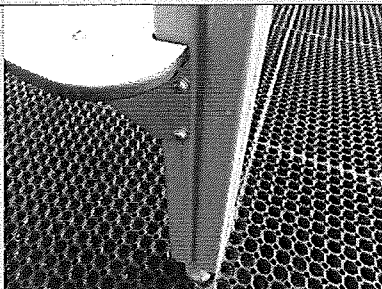
| <p><b>Multi Play Unit</b></p> <p>There is minor splitting to one of the posts, where a climbing step has been attached to it</p> <p>Risk (4) Low</p> <p>Consider replacing the damaged post</p> | |

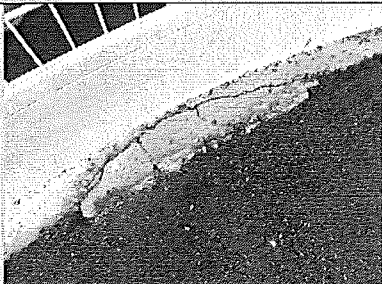
| <p><b>PANNA</b></p> <p>The concrete surfacing inside the PANNA is breaking up</p> <p>Risk (4) Low</p> <p>Ensure any loose pieces are removed and the area refilled to ensure a level surface.</p> | |

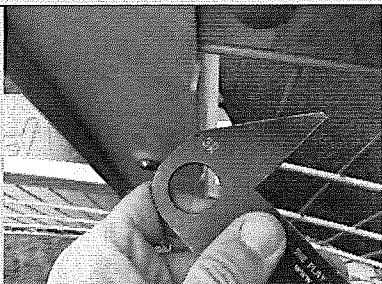
| <p><b>Cradle Seat Swing</b></p> <p>One of the post covering plates has been fitted the wrong way round and as a result edges with a radius of less than 3mm are evident</p> <p>Risk (6) Low</p> <p>Ensure the facing plate is re fitted correctly.</p> | |

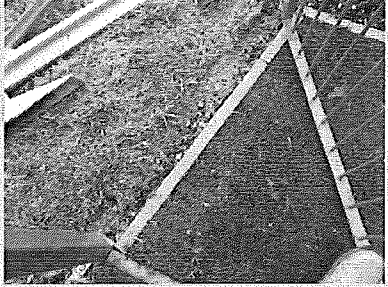
| Gate (Nearest the main Road) | |

| Gate (Nearest the main Road) | |
|---|---|
| <p>There is a trip point between the PCC edges and the grass surfacing.</p> <p>Risk (8)</p> <p>Ensure the trip point is removed</p> | |

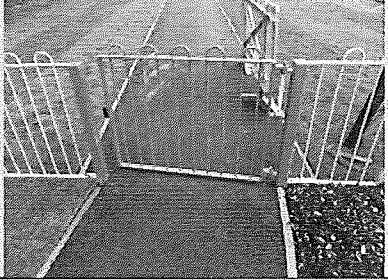
| Gate (Nearest the main Road) | |
|---|---|
| Gate (Nearest the aerial Runway) | |

| Gate (Nearest the main Road) | |
|---|---|
| <p>The gate fails to close correctly</p> <p>Risk (4)</p> <p>Ensure the gate is tensioned and operates correctly</p> | |
