## Post Installation Report

Barratt Southampton

Blakes Mead

Post Installation Report - 21 July 2017 at 09:40 Inspector: Chris Buss RPII Annual Inspector

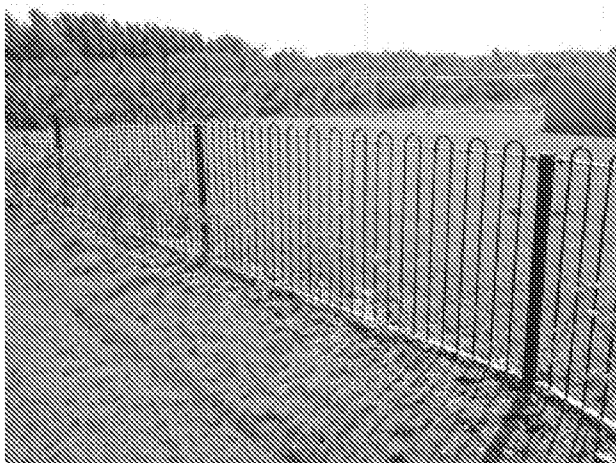
| 8 - Low Risk | |
|---|---|
| <b>Finding 1</b><br>The panel to gate post fixings are loose - Secure | <b>Finding 2</b><br>Some posts are loose in the ground - Secure |
| <b>Finding 3</b><br>There are loose panel fixings - Secure | <b>Finding 4</b><br>There are incomplete shear nut fixings - Complete installation |

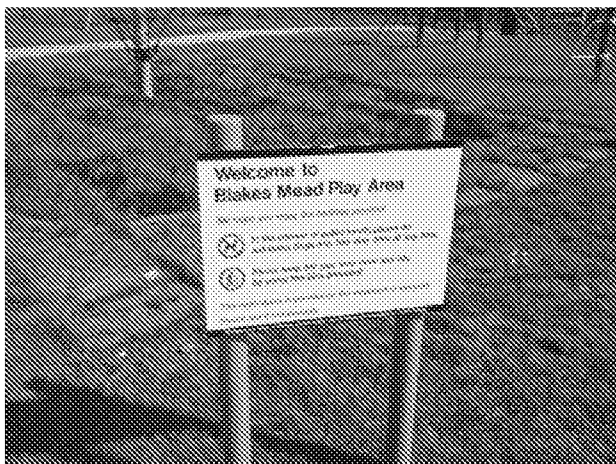
| 6 - Low Risk | |
|---|---|
| <b>Finding 1</b><br>There is some damage to the sign - File down rough edges | |

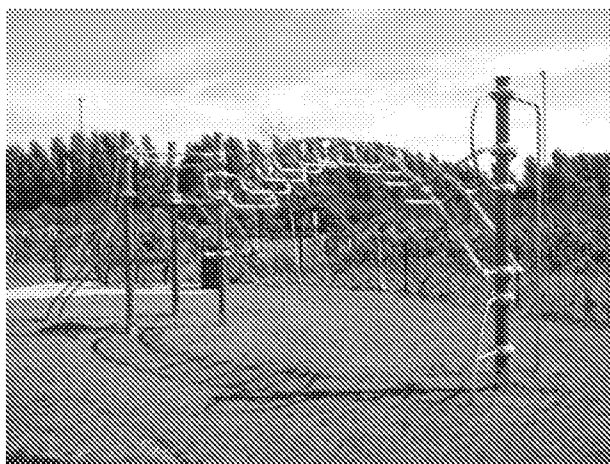
The net fixings are working loose - Secure

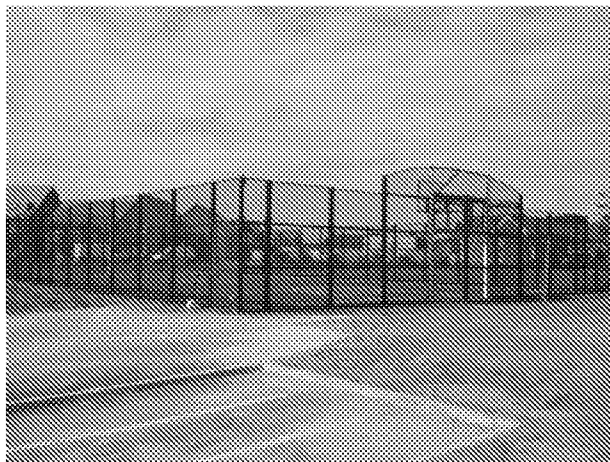
One gate has been vandalised - Repair and make good as required

The gate hinge fixings are loose - Secure

The gate latches are stiff or not closing - Adjust

One gate is snagging on the ground - Adjust

There are finger entrapments around the mesh panels in places and the item fails to meet the requirements of BS EN 15312 Clause 4.4.2.2 Entrapment of fingers - Refer to the manufacturer

There is broken glass and debris in the court - Clean and maintain

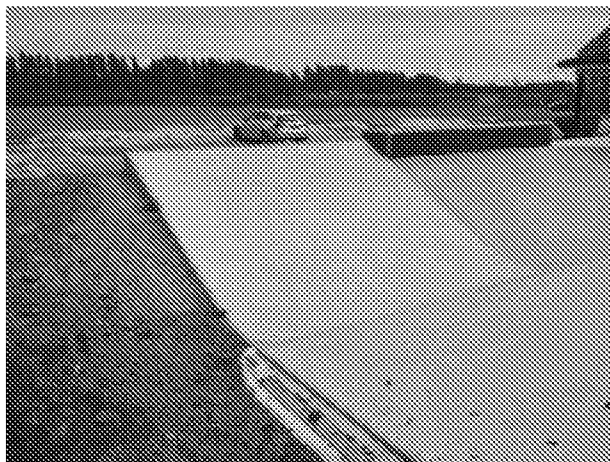
There is some damage to the riding surface adjacent to the metal edging - Monitor for any further deterioration and repair as required

The rear area of the ramp has been infilled so that any users not fully in control of their equipment has the opportunity to regain control - Monitor use and review the risk assessment regularly

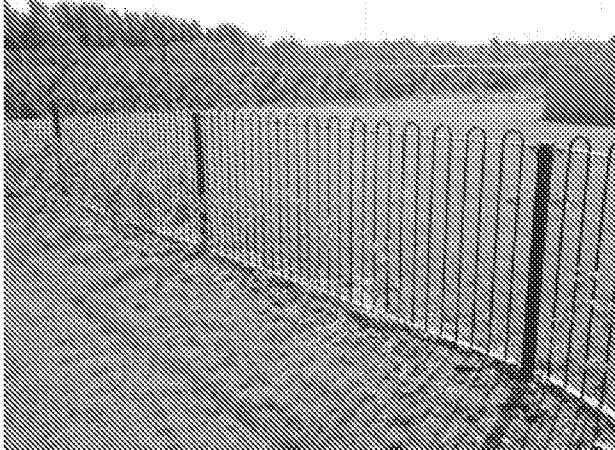
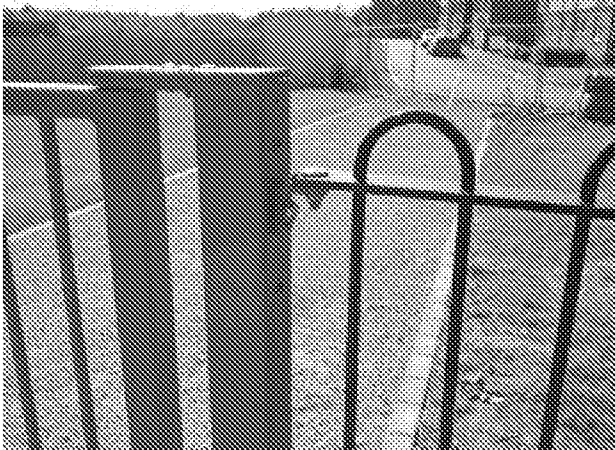
| <b>8 - Low Risk (Finding 1)</b> | | | |
|---|---|---|---|
| <b>Finding:</b> | The panel to gate post fixings are loose | | <b>Action:</b> Secure |

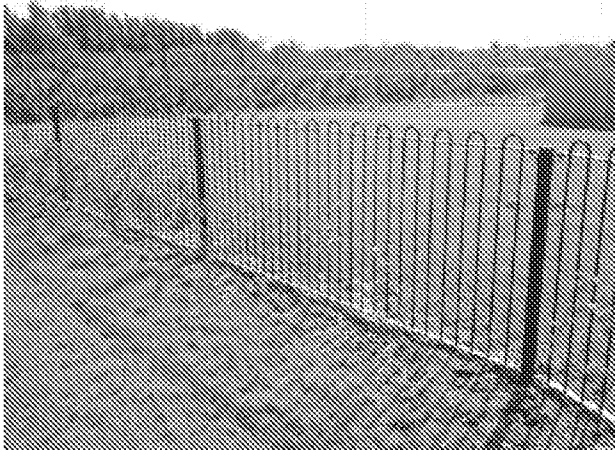
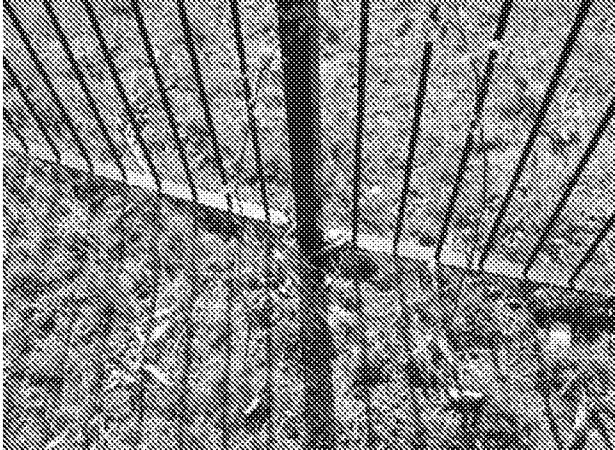
| <b>4 - Very Low Risk (Finding 2)</b> | | | |
|---|---|---|---|
| <b>Finding:</b> | Some posts are loose in the ground | | <b>Action:</b> Secure |

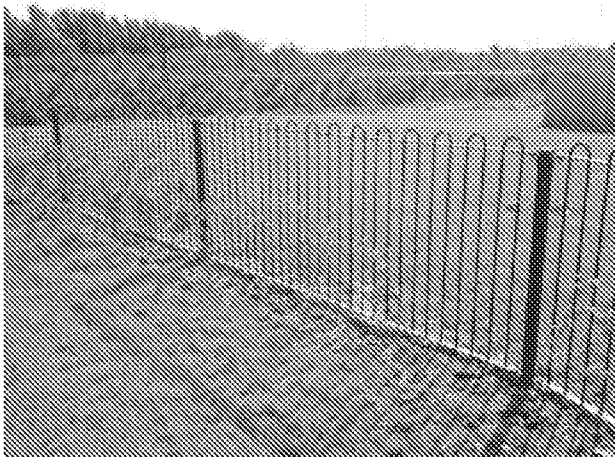
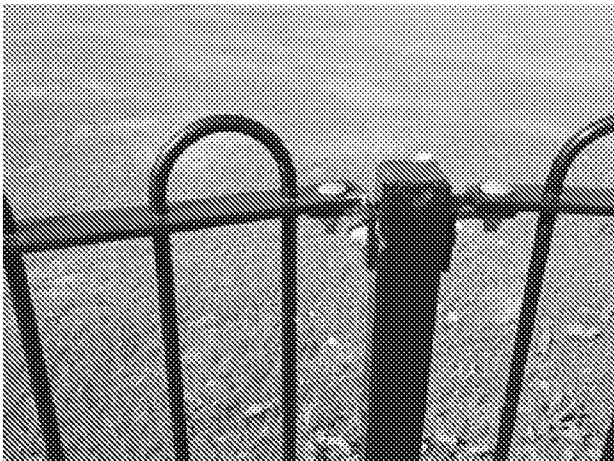
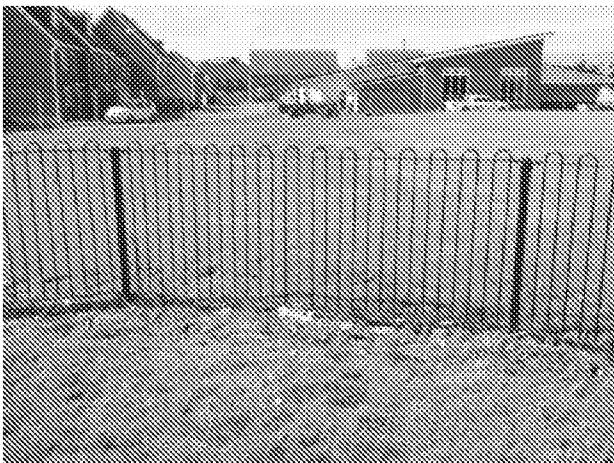
| <b>B - Low Risk (Finding 3)</b> | | | |
|---|---|---|---|
| <b>Finding:</b> | There are loose panel fixings | | <b>Action:</b> Secure |

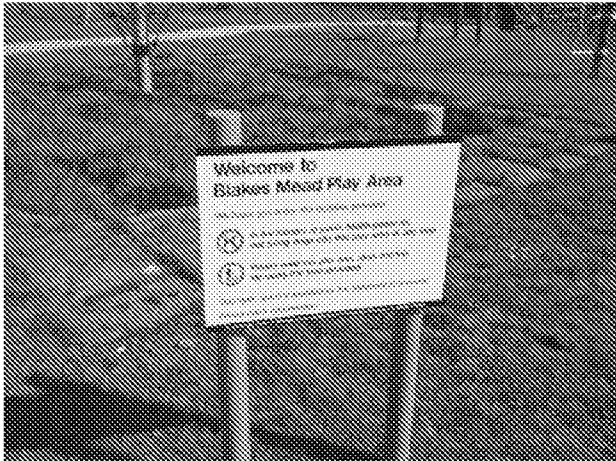
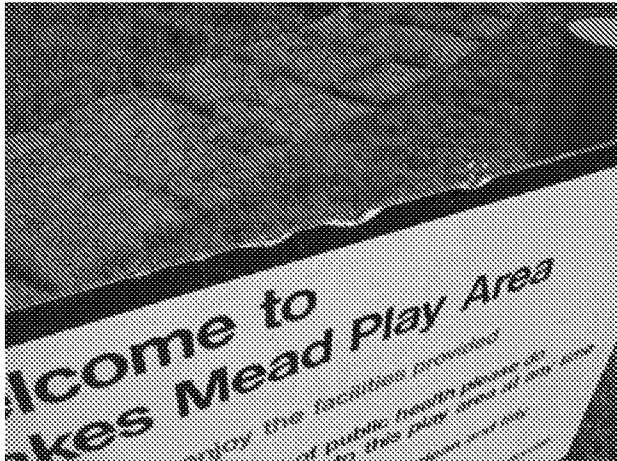
| <b>B - Low Risk (Finding 1)</b> | | | |
|---|---|---|---|
| <b>Finding:</b> | There is some damage to the sign | | <b>Action:</b> File down rough edges |

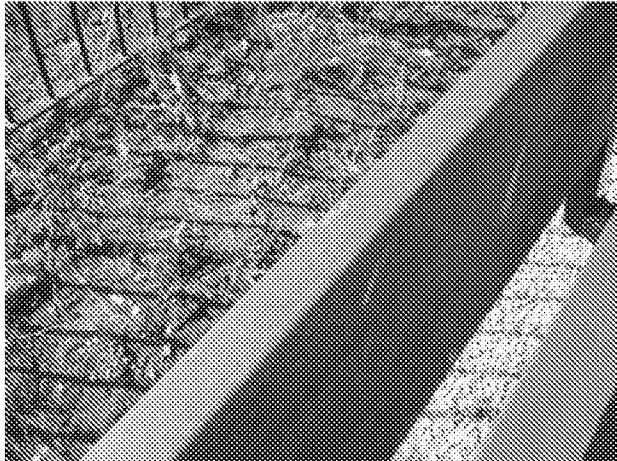
| <b>B - Low Risk (Finding 1)</b> | | | |
|---|---|---|---|
| <b>Finding:</b> | Parts of the timber are rough or splintered | | <b>Action:</b> Remove all rough or sharp edges |

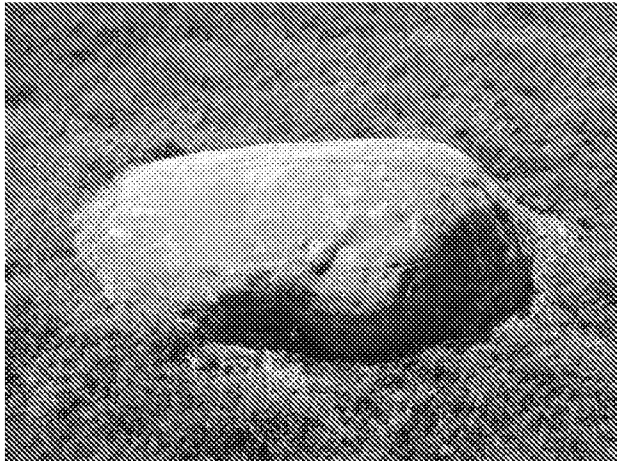
| <b>5 - Very Low Risk (Finding 1)</b> | | | |
|---|---|---|---|
| <b>Finding:</b> | The use of boulders in the play area presents a risk to users of falling onto hard objects | | <b>Action:</b> Monitor use |

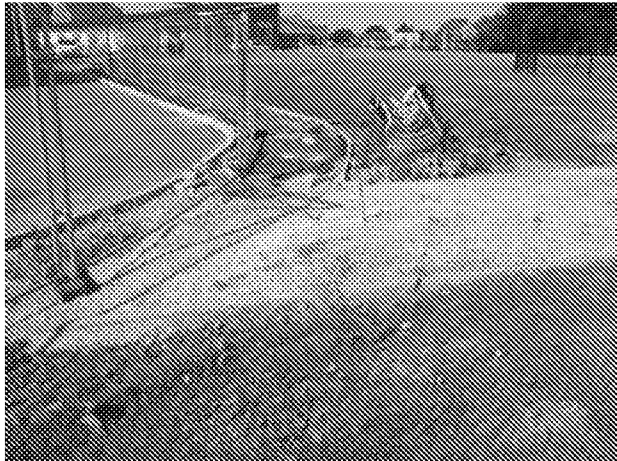
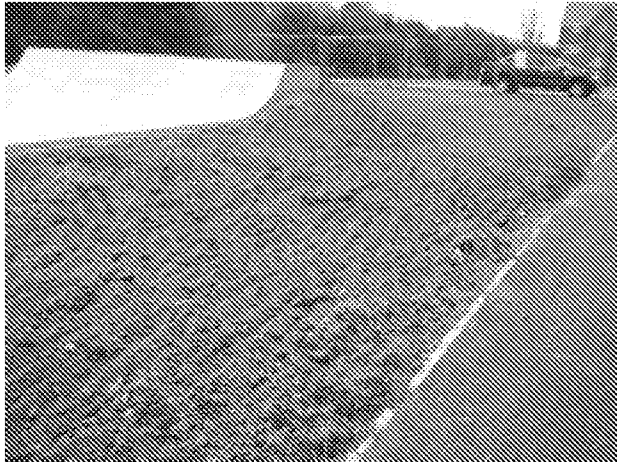
| <b>B - Low Risk (Finding 1)</b> | | | |
|---|---|---|---|
| <b>Finding:</b> | There are ongoing works to the surrounding landscaping | | <b>Action:</b> Complete installation |

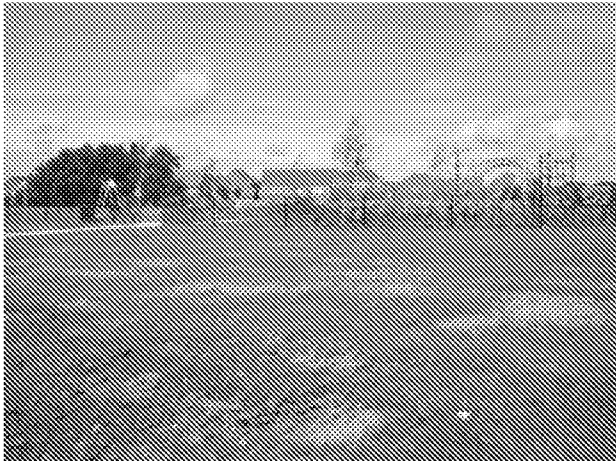
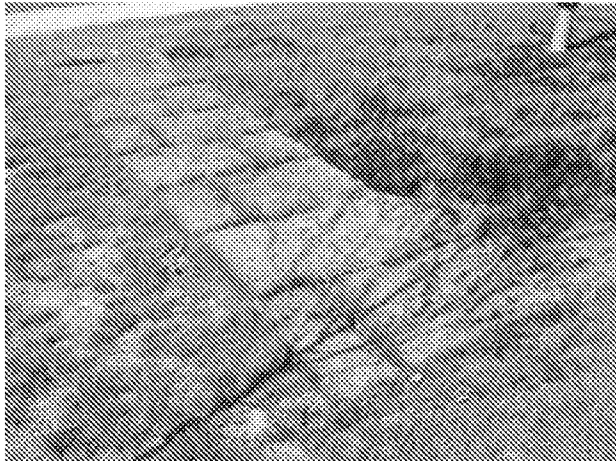
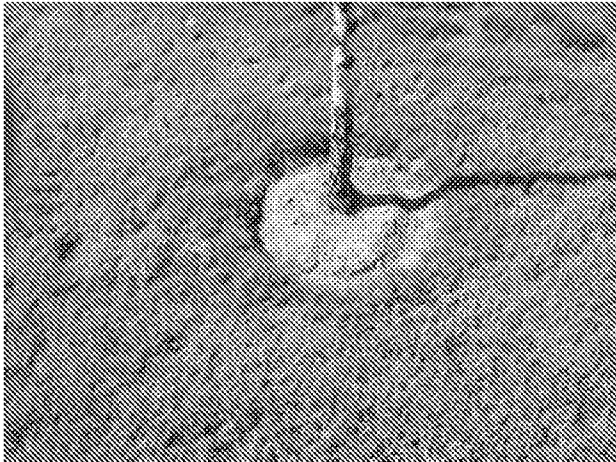
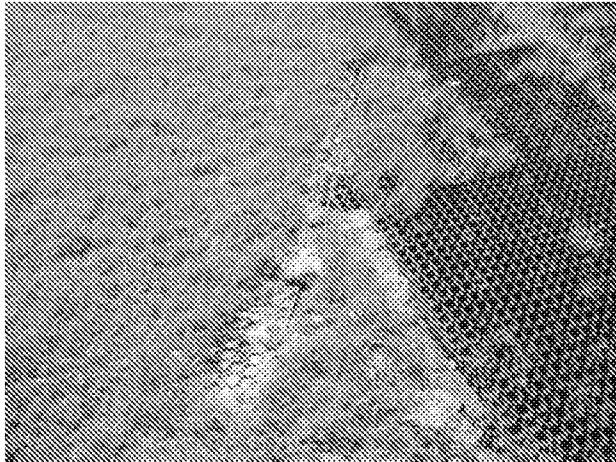
| <b>B - Low Risk (Finding 2)</b> | | | |
|---|---|---|---|
| <b>Finding:</b> | The landscaping on site is not fully established and has deteriorated since the initial completion of the site | | <b>Action:</b> Reinstate/make good the landscaping on site |

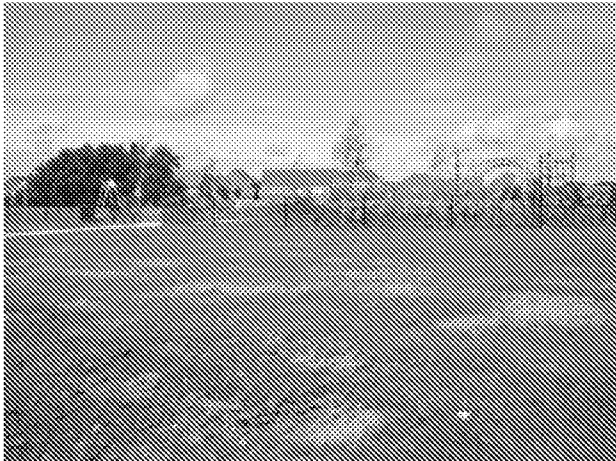
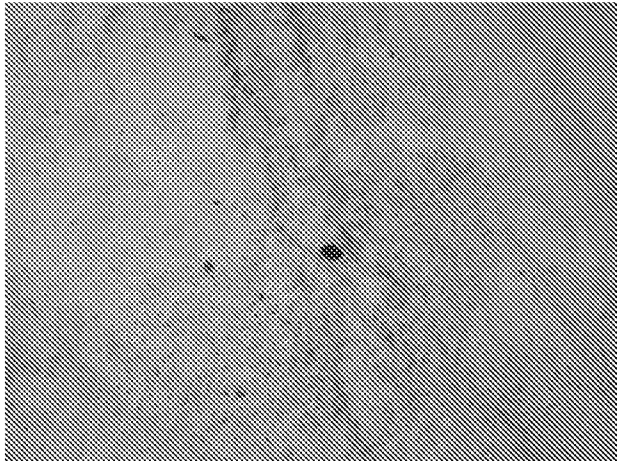
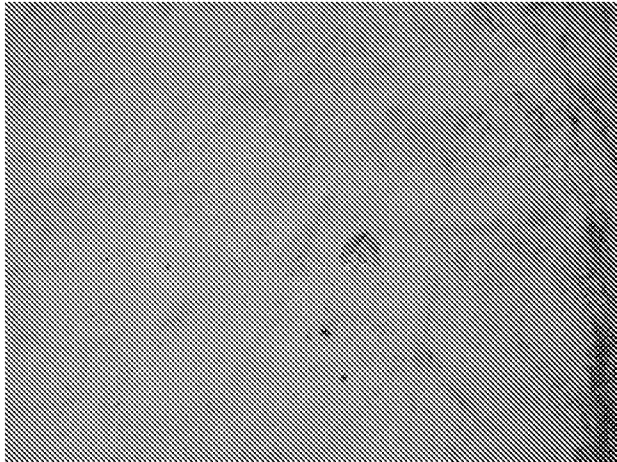
| <b>B - Low Risk (Finding 3)</b> | | | |
|---|---|---|---|
| <b>Finding:</b> | There are small holes in the riding surface in places and some minor damage to the surface around site | | <b>Action:</b> Monitor for any further deterioration and repair as required |

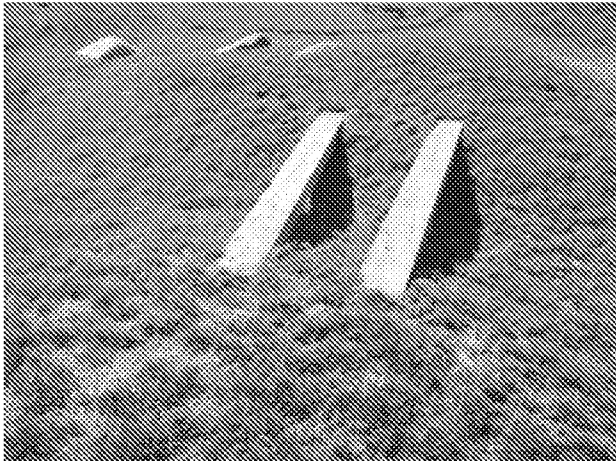
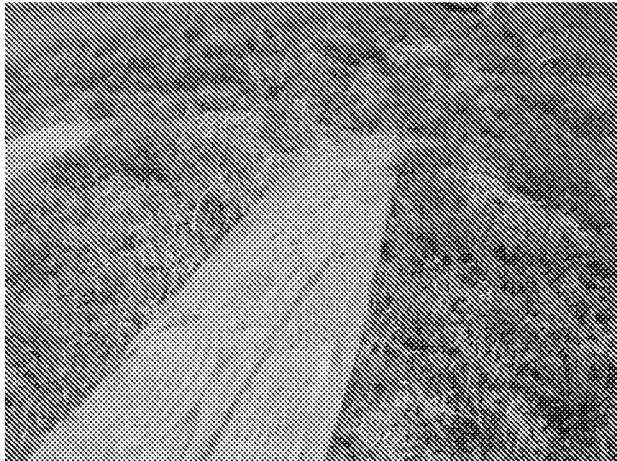
| <b>8 - Low Risk (Finding 2)</b> | | | |
|---|---|---|---|
| <b>Finding:</b> | The ground fixings are working loose on one beam | | <b>Action:</b> Secure |

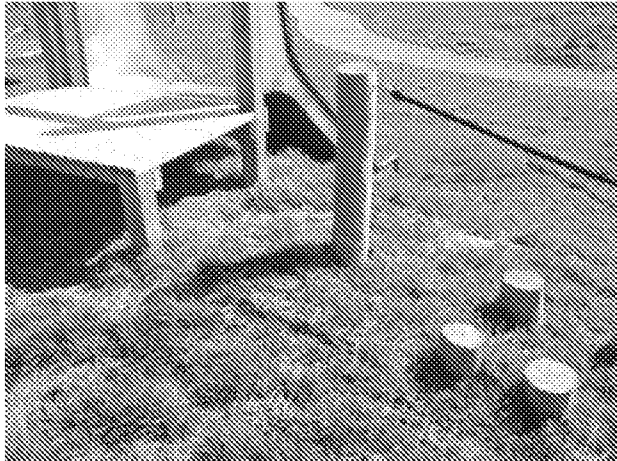
| <b>4 - Very Low Risk (Finding 1)</b> | | | |
|---|---|---|---|
| <b>Finding:</b> | The step between the stepping stones and the slide platform is quite large and users may not be able to complete the step without touching ground, the items could therefore be considered to be within the falling space of each other, however the intention of the play activity continuity is easily apparent and foreseeable to the user (stepping stone to platform 1.15m) | | <b>Action:</b> Monitor use |

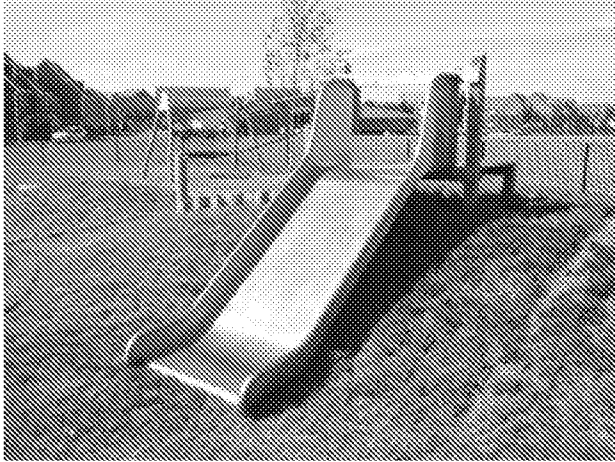
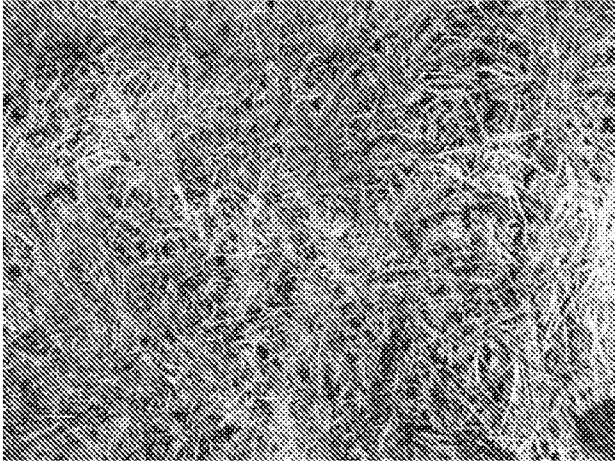
| <b>8 - Low Risk (Finding 1)</b> | | | |
|---|---|---|---|
| <b>Finding:</b> | Fixing Pins have been installed in the impact areas of the grass mats | | <b>Action:</b> Remove pins from impact areas |

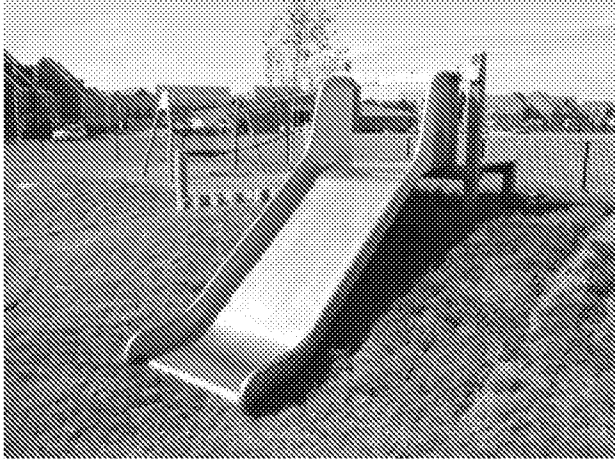
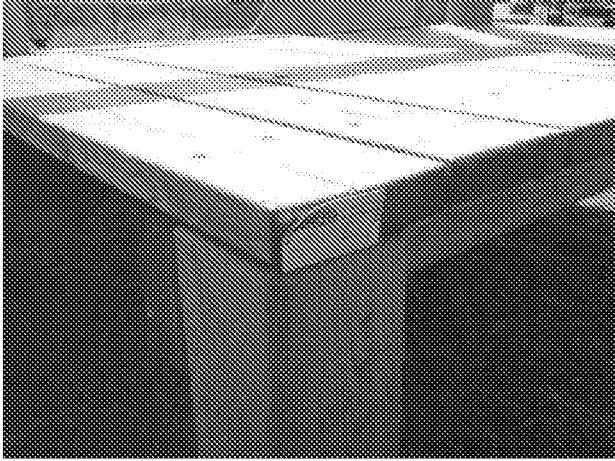
| <b>6 - Low Risk (Finding 2)</b> | | | |
|---|---|---|---|
| <b>Finding:</b> | The identification label is loose and damaged | | <b>Action:</b> Repair |

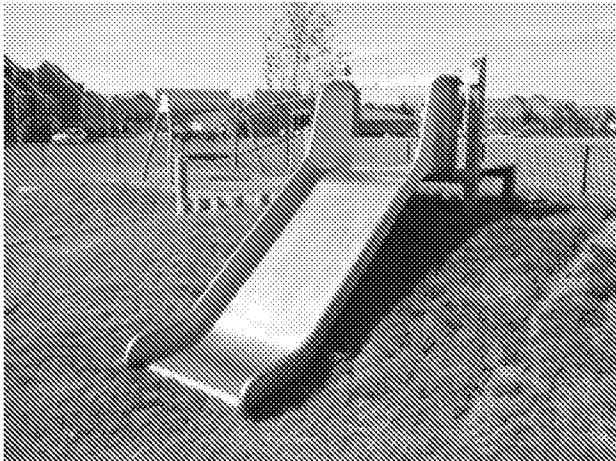
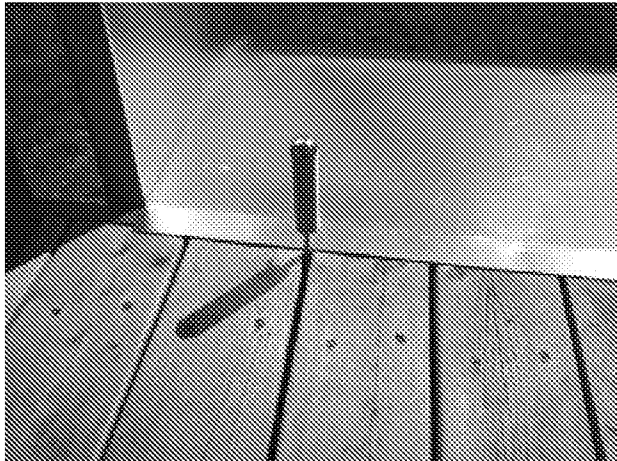
| <b>5 - Very Low Risk (Finding 3)</b> | | | |
|---|---|---|---|
| <b>Finding:</b> | There is a finger entrapment in one opening at the top of the slide and the item fails to meet the requirements of BS EN 1176:2008 Part 1 4.2.7.6 Entrapment of fingers | | <b>Action:</b> Refer to the manufacturer |

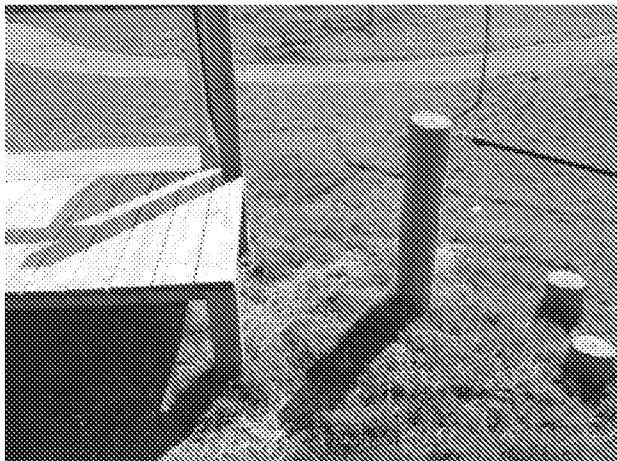
| <b>4 - Very Low Risk (Finding 4)</b> | | | |
|---|---|---|---|
| <b>Finding:</b> | The step between the slide platform and rope pull is quite large and users may not be able to complete the step without touching ground, the items could therefore be considered to be within the falling space of each other, however the intention of the play activity continuity is easily apparent and foreseeable to the user (platform to post 600mm) | | <b>Action:</b> Monitor use |

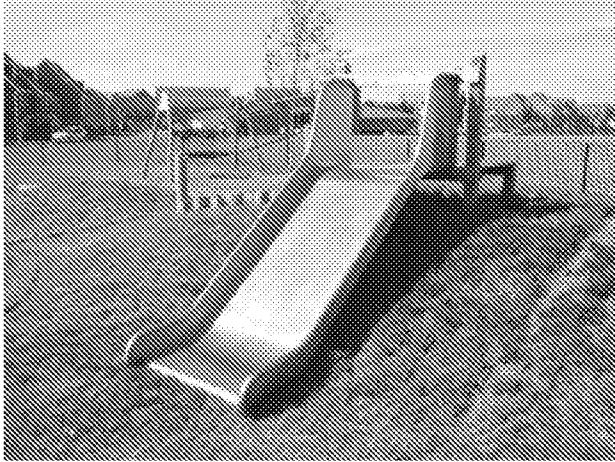
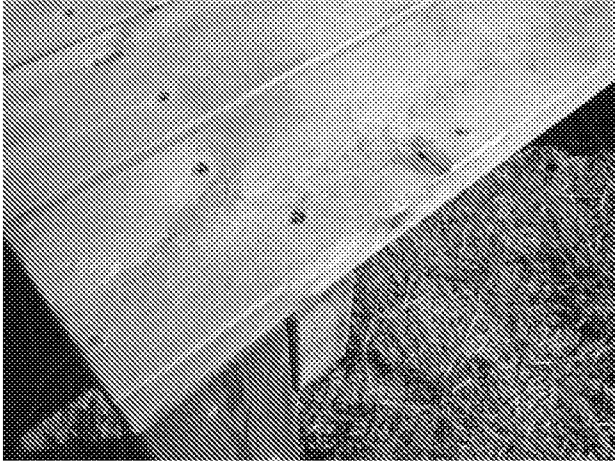
| <b>8 - Low Risk (Finding 5)</b> | | | |
|---|---|---|---|
| <b>Finding:</b> | Parts of the timber are rough or splintered | | <b>Action:</b> Remove all rough or sharp edges |

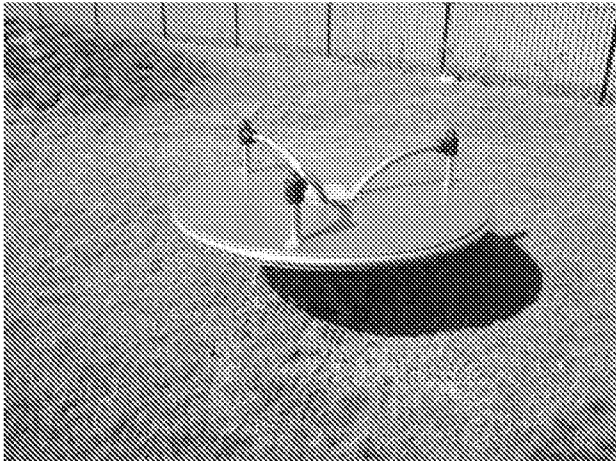
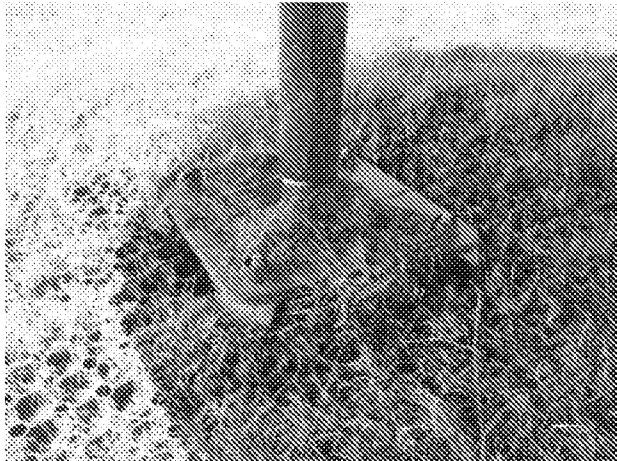
| <b>B - Low Risk (Finding 2)</b> | | | |
|---|---|---|---|
| <b>Finding:</b> | The base is loose in the ground | | <b>Action:</b> Secure |

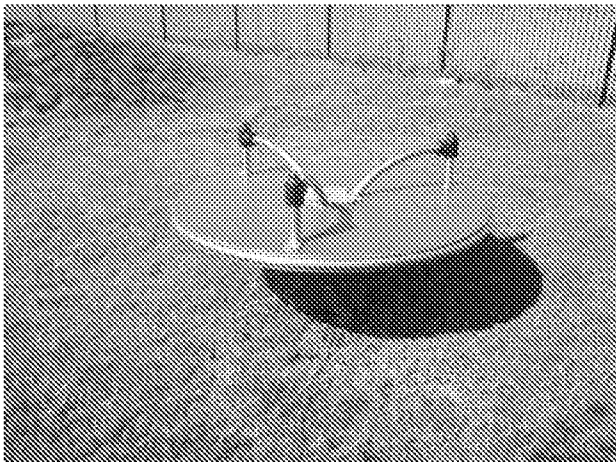
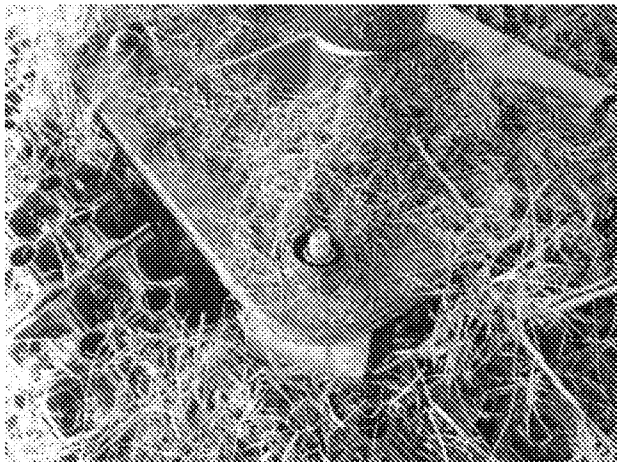
| <b>B - Low Risk (Finding 3)</b> | | | |
|---|---|---|---|
| <b>Finding:</b> | There is/are bolt cap covers missing or damaged on the item | | <b>Action:</b> Replace missing or damaged bolt cap covers |

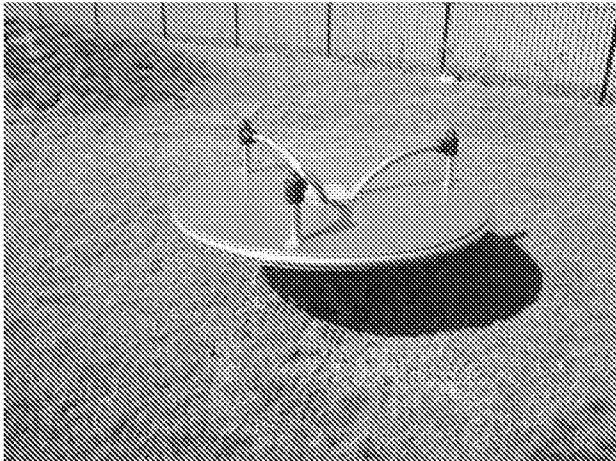
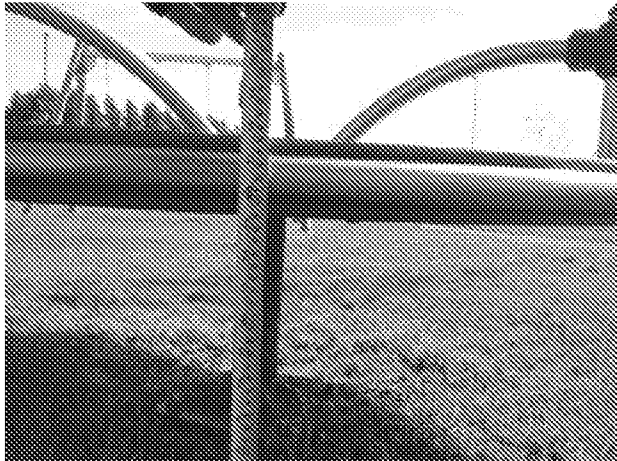
| <b>8 - Low Risk (Finding 4)</b> | | | |
|---|---|---|---|
| <b>Finding:</b> | The height of the roundabout platform is less than 400mm (385mm) and fails the requirements of BS EN 1176 Part 5 (this is due to the base being loose and the item leaning) | | <b>Action:</b> Refer to the manufacturer |

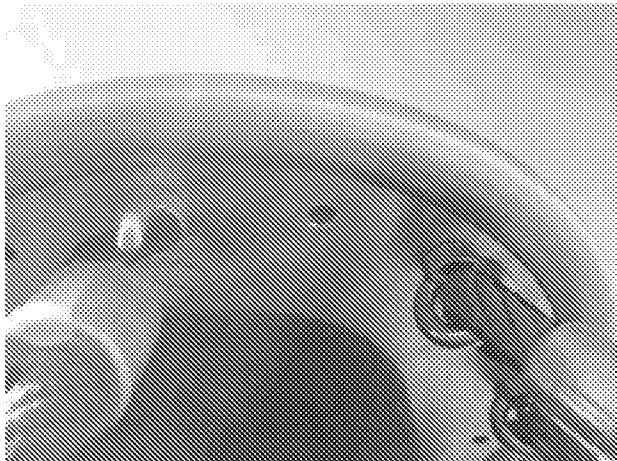
| <b>5 - Very Low Risk (Finding 1)</b> | | | |
|---|---|---|---|
| <b>Finding:</b> | There are unused fixing points on the post cap that create potential finger entrapments | | <b>Action:</b> Provide inserts |

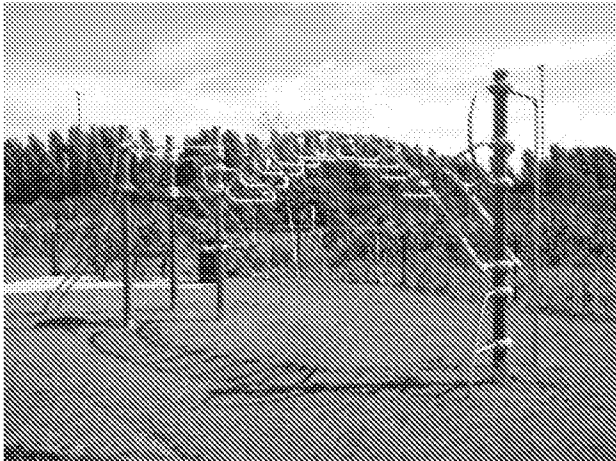
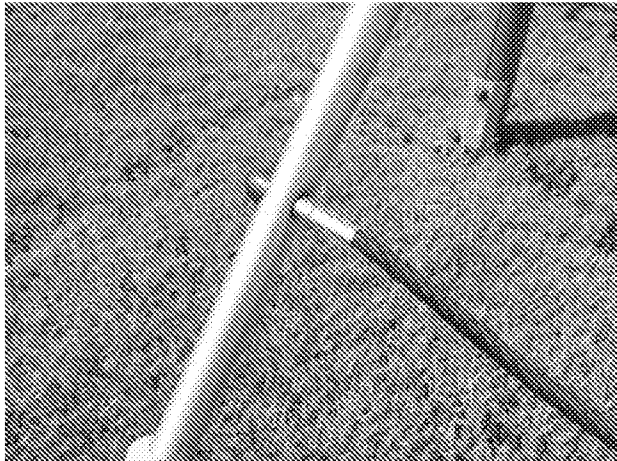
| <b>B - Low Risk (Finding 1)</b> | | | |
|---|---|---|---|
| <b>Finding:</b> | The net fixings are working loose | | <b>Action:</b> Secure |

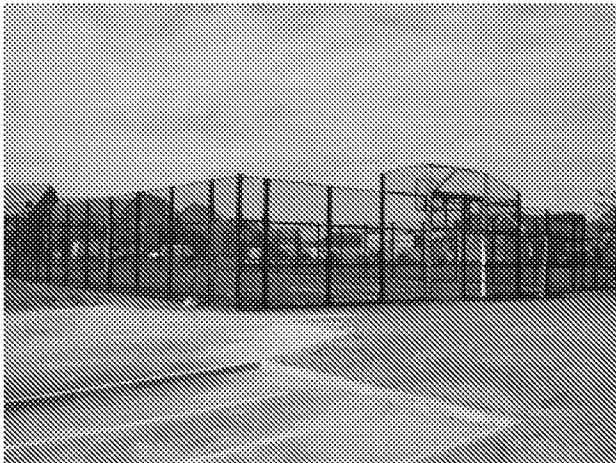
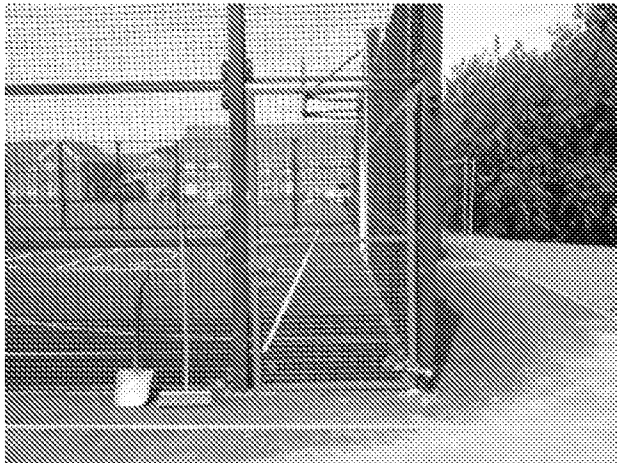
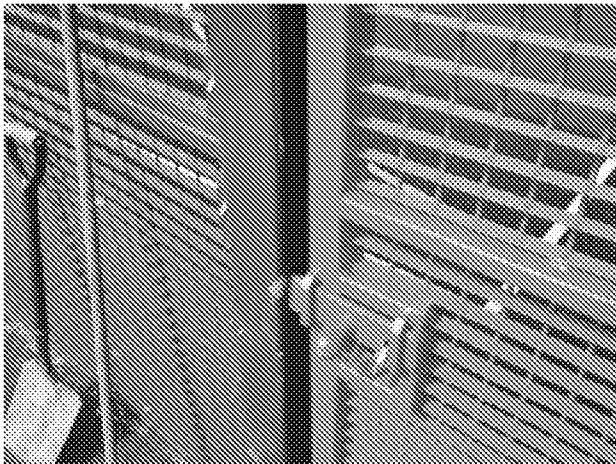
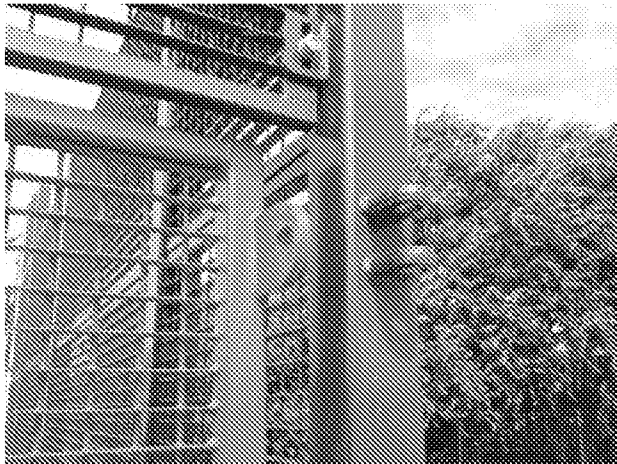
| <b>12 - Moderate Risk (Finding 1)</b> | | | |
|---|---|---|---|
| <b>Finding:</b> | One gate has been vandalised | | <b>Action:</b> Repair and make good as required |

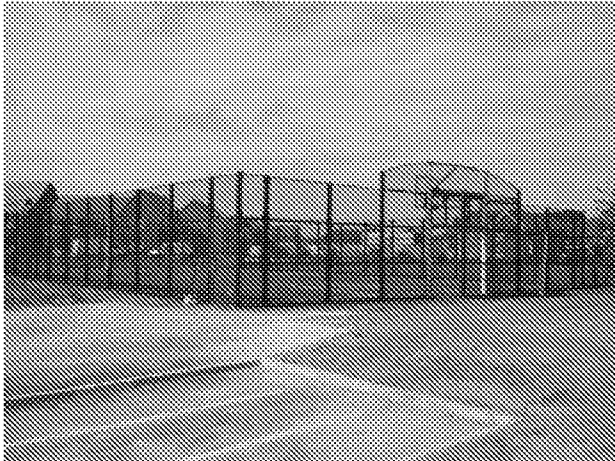
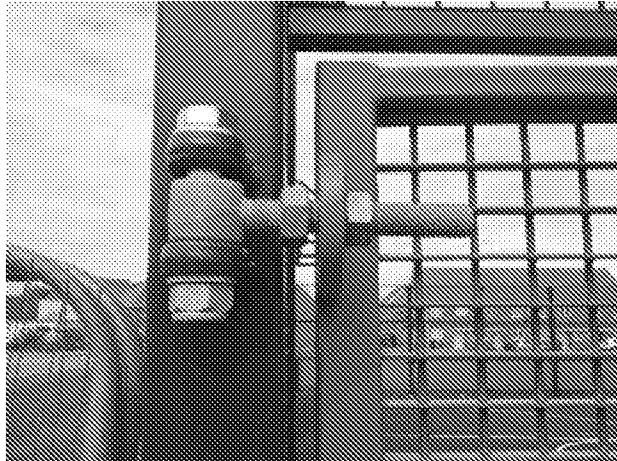
| <b>B - Low Risk (Finding 2)</b> | | | |
|---|---|---|---|
| <b>Finding:</b> | The gate hinge fixings are loose | | <b>Action:</b> Secure |

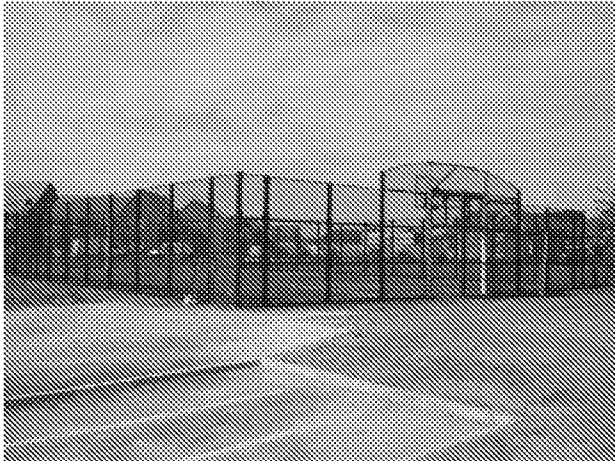
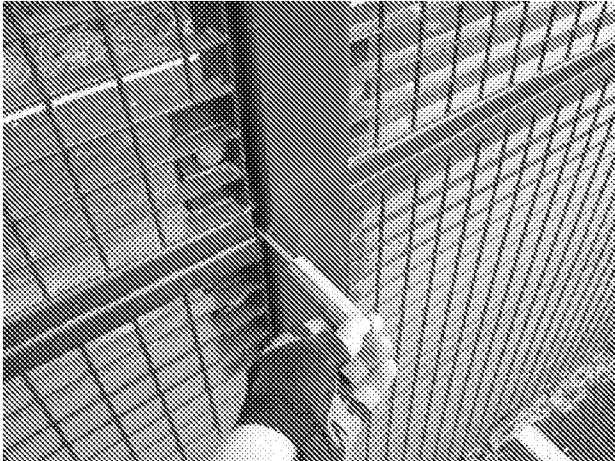
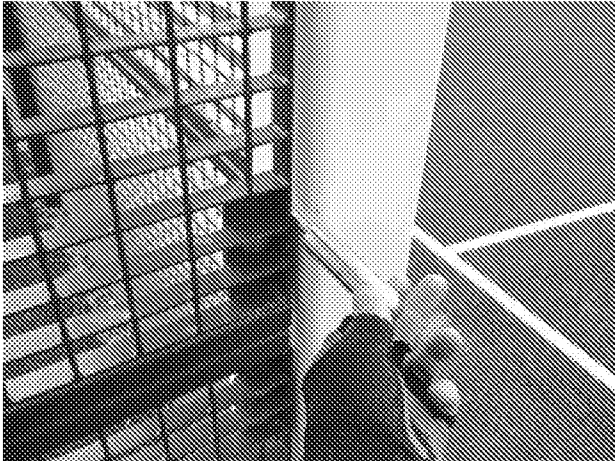
| <b>5 - Very Low Risk (Finding 5)</b> | | | |
|---|---|---|---|
| <b>Finding:</b> | There are finger entrapments around the mesh panels in places and the item fails to meet the requirements of BS EN 15312 Clause 4.4.2.2 Entrapment of fingers | | |

| <b>5 - Very Low Risk (Finding 5)</b> | | | |
|---|---|---|---|
| <b>Action:</b> | Refer to the manufacturer | | |

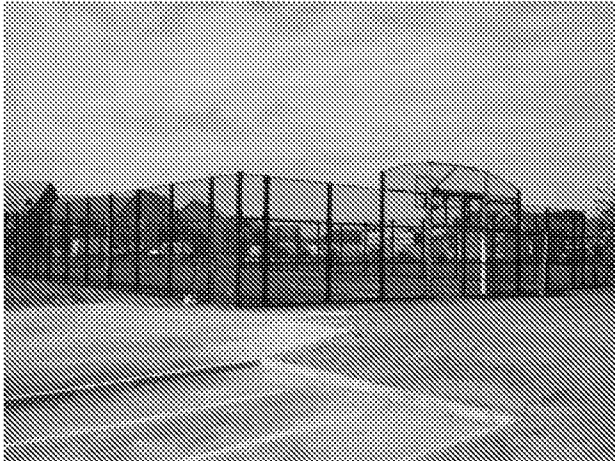
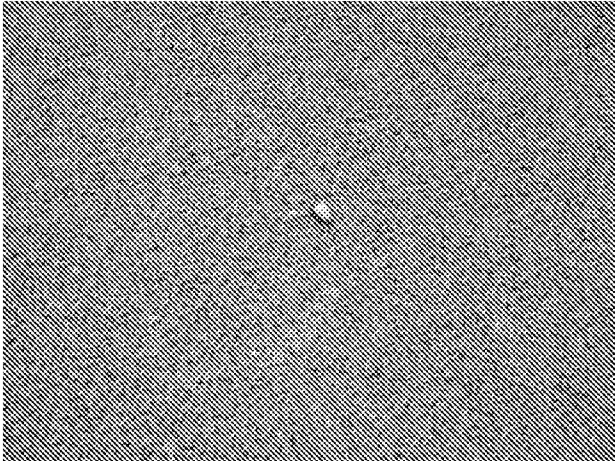
| <b>B - Low Risk (Finding 6)</b> | | | |
|---|---|---|---|
| <b>Finding:</b> | There is broken glass and debris in the court | | <b>Action:</b> Clean and maintain |

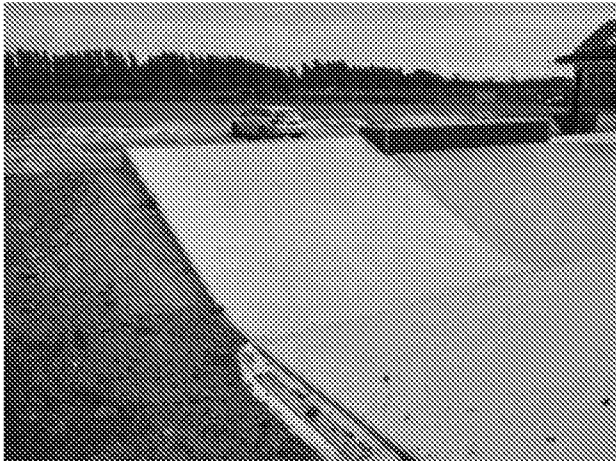
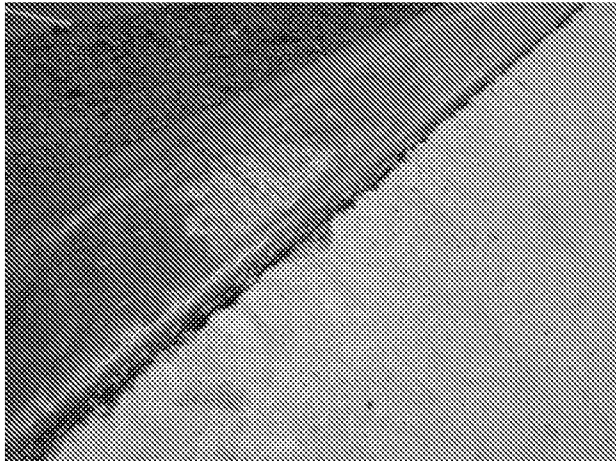
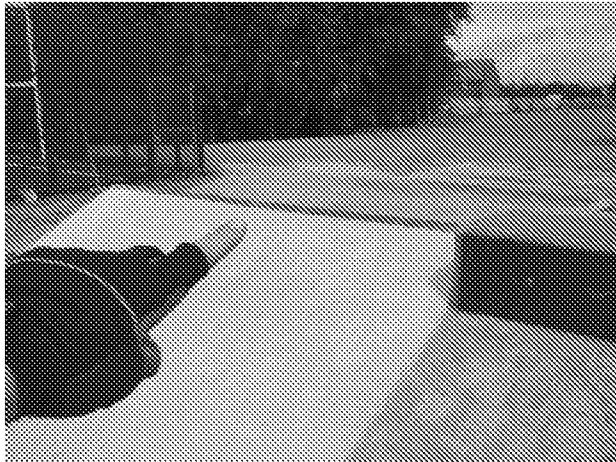
| <b>B - Low Risk (Finding 1)</b> | | | |
|---|---|---|---|
| <b>Finding:</b> | There is some damage to the riding surface adjacent to the metal edging | | <b>Action:</b> Monitor for any further deterioration and repair as required |

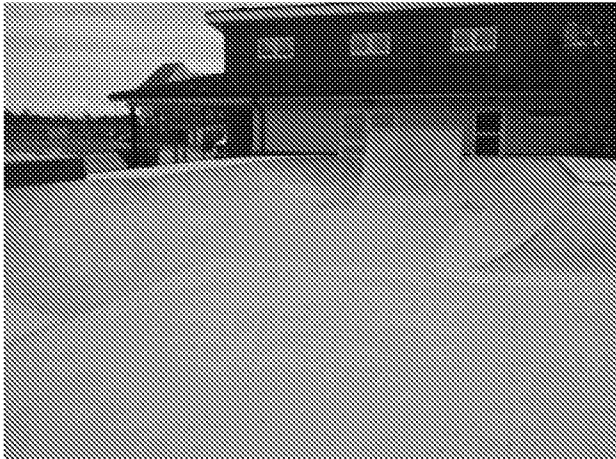
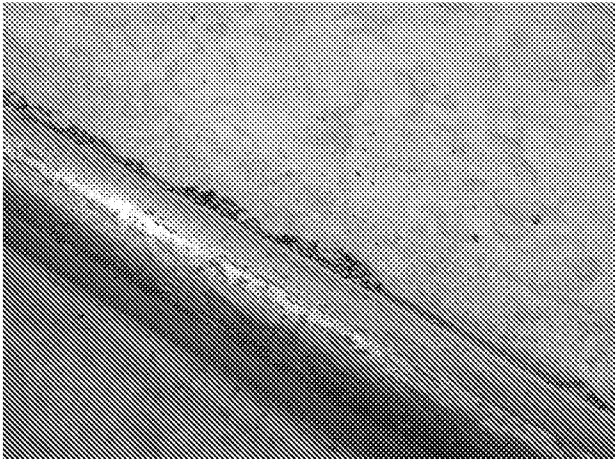
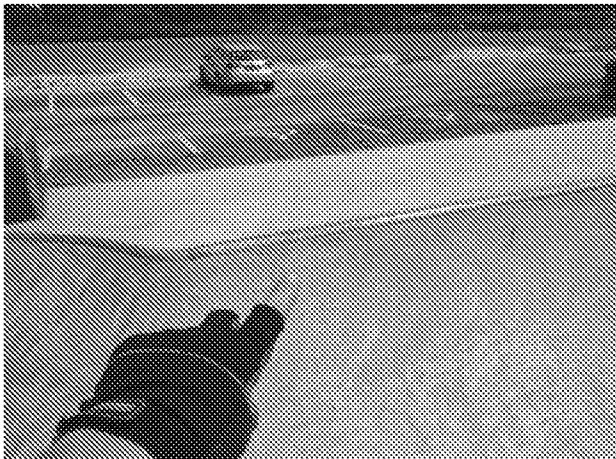
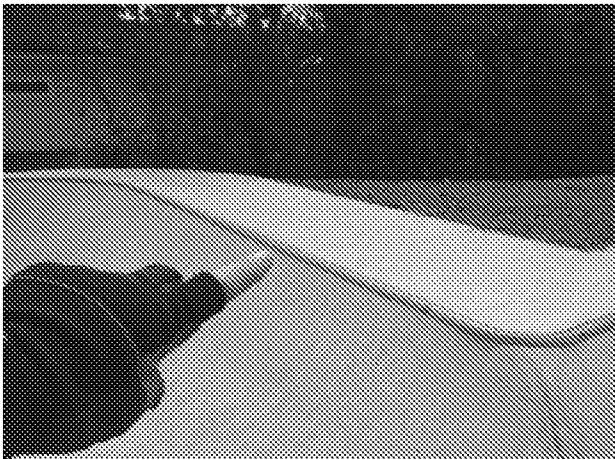
| <b>B - Low Risk (Finding 2)</b> | | | |
|---|---|---|---|
| <b>Finding:</b> | There is some damage to the concrete riding surface adjacent to the copings | | <b>Action:</b> Monitor for any further deterioration and repair as required |
