## Post Installation Report

Barratt Southampton

Blakes Mead

Post Installation Report - 15 December 2016 at 12:28 Inspector: Robert Baldock (RPII Annual Inspector)

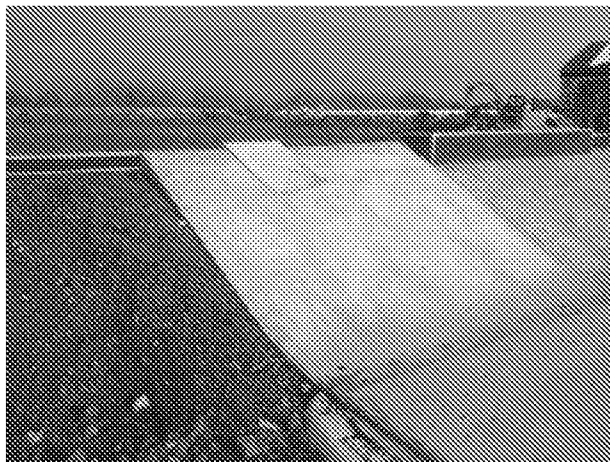
**Item:** Wheeled Sports - Jump Ramp  
**Manufacturer:** Not Identified  
**Surface Type:** Concrete  
**Equipment Compliance:** No  
**Surface Area Compliance:** No  
**Ref/Part Number:**  
**Total Findings:** 1

The item has insufficient safety zone allowed as required by BS EN 14974. This should equal at least 2.0 metres on most items and 5.0 metres behind a Jump Ramp. Actual dimension 2.4m measured horizontally from the ramp to the path and 4.4m to the parking bays - Refer to the manufacturer

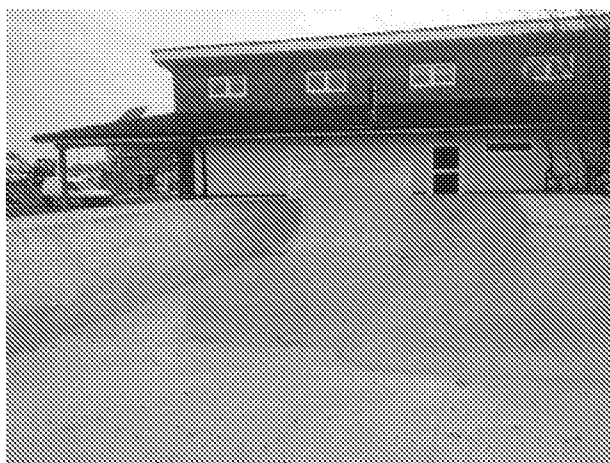
**Item:** Wheeled Sports - Concrete Bowl  
**Manufacturer:** Not Identified  
**Surface Type:** Concrete  
**Equipment Compliance:** No  
**Surface Area Compliance:** Yes  
**Ref/Part Number:**  
**Total Findings:** 1

The depth of the table perimeter is less than the 1200mm recommended by BS EN 14974. A measurement of 370mm was recorded at the smallest point - Build up spoil to the rear of the ramp to achieve 1.2m minimum depth

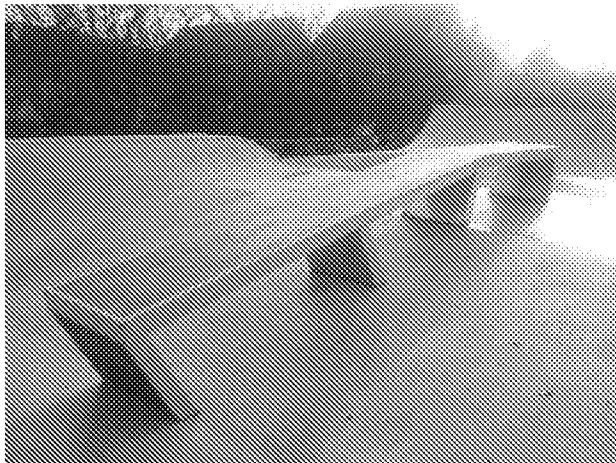
| 4 - Very Low Risk | |
|---|---|
| <b>Item:</b> | Wheeled Sports - Grind Bench |

| Finding 1 |
|---|
| This item is satisfactory - no work required |

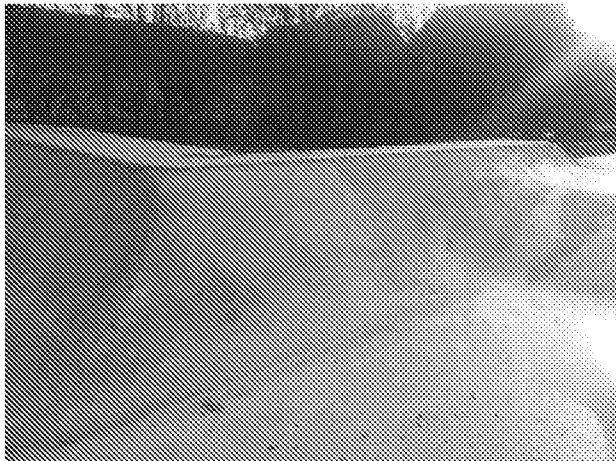
| 4 - Very Low Risk | |
|---|---|
| <b>Item:</b> | Wheeled Sports - Concrete Ramp |

| Finding 1 |
|---|
| This item is satisfactory - no work required |

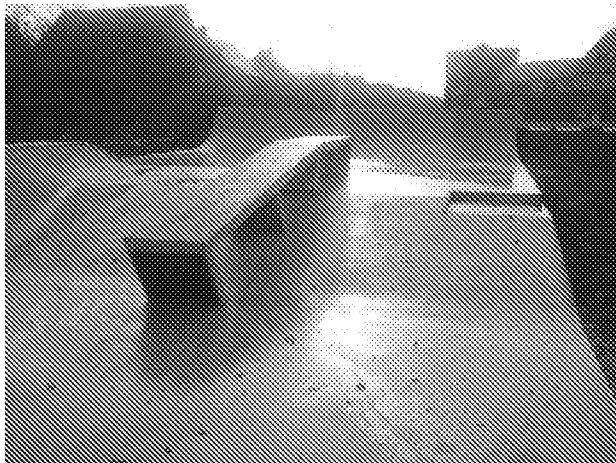
| 4 - Very Low Risk | |
|---|---|
| <b>Item:</b> | Wheeled Sports - Concrete Ramp |

| Finding 1 |
|---|
| This item is satisfactory - no work required |

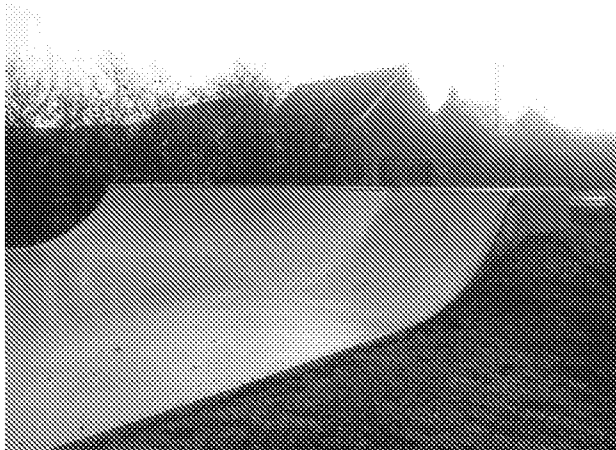
| 5 - Low Risk | |
|---|---|
| <b>Item:</b> | Wheeled Sports - Curved Start Ramp |

| Finding 1 |
|---|
| The depth of the table is less than the 1200mm recommended by BS EN 14974. A dimension at smallest point of 560mm was recorded - Build up spoil to the rear of the ramp to achieve 1.2m minimum depth |

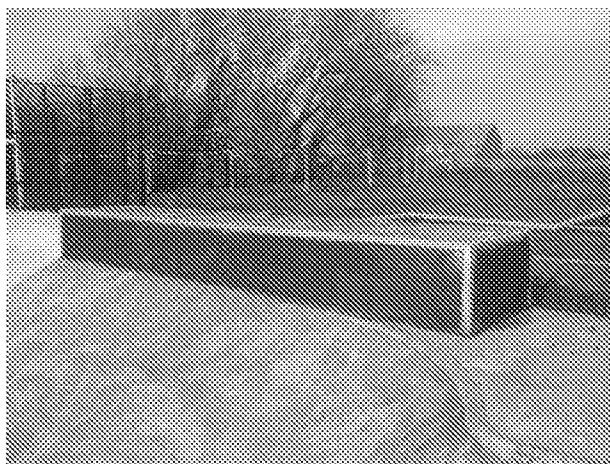
**Item:** Wheeled Sports - Ledge  
**Manufacturer:** Not Identified  
**Surface Type:** Concrete  
**Equipment Compliance:** Yes  
**Surface Area Compliance:** Yes  
**Ref/Part Number:**  
**Total Findings:** 1

This item is satisfactory - no work required

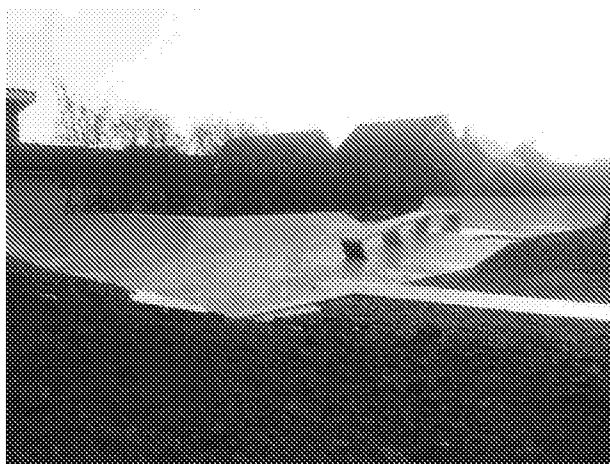
**Item:** Ancillary Items - Site General  
**Manufacturer:** Not Applicable  
**Surface Type:** N/A  
**Equipment Compliance:** N/A  
**Surface Area Compliance:** N/A  
**Ref/Part Number:**  
**Total Findings:** 2

Signage should be provided as recommended in BS EN 14974; this will include, but not exclusively, the use of the area, a recommendation to wear protective equipment, emergency contact details etc. - Provide signage as recommended by BS EN 14974

There are trip hazards at the edges of the surface - Reinstate surrounding surface levels to remove the trip points

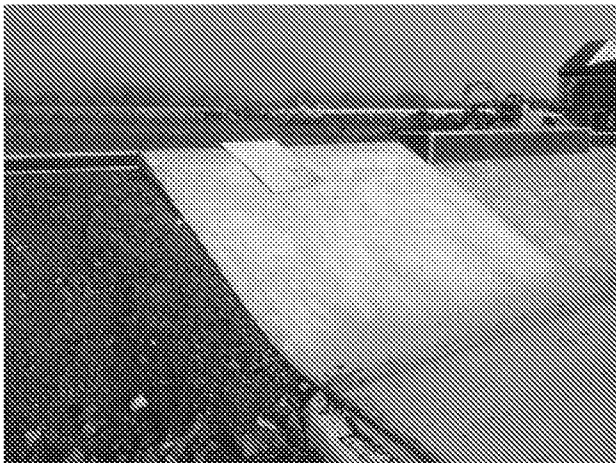
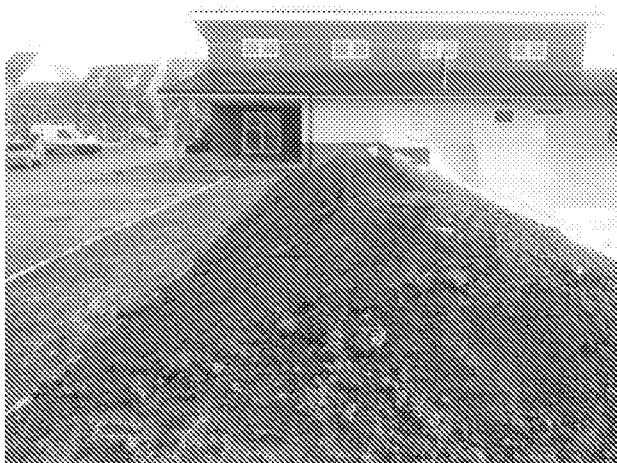
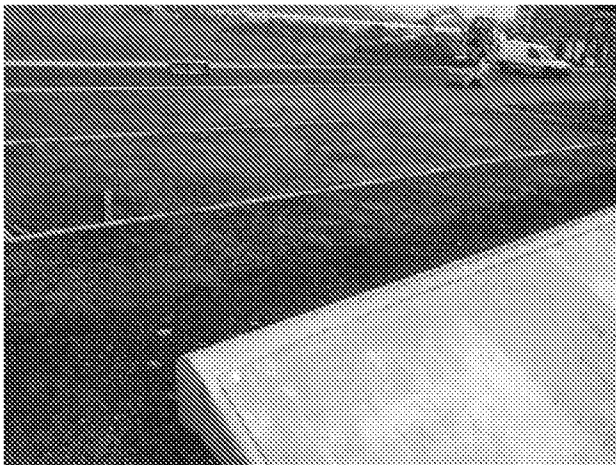
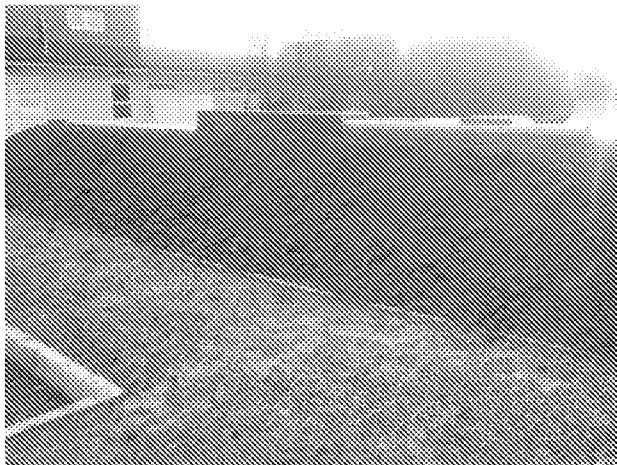
| <b>12 - Moderate Risk (Finding 1)</b> | | | |
|---|---|---|---|
| <b>Item:</b> | Wheeled Sports - Jump Ramp | <b>Risk Level:</b> | M - Moderate Risk |
| <b>Finding:</b> | <p>The item has insufficient safety zone allowed as required by BS EN 14974. This should equal at least 2.0 metres on most items and 5.0 metres behind a Jump Ramp. Actual dimension 2.4m measured horizontally from the ramp to the path and 4.4m to the parking bays</p> | | |

| <b>12 - Moderate Risk (Finding 1)</b> | | | |
|---|---|---|---|
| <b>Action:</b> | <p>Refer to the manufacturer</p> | | |

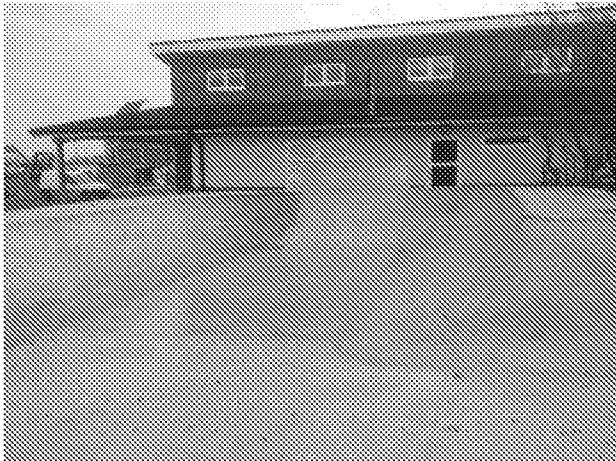
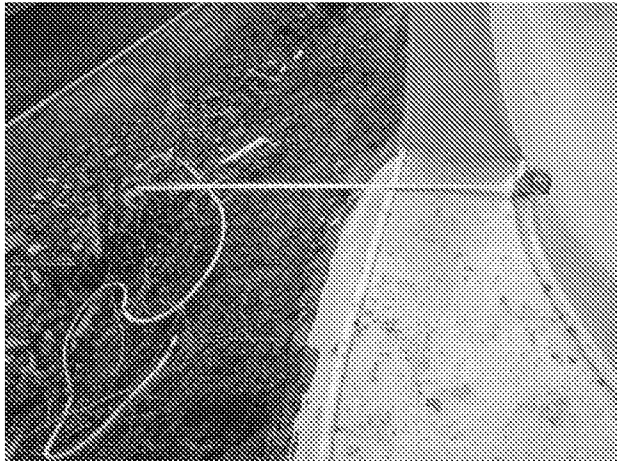
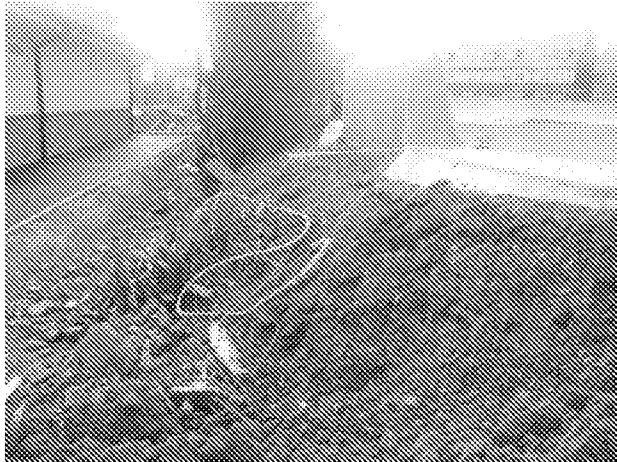
| <b>B - Low Risk (Finding 1)</b> | | | |
|---|---|---|---|
| <b>Item:</b> | Wheeled Sports - Concrete Bowl | <b>Risk Level:</b> | L - Low Risk |
| <b>Finding:</b> | The depth of the table perimeter is less than the 1200mm recommended by BS EN 14974. A measurement of 370mm was recorded at the smallest point | | <b>Action:</b> Build up spoil to the rear of the ramp to achieve 1.2m minimum depth |

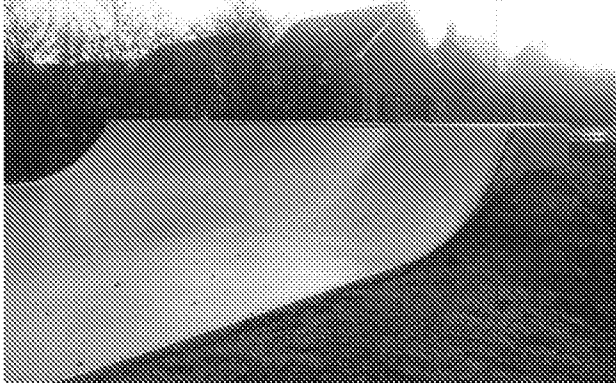
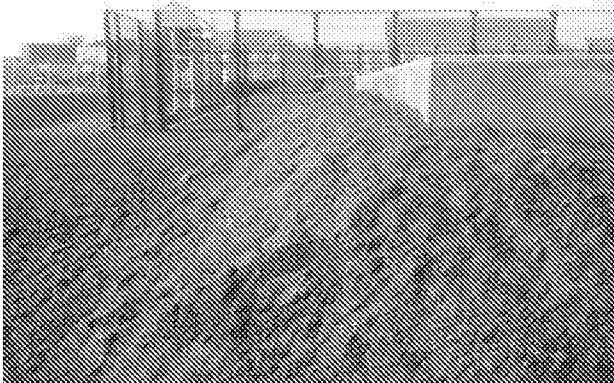
| 8 - Low Risk (Finding 1) | | | |
|---|---|---|---|
| <b>Item:</b> | Wheeled Sports - Curved Start Ramp | <b>Risk Level:</b> | L - Low Risk |
| <b>Finding:</b> | The depth of the table is less than the 1200mm recommended by BS EN 14974. A dimension at smallest point of 560mm was recorded | | <b>Action:</b> Build up spoil to the rear of the ramp to achieve 1.2m minimum depth |

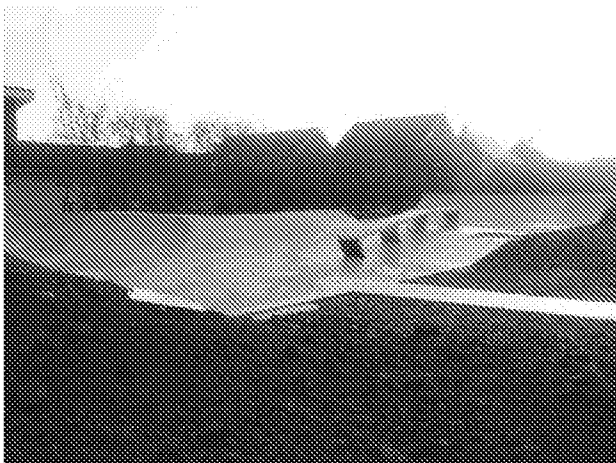
| 4 - Very Low Risk (Finding 1) | | | |
|---|---|---|---|
| <b>Item:</b> | Ancillary Items - Site General | <b>Risk Level:</b> | V - Very Low Risk |
| <b>Finding:</b> | Signage should be provided as recommended in BS EN 14974; this will include, but not exclusively, the use of the area, a recommendation to wear protective equipment, emergency contact details etc. | | <b>Action:</b> Provide signage as recommended by BS EN 14974 |

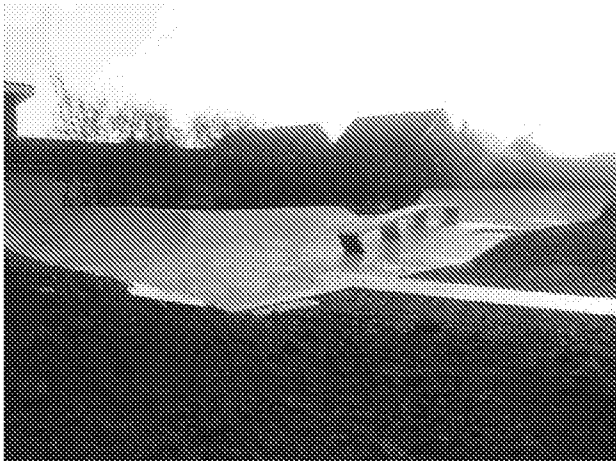
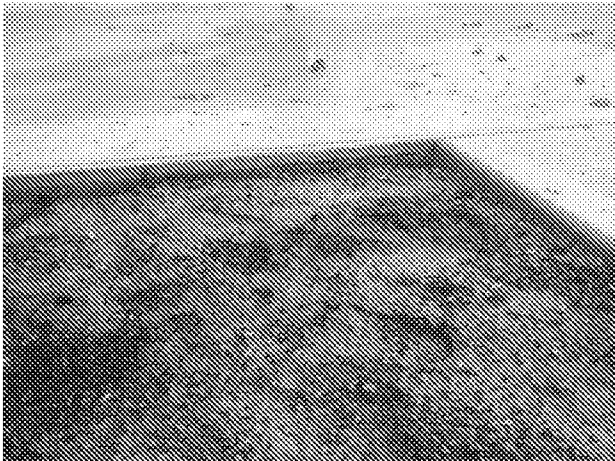
| 8 - Low Risk (Finding 2) | | | |
|---|---|---|---|
| <b>Item:</b> | Ancillary Items - Site General | <b>Risk Level:</b> | L - Low Risk |
| <b>Finding:</b> | There are trip hazards at the edges of the surface | | <b>Action:</b> Reinstate surrounding surface levels to remove the trip points |
