## Post Installation Report

Barratt Southampton

Blakes Mead Play Area 2

Inspection Ref: 638829

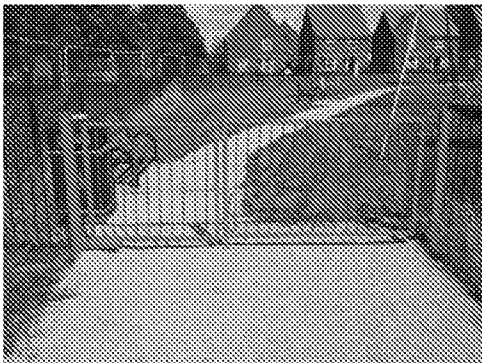
| 6 - Low Risk | |
|---|---|
| Item: | Gate - Combination |

| 6 - Low Risk | |
|---|---|
| There is no padlock on the maintenance gate - Provide a padlock to secure the gate | |

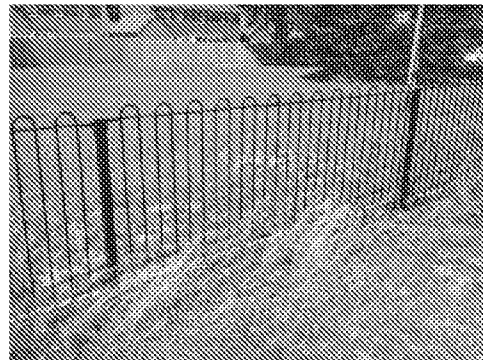
**Item:** Fence - Bow Top  
**Manufacturer:** Not Identified  
**Surface Type:** N/A  
**Equipment Compliance:** N/A  
**Surface Area Compliance:** N/A

There are projecting corners on parts of the fencing - Remove projecting corners

There are loose fixings on the panels adjacent to the gates - Secure

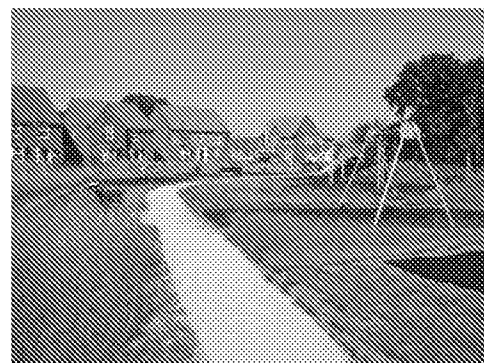
**Item:** Site General  
**Manufacturer:** Not Applicable  
**Surface Type:** N/A  
**Equipment Compliance:** N/A  
**Surface Area Compliance:** N/A

It is recommended that information signs with emergency contact details are installed at each entrance/exit point to the playground - Provide in accordance with the recommendations set out in BS EN 1176

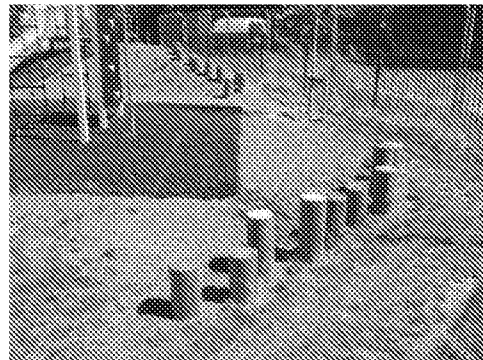
**Item:** Stepping Stones  
**Manufacturer:** Not Identified  
**Surface Type:** Grass  
**Equipment Compliance:** No  
**Surface Area Compliance:** Yes

The hedge is located approximately 300mm and 500mm within the falling space of the equipment - Refer to the manufacturer

Parts of the timber on the relocated post are rough or splintered - Remove all rough or sharp edges

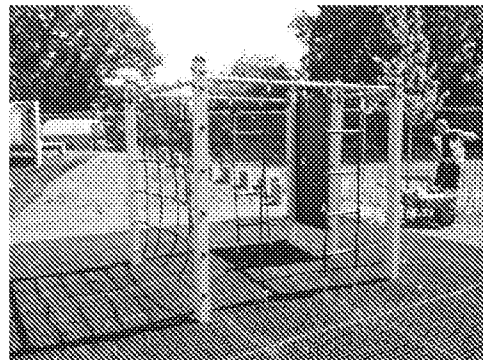
**Item:** Climbing Frame  
**Manufacturer:** Vinci Play  
**Surface Type:** Grass Matrix Tiles  
**Equipment Compliance:** Yes  
**Surface Area Compliance:** Yes

Some of the net fixings are slightly loose - Secure

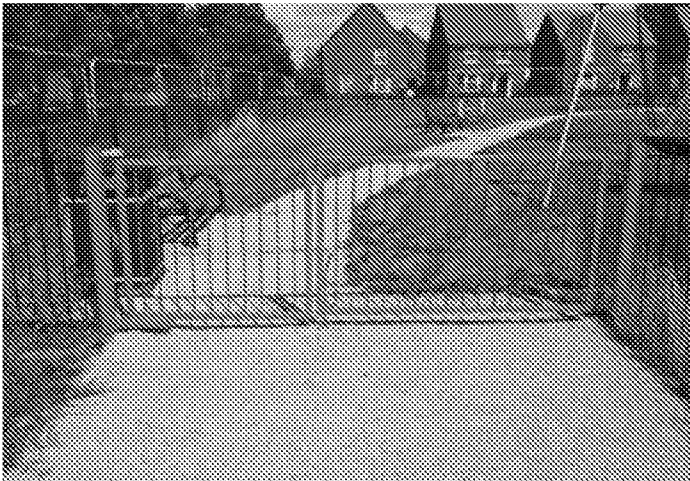
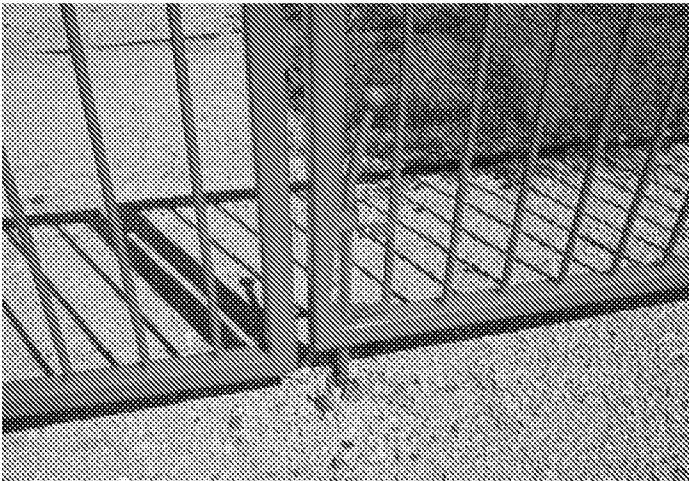
| 6 - Low Risk (Finding 1) | | | |
|---|---|---|---|
| <b>Item:</b> | Ancillary Items - Gate - Combination | <b>Risk Level:</b> | L - Low Risk |

| 6 - Low Risk (Finding 1) | | | |
|---|---|---|---|
| <b>Finding:</b> There is no padlock on the maintenance gate | | <b>Action:</b> Provide a padlock to secure the gate | |

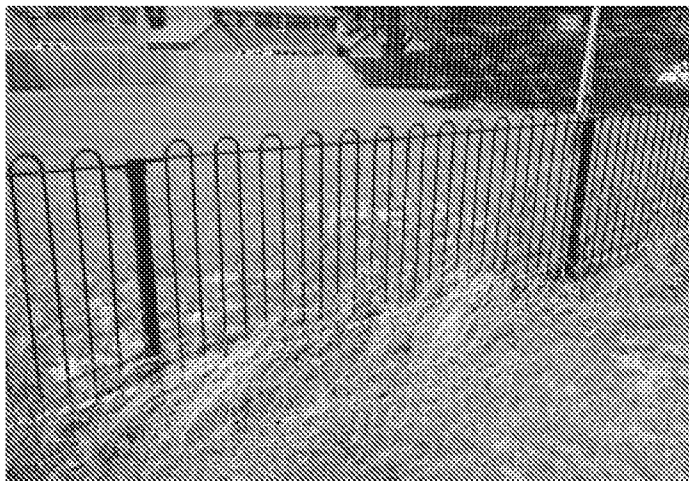
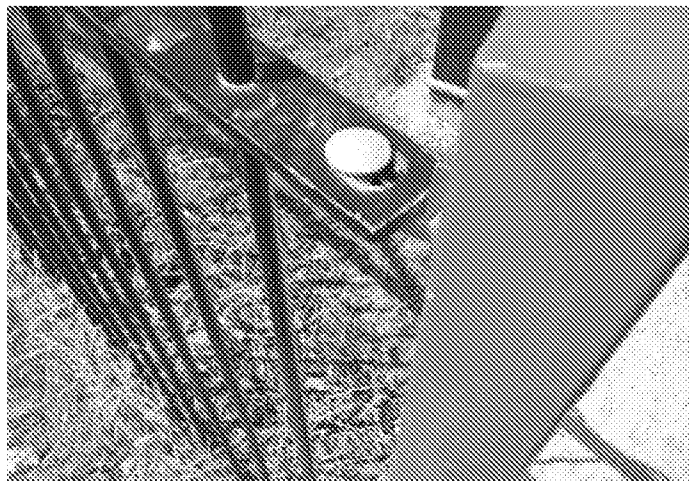
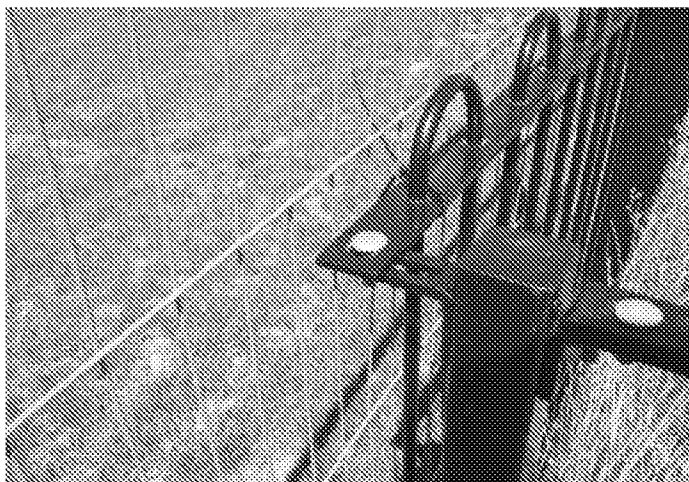
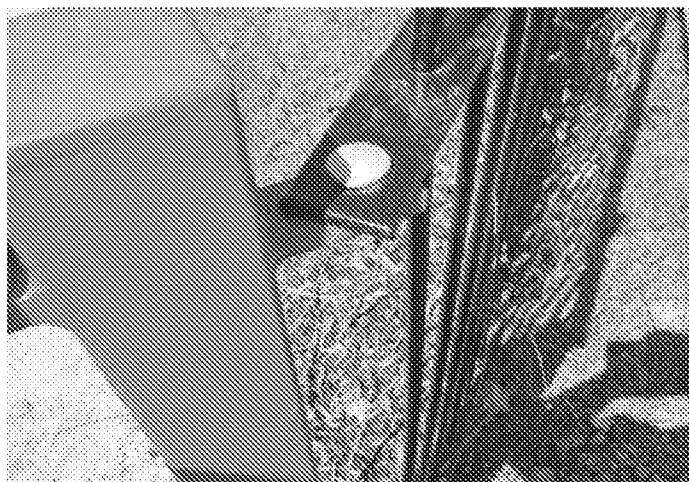
**Item:** Ancillary Items - Fence - Bow Top  
**Manufacturer:** Not Identified

**Finding:** There are projecting corners on parts of the fencing

**Action:** Remove projecting corners

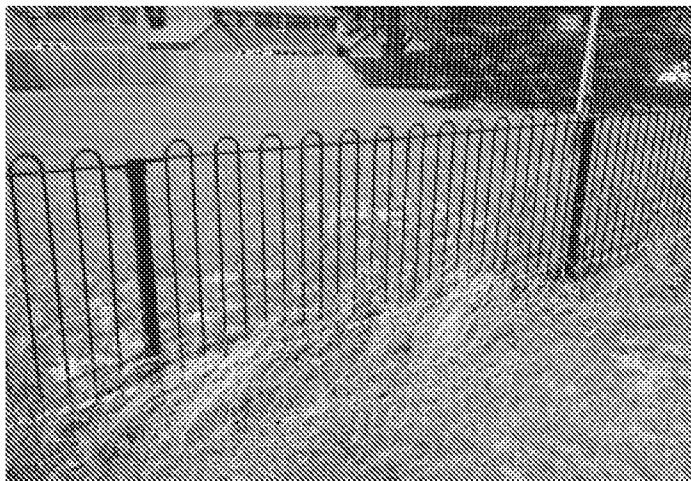
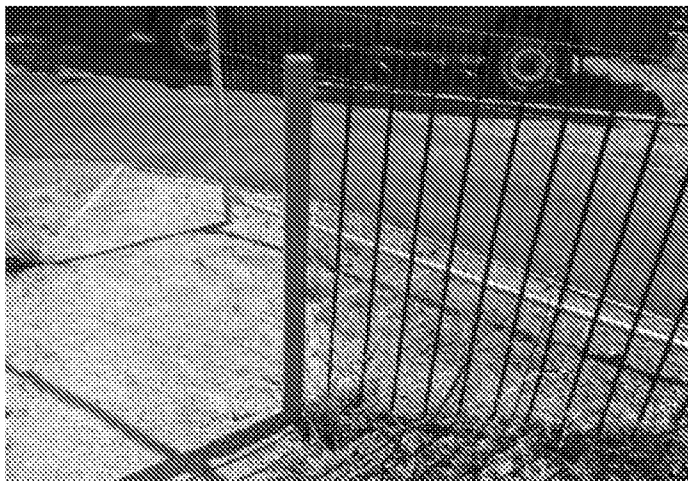
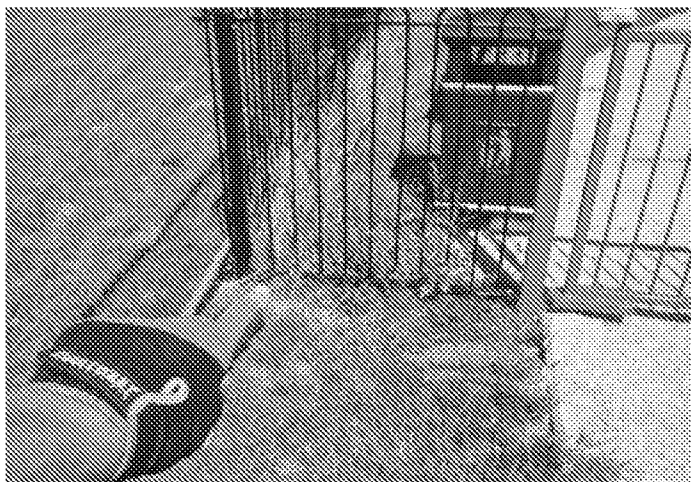
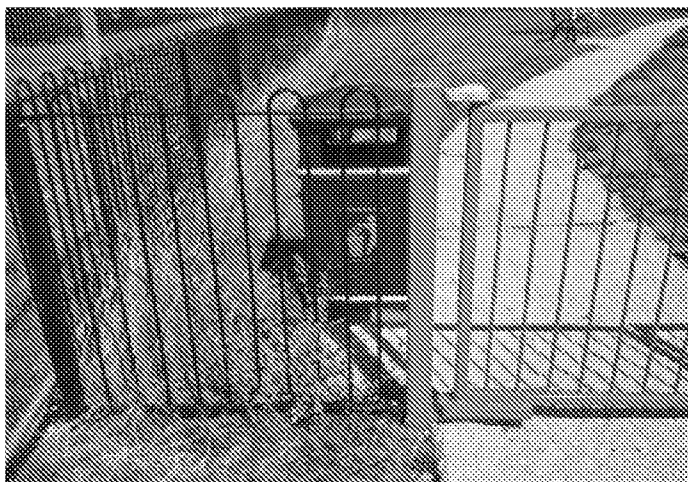
**Item:** Ancillary Items - Fence - Bow Top  
**Manufacturer:** Not Identified

**Finding:** There are loose fixings on the panels adjacent to the gates  
**Action:** Secure

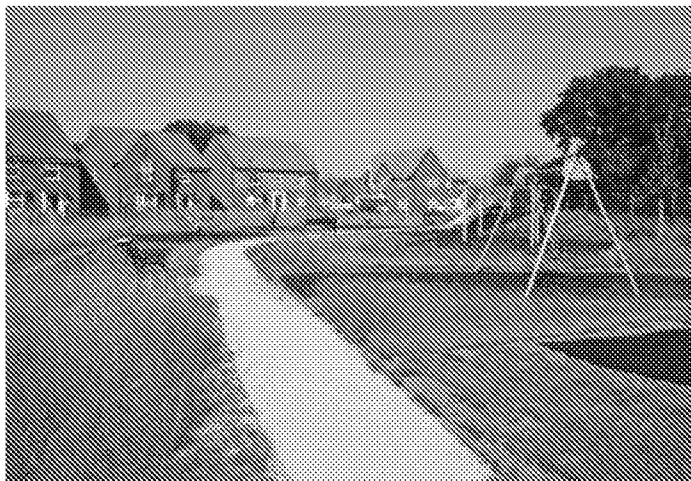
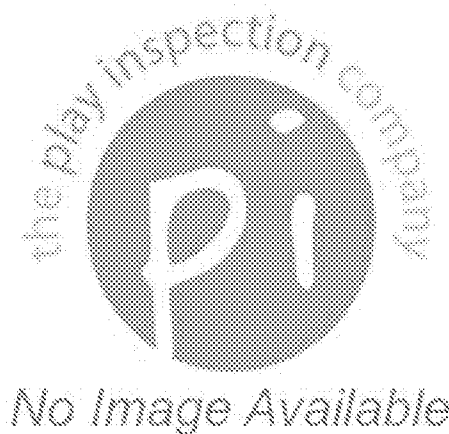
**Item:** Ancillary Items - Site General

**Finding:** It is recommended that information signs with emergency contact details are installed at each entrance/exit point to the playground

**Action:** Provide in accordance with the recommendations set out in BS EN 1176

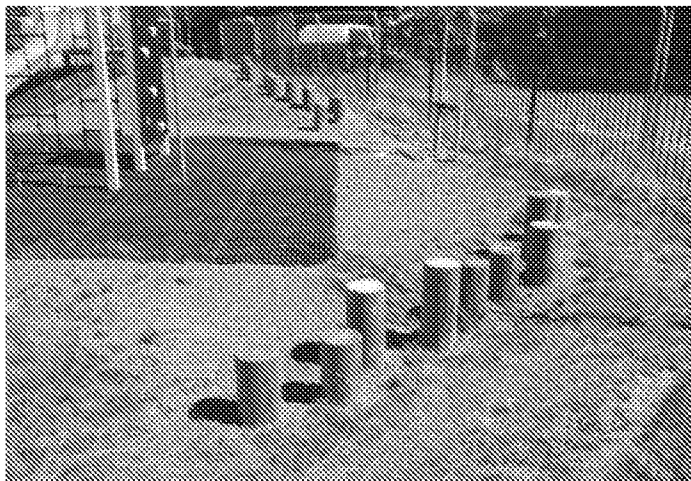
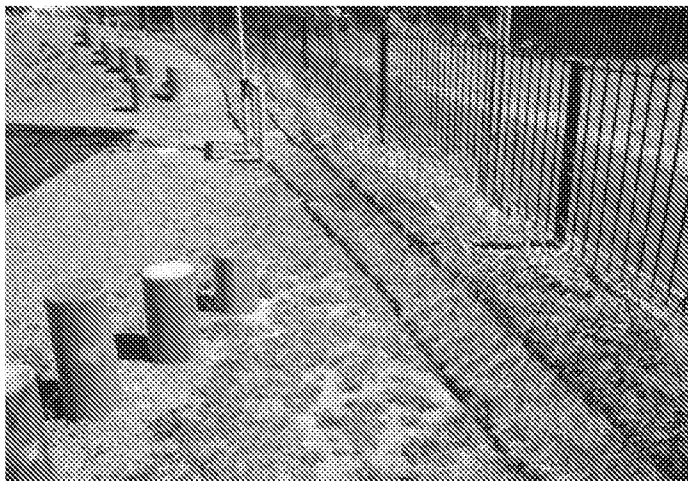
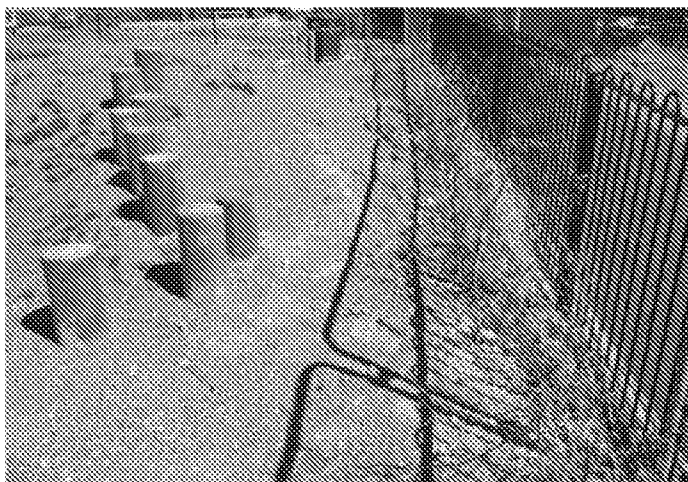
**Item:** Activity Equipment - Stepping Stones

**Finding:** The hedge is located approximately 300mm and 500mm within the falling space of the equipment

**Action:** Refer to the manufacturer

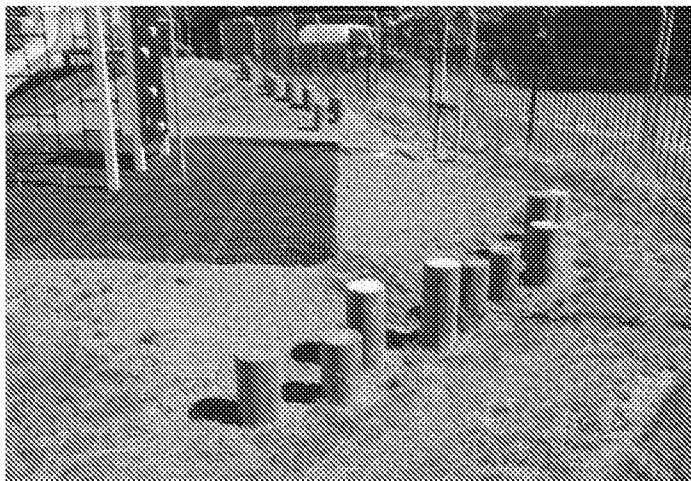
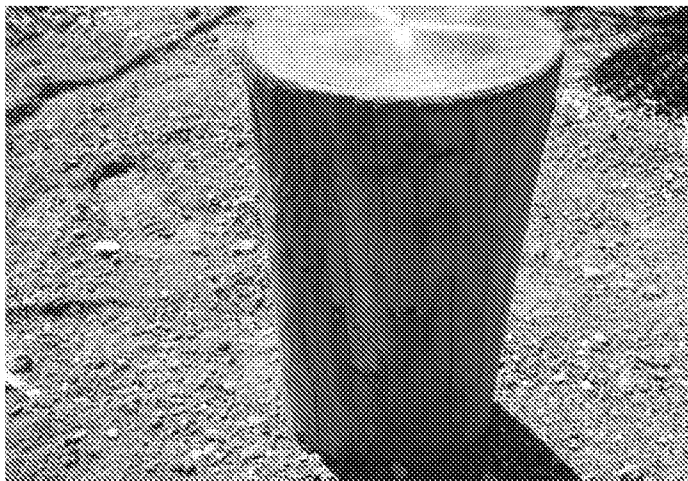
**Item:** Activity Equipment - Stepping Stones  
**Manufacturer:** Not Identified

**Finding:** Parts of the timber on the relocated post are rough or splintered  
**Action:** Remove all rough or sharp edges

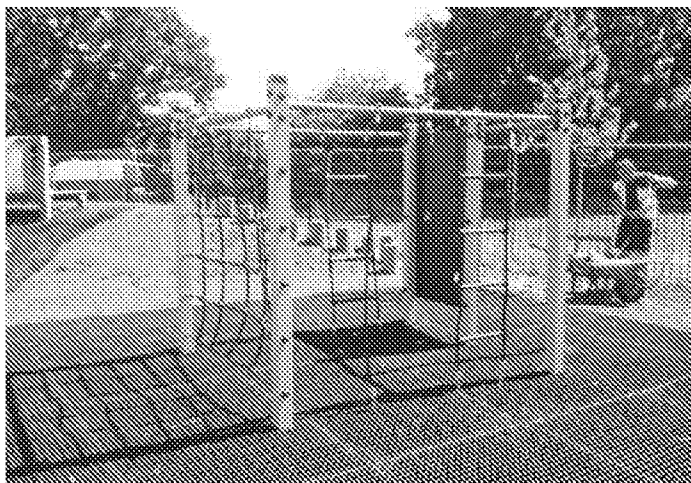
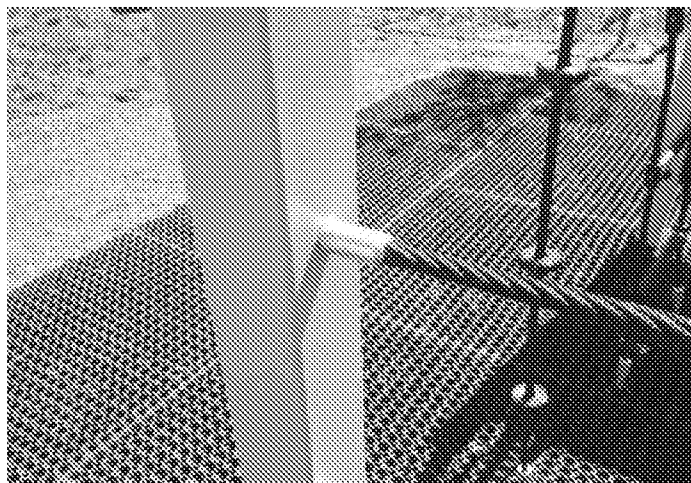
**Item:** Activity Equipment - Climbing Frame  
**Manufacturer:** Vinci Play

**Finding:** Some of the net fixings are slightly loose  
**Action:** Secure
