## ARBORICULTURAL REPORT IN RELATION TO TREES NEAR BUILDINGS

**REF:** PJE/170/2014

**Location:** The Mead, 7 Rife Way, Felpham, Bognor Regis, West Sussex, PO22 7BN.

**INSPECTION DATE:** 10<sup>th</sup> April 2014

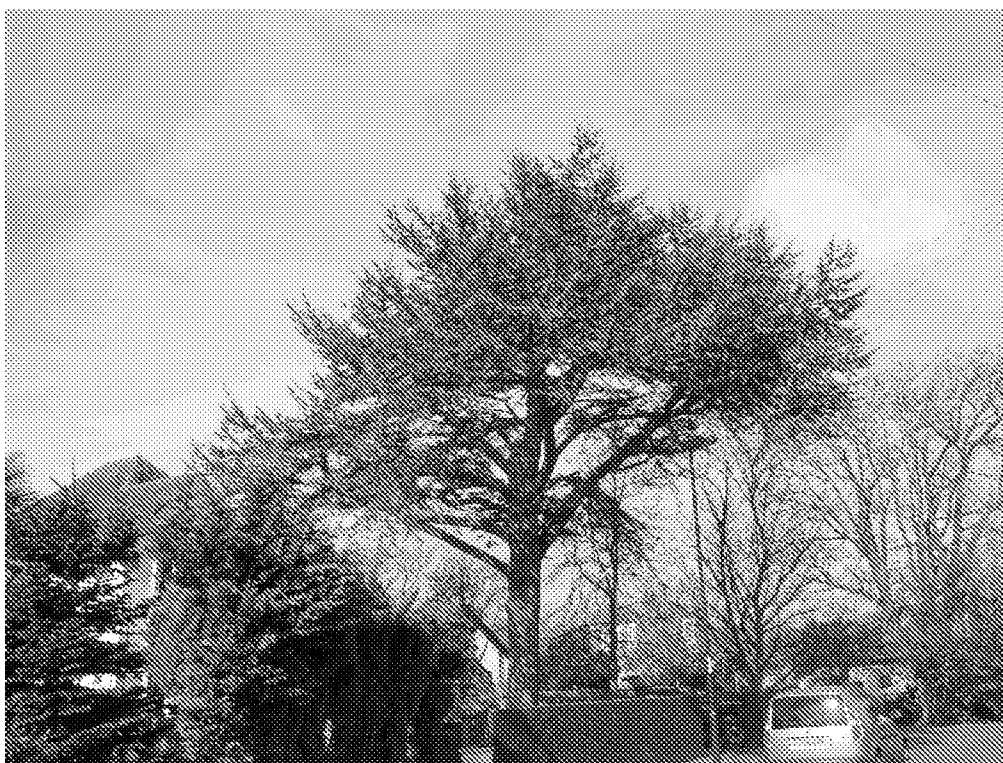
- 3.1 The subject tree is a Blue Cedar located in the front garden of the property between road and house. The tree is in fair condition with only one branch and lighter branches on the south side damaged from the storms of last winter. The tree has previously been crown lifted and crown reduced to keep it within its confines. A number of previous pruning wounds were seen that are occluding adequately. There is some deadwood in the crown that could be removed to prevent falling off in time to prevent damage to life, limb and property. At the time of inspection tree had recently lost needles (leaves), likely seasonal loss before onset of summer growth. Subject tree has not produce seed cones for two or three years that might be a clue to its health. There is a highway street light immediately under canopy of the tree that prevents illumination of the street adequately. Running through the crown are three telephone lines. Pigeons roost in the tree that defecates onto the ground creating a health hazard. Has the Potential to grow larger and the root system is now considered to be starting to cause damage to structures. Root systems of cedars are relatively shallow and are responsible for lifting structures including walls. Subject tree has received management in the past with the crown reduced of tree previously. This species has potential to influence the house foundations by roots causing heave indicated by cracks in the brickwork. It also casts a heavy shadow over the house cutting out light at the front from midday especially in the winter.

**Fig 1 View of subject tree taken from road**

- 4.1 As the tree has got larger since application to fell in 2001 now outgrown its current position and removal is the preferred option by the owner and neighbour rather than prune every few years. If removal is permitted a replacement of a more suitable species would be planted during the next planting season of a deciduous species. Also the adjoining deciduous trees would benefit and be able to develop. Suitable garden species to replace with could be from the following: Birch, Crab apple, Cherry, Foxglove tree, Handkerchief tree, Mountain ash, Pride of India and Whitebeam.
- 4.2 The inspector at the appeal to remove tree in 2001 did recommend removal for reason of size see appendix A. Why this was not acted on at the time I am not clear but had a more suitable tree been planted then it would now be established.

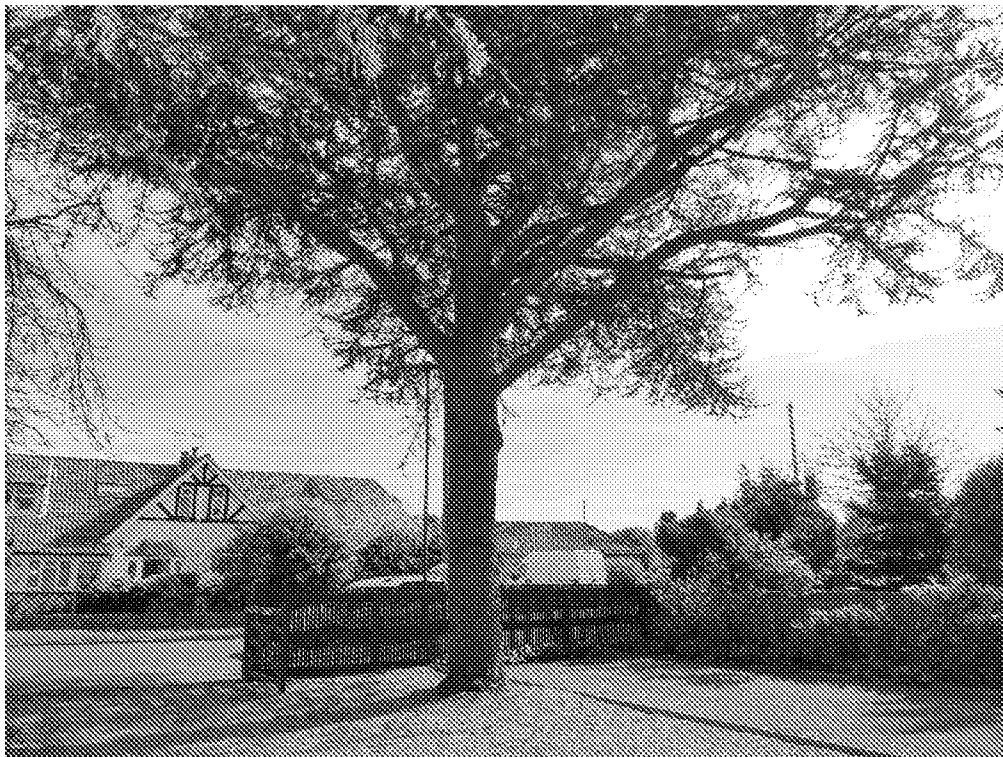
**Fig 2 view of tree from garden**

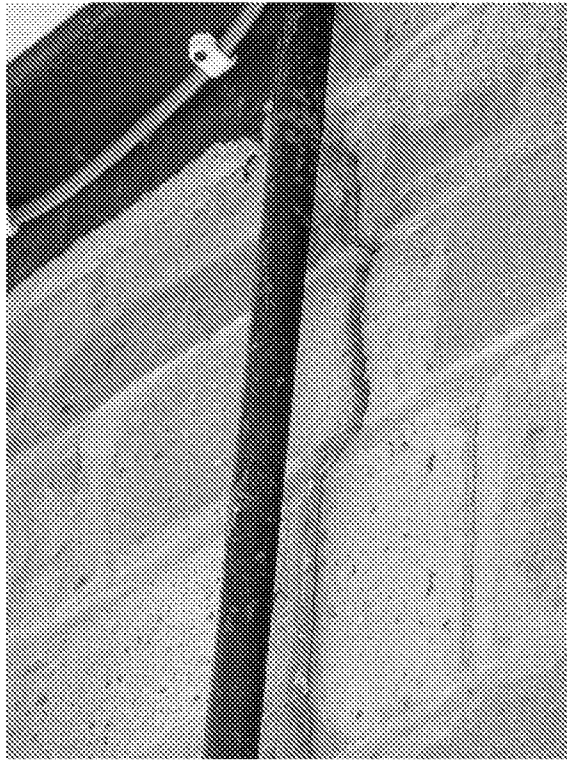
- 3.2 I did find damage to the house in terms of cracks at the front and rear that could be attributable to tree roots causing heave of the soil, lifting foundations. Given the age of tree this quite likely but specialist investigation may help confirmation.

- 3.5 The J. P. Tupper surveyors report dated 31<sup>st</sup> July 2001 attached as Appendix B suggests that the foundation depth of house is inadequate by today's standards. They also indicate that there are a number of cases locally where subsidence has occurred when underpinning was required. I observed a number of cracks in the brickwork that could be attributable to the tree.

**Fig 3 Showing crack in brickwork inside garage.**

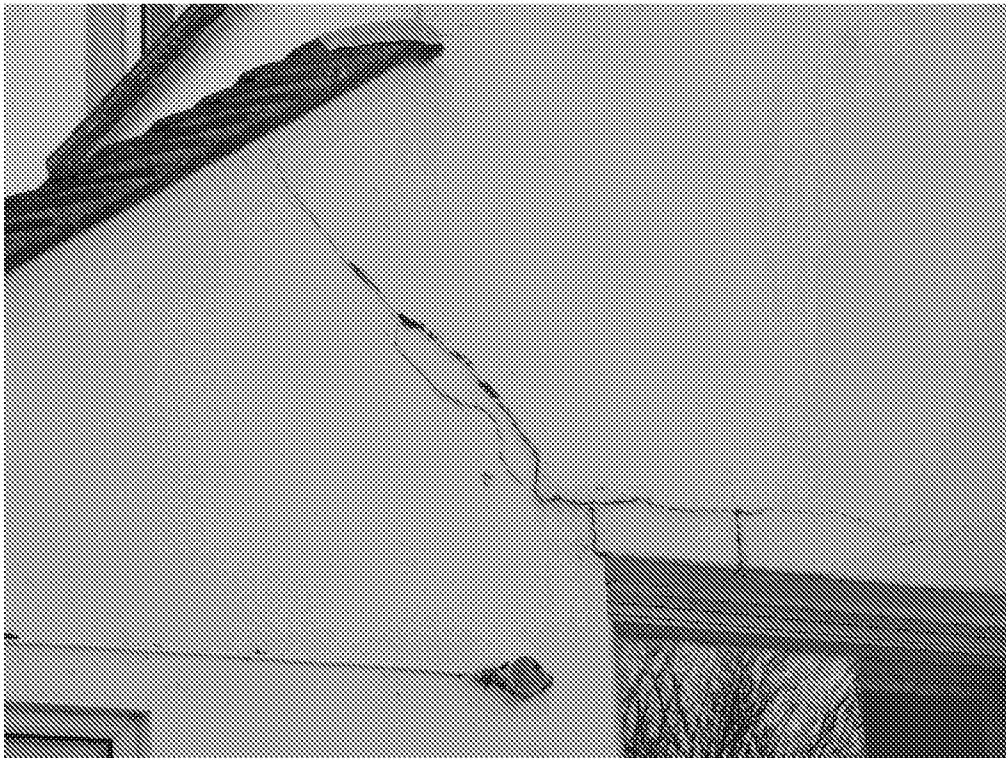
**Fig 4 showing cracks in wall at rear of house**
