# Andrew Gale Tree Surgery

## Tree Condition Report for 5 Admiralty Road Felpham

March 2017

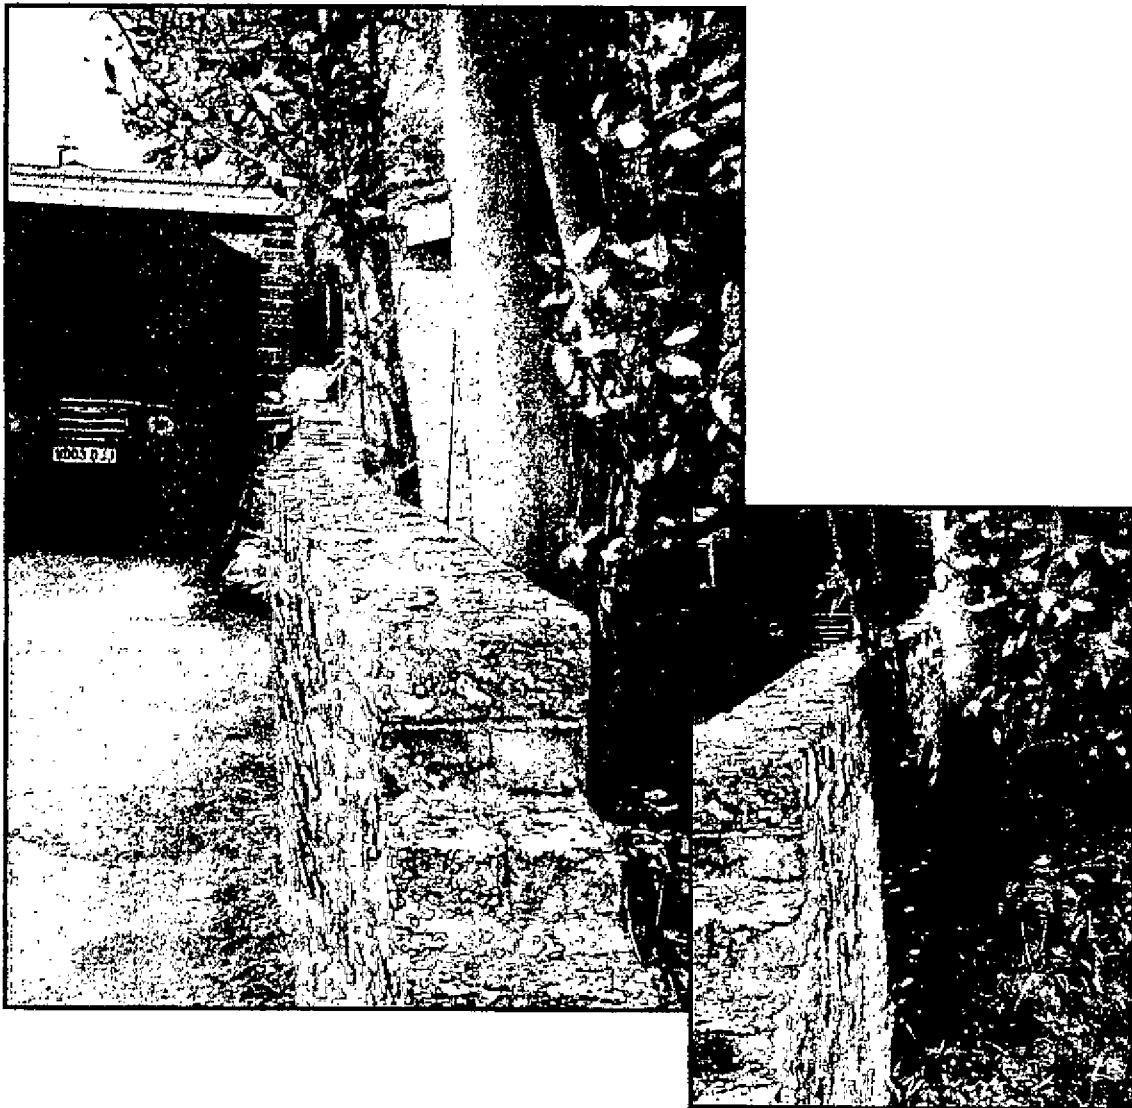
The boundary wall that bisects the 5 Admiralty Road with 3 Admiralty Road is being pushed over by the western buttress root and sucker growth tree as the Photo 2 below shows.
