**RJS6308**

Ford AirField  
Arundel  
West Sussex  
BN18 0DD

The survey was conducted to establish the presence of asbestos containing materials in the areas noted below:  
**Demolition Survey to Bleach Warehouse, adjacent Barn Storage and Old Hangar**

#### Demolition

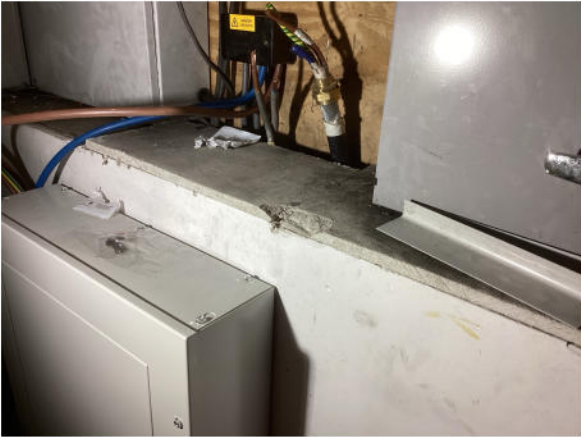
| PHOTO | Sample No. | Location | Product Details | Analysis Result |
|---|---|---|---|---|
| 01 | 01 | Bleach warehouse: G.02 -<br>Electrical intake room | Cladding panels | No asbestos detected |
| | | | Product Type: | 2 (Medium) |
| | | | Surface Treatment: | 2 (Medium) |
| | | | Condition: | 2 (Medium) |
| | | | Risk Level: | None |

| PHOTO | Sample No. | Location | Product Details | Analysis Result |
|---|---|---|---|---|
| | | | Recommendation | No Action Required |

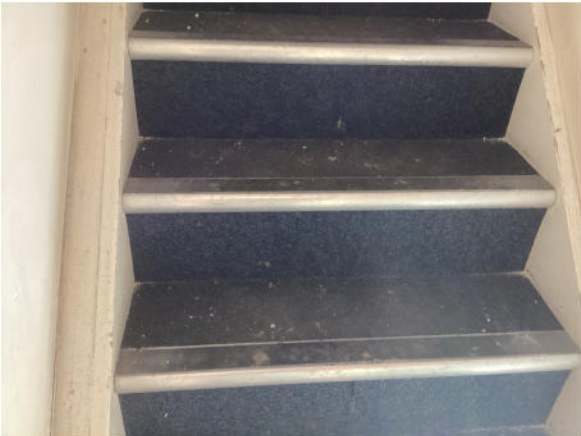
| PHOTO | Sample No. | Location | Product Details | Analysis Result |
|---|---|---|---|---|
| 02 | 02 | Bleach warehouse: G.05 -<br>Hallway | Stair nosings | No asbestos detected |
| | | | Product Type: | 1 (Low) |
| | | | Surface Treatment: | 0 (None) |
| | | | Condition: | 0 (None) |
| | | | Risk Level: | None |

| PHOTO | Sample No. | Location | Product Details | Analysis Result |
|---|---|---|---|---|
| | | | Recommendation | No Action Required |

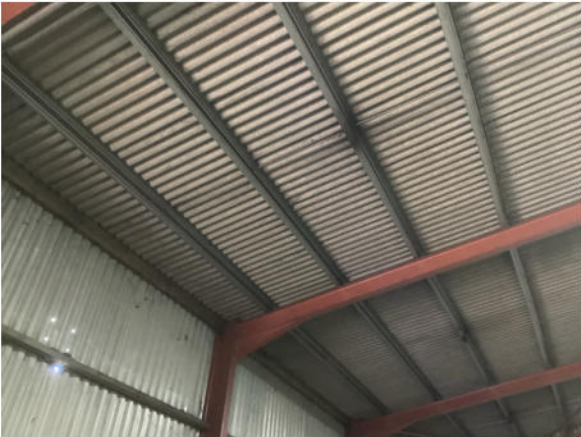
| PHOTO | Sample No. | Location | Product Details | Analysis Result |
|---|---|---|---|---|
| 03 | 03 | Bleach warehouse: G.01 -<br>Warehouse space | Roof sheeting | No asbestos detected |
| | | | Product Type: | 1 (Low) |
| | | | Surface Treatment: | 1 (Low) |
| | | | Condition: | 1 (Low) |
| | | | Risk Level: | None |

| PHOTO | Sample No. | Location | Product Details | Analysis Result |
|---|---|---|---|---|
| | | | Recommendation | No Action Required |

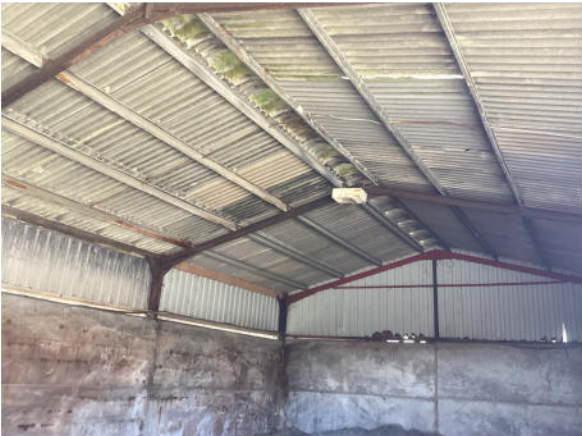
| Building: <b>Main</b> | | | | |
|---|---|---|---|---|
| G.07 - Storage area<br>Cement sheeting to roof | 04 | 04 | Was found to contain<br>Chrysotile (White Asbestos) | Remove |

| Building Room Number/ Name<br>Product Details | Sample No. | Bulk ID | Photo No. | Product Type | Surface Treatment | Surface Condition | Type | Score | Possible Disturbance | Quantity M, M2,x? | ID A, SP, P | Rmd MM, E, R, Other. |
|---|---|---|---|---|---|---|---|---|---|---|---|---|
| Storage barn: G.07 - Storage area<br>Cement sheeting to roof | 04 | AA32958/B04 | 04 | 1 | 1 | 3 | 1 | 6 | 1 | 180m <sup>2</sup> | A | R |

| PHOTO<br>04 | Sample No.<br>04 | Location<br>Storage barn: G.07 - Storage<br>area | Product Details<br>Cement sheeting to<br>roof | Analysis Result<br>Chrysotile |
| | | | Product Type: | 1 (Low) |
| | | | Surface Treatment: | 1 (Low) |
| | | | Condition: | 3 (High) |
| | | | Risk Level: | Low |

| AA Sample Reference | Client Sample Number | Sample Description / Material Type<br>(disclosed by client) | Fibre Type Detected |
|---|---|---|---|
| B04 | S4 | Storage barn roof | CHRYSTOTILE |

| PHOTO<br>04 | Sample No.<br>04 | Location<br>Storage barn: G.07 - Storage<br>area | Product Details<br>Cement sheeting to<br>roof | Analysis Result<br>Chrysotile |
|---|---|---|---|---|
| | | | Recommendation | Remove |
