# Kingston Manor

Photographic Schedule of Condition & Statement

September 2020

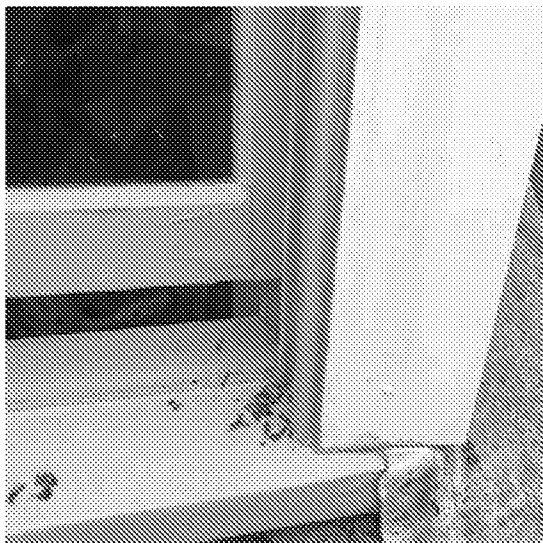
## **WS2**

Lifting of paint most probably due to water ingress leading to internal rot and capillary action leading to the frame holding moisture. Failed putty.
