# Kingston Manor

Photographic Schedule of Condition & Statement

September 2020

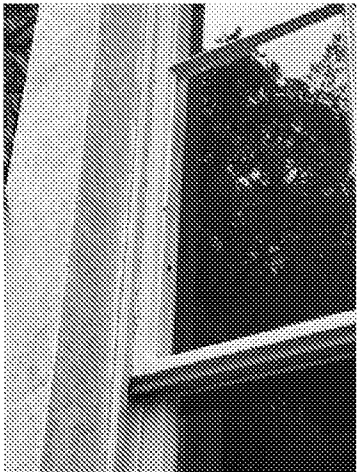
| | <p><b>WG1</b></p> <p>Cracked and chipped paint, general cracking and weathering noted across the external face. Lifting of paint due to internal rot and frame holding moisture.</p> |

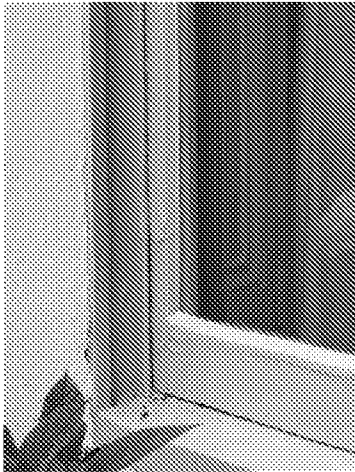
| | <p><b>WG2</b></p> <p>Lifting of paint most probably due to water ingress leading to internal rot and capillary action leading to the frame holding moisture.</p> |

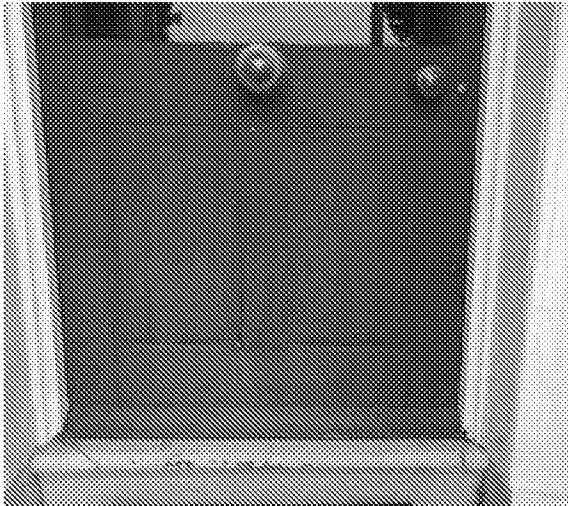
| | <p><b>D1</b></p> <p>Evidence of general rot degradation, and weathering throughout.</p> |

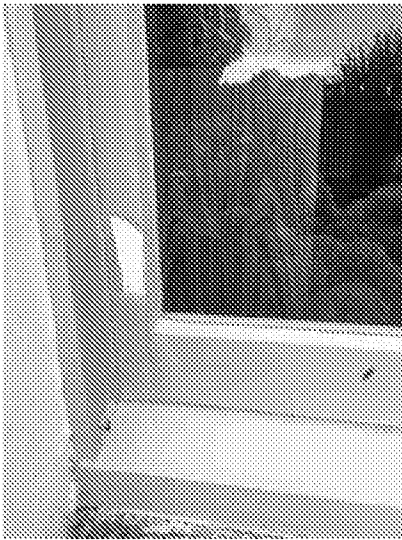
| | <p><b>WG3</b></p> <p>Lifting of paint most probably due to water ingress leading to internal rot and capillary action leading to the frame holding moisture.</p> |

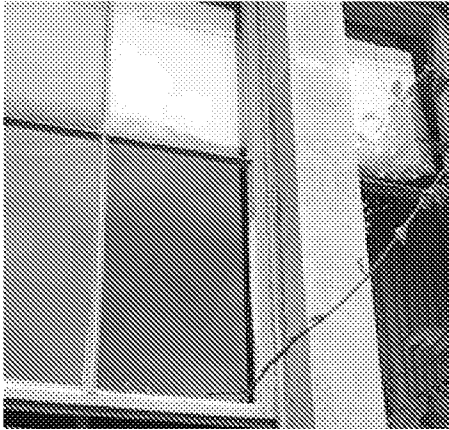
**WG4**

General window rot, degradation.

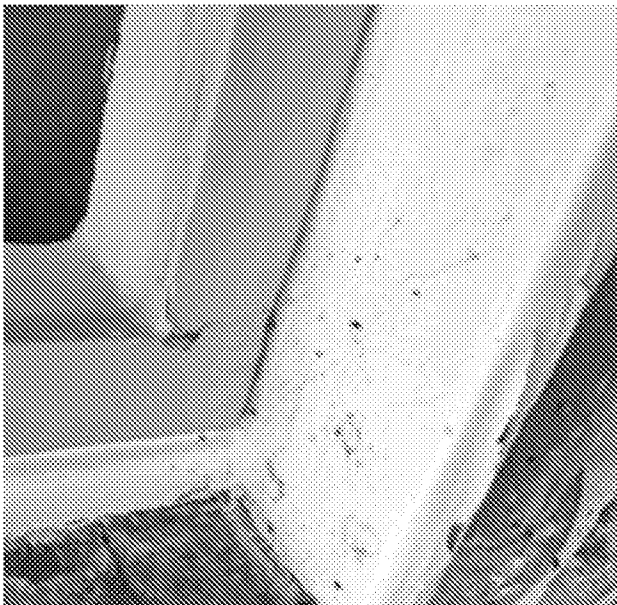
**WG5**

Paint cracking.

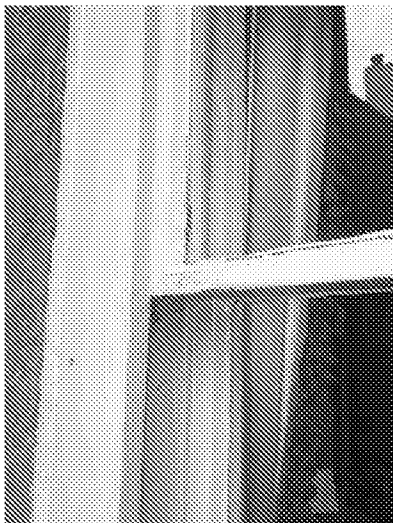
**WG9**

Cracked and chipped paint, general cracking and weathering noted across the external face. Lifting of paint due to internal rot and frame holding moisture. Failed putty.

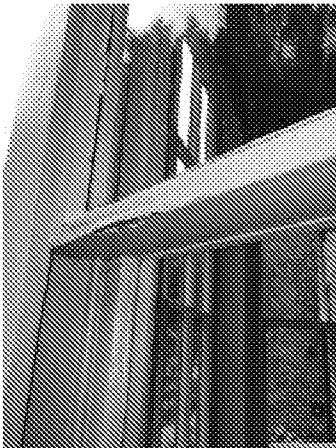
| | <p><b>D2</b></p> <p>Meeting rail degradation and rot present, noted in several of the sash window rails. Failed putty.</p> |

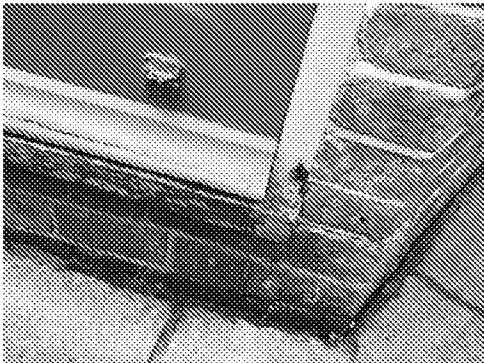
| | <p><b>D2</b></p> <p>Rot to door frame and weather bar.</p> |

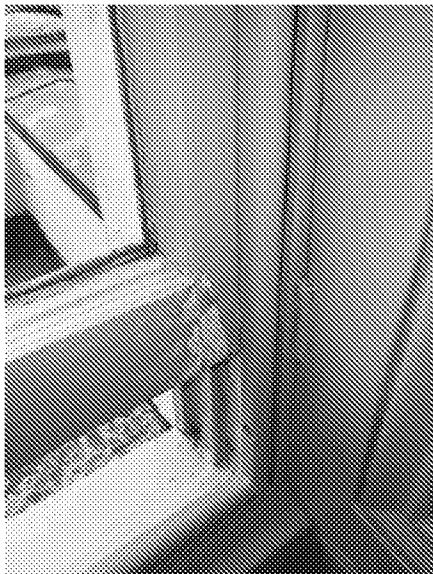
| | <p><b>WF1</b></p> <p>Paint flaking and rot on the internal frame due to penetrating damp, external rot present also.</p> |

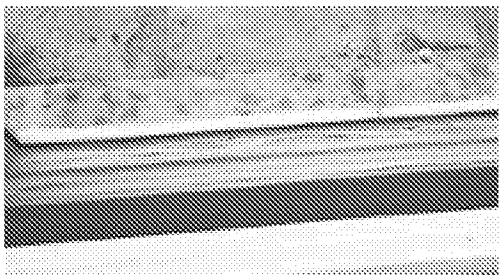
| | <p><b>WF2</b></p> <p>Internal paint flaking due to frame holding moisture, failed putty, rot present also.</p> |

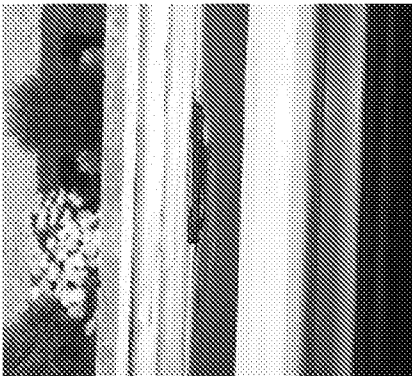
| | <p><b>WF3</b></p> <p>Internal paint flaking due to rot.</p> |

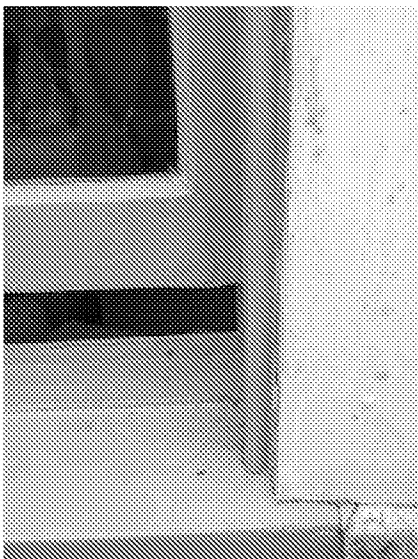
| | <p><b>WS1</b></p> <p>Lifting of paint most probably due to water ingress failed putty, leading to internal rot and capillary action leading to the frame holding moisture.</p> |

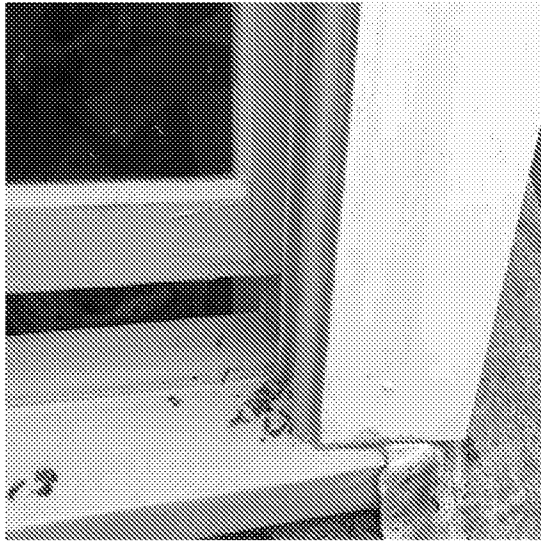
## **WS2**

Lifting of paint most probably due to water ingress leading to internal rot and capillary action leading to the frame holding moisture. Failed putty.
