## **Condition Report Following Water Damage**

**Property Address: 9 South Terrace,  
Littlehampton BN17 5NZ**

**Inspection Dates: 31<sup>st</sup> January 2020 and 07<sup>th</sup> February 2020**

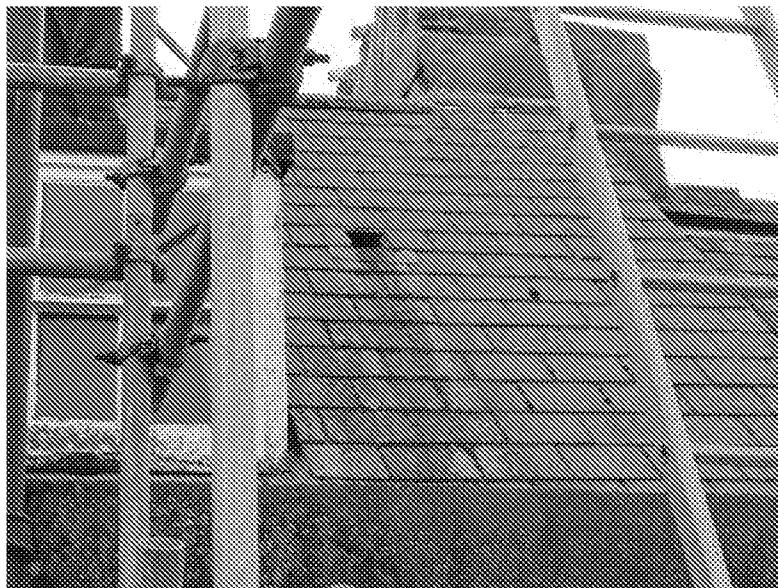
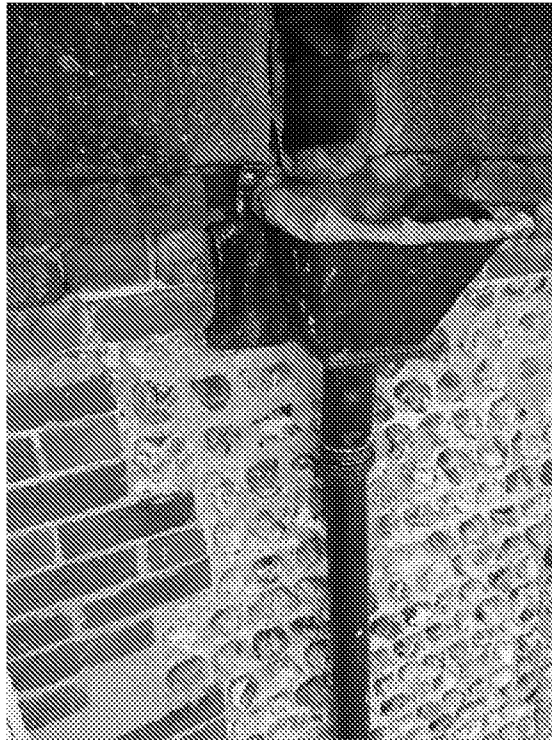
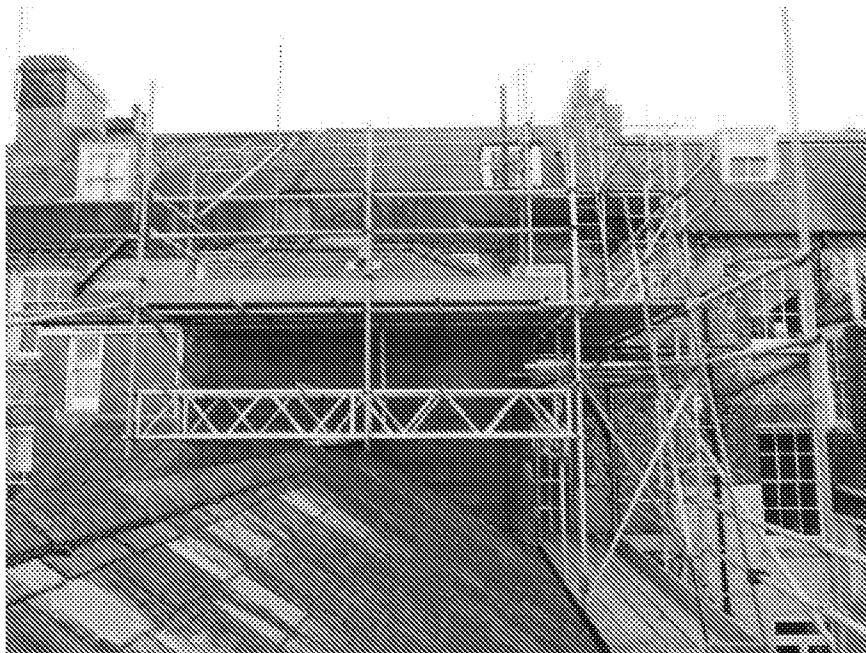
The building has been the subject of extensive water ingress from the roof earlier in the year. This appears to have occurred from the valley between the two pitched roofs. There is resultant damage and mould which has formed on 3 floors and within the roof space. Much of the damaged furniture and finishes have been removed prior to my inspection.

As described above, the method in which the valley rainwater discharges is through an internal channel in the roof void to an outlet in the rear roof slope and then subsequently joins the rear parapet rainwater at a hopper head. See below;

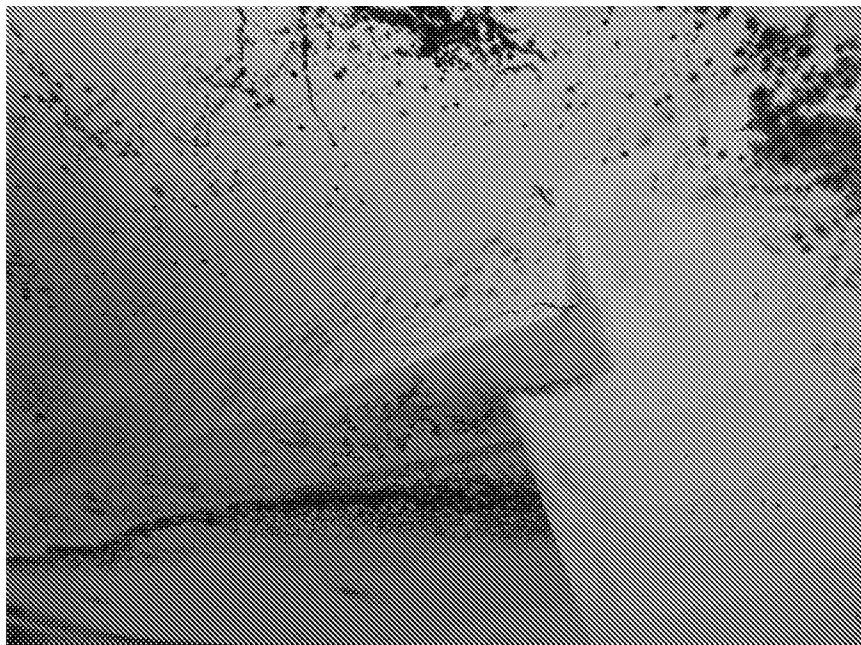
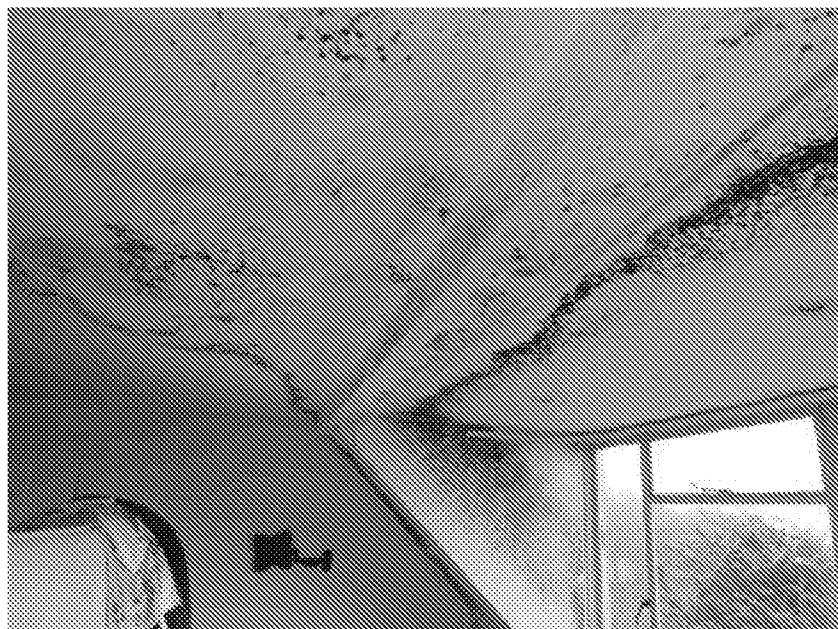
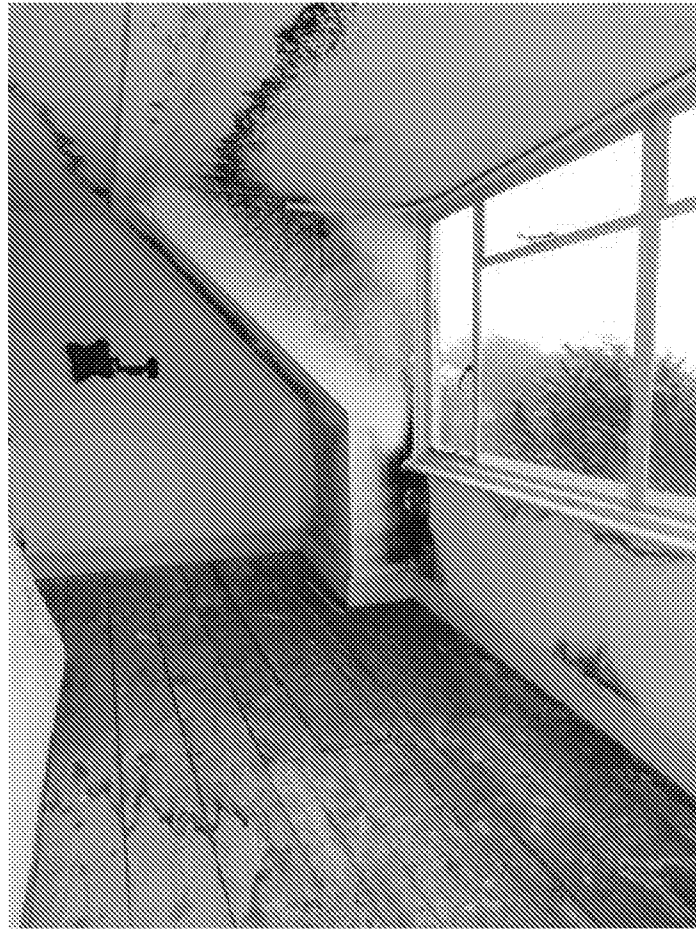
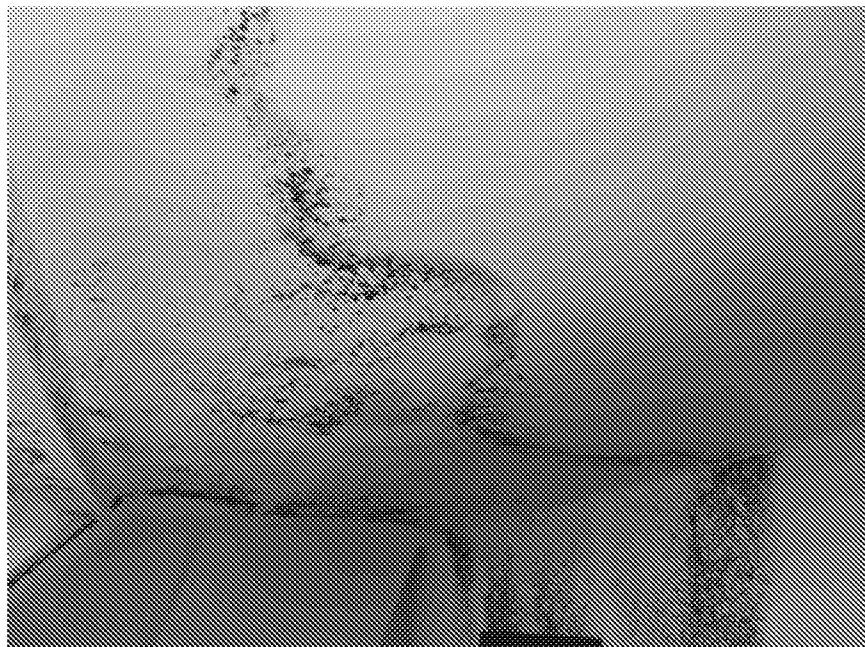
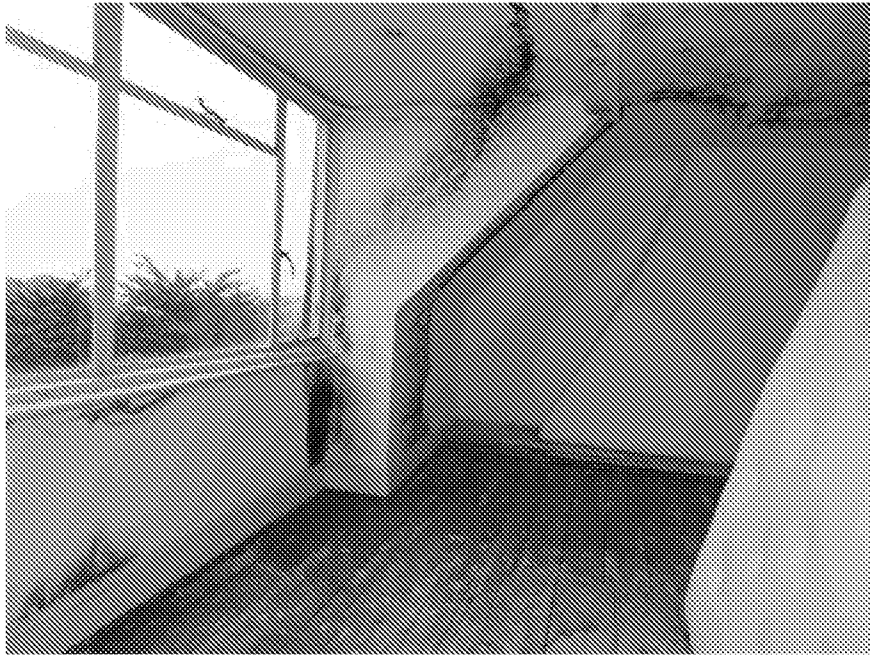
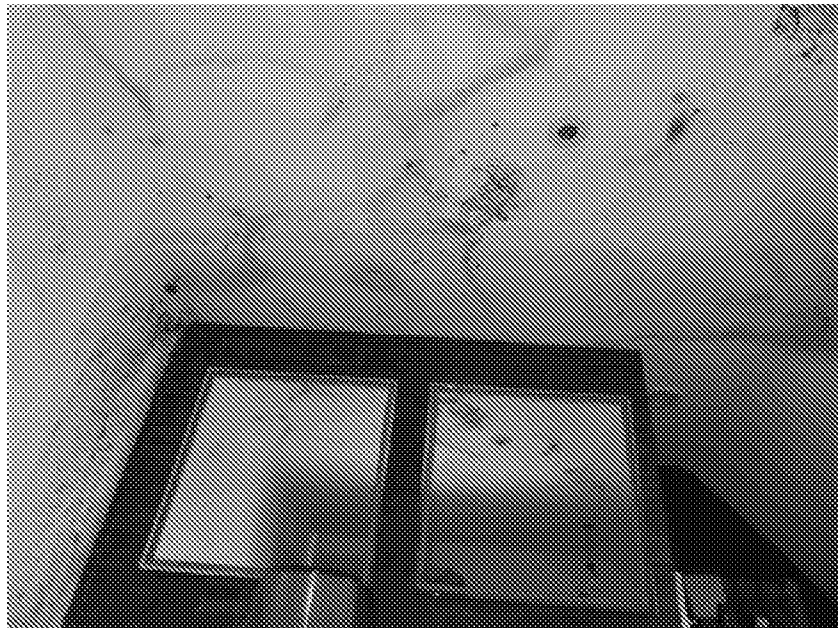
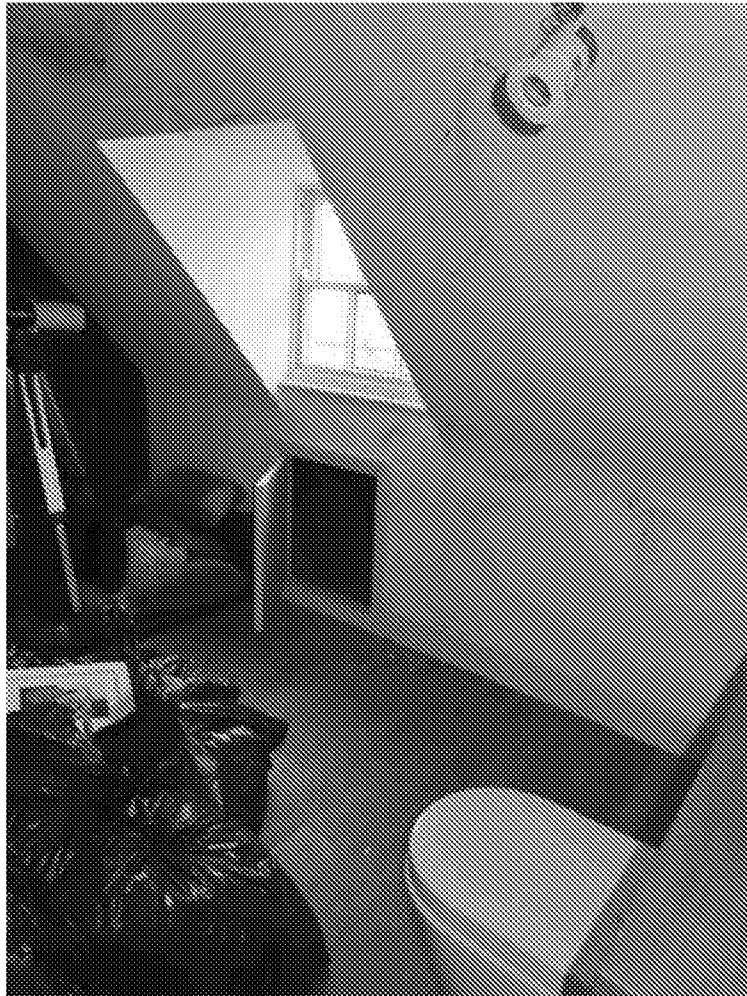
### Attic Rooms

Ceilings: There are ceilings of lath and plaster and of modern plasterboard, as described. Water damage has resulted in the collapse of some ceiling finishes. Some removal works has occurred prior to my inspection.

There is considerable mould and damage to the structure and fabric of the building. All finishes should be removed, further drying out confirmed to be sufficient, and repair either by patch repair to lath and plaster or re- boarding and plastering.

The detail of the repair will be the subject of a Listed Building Consent, and the locations are denoted on the attached drawing.

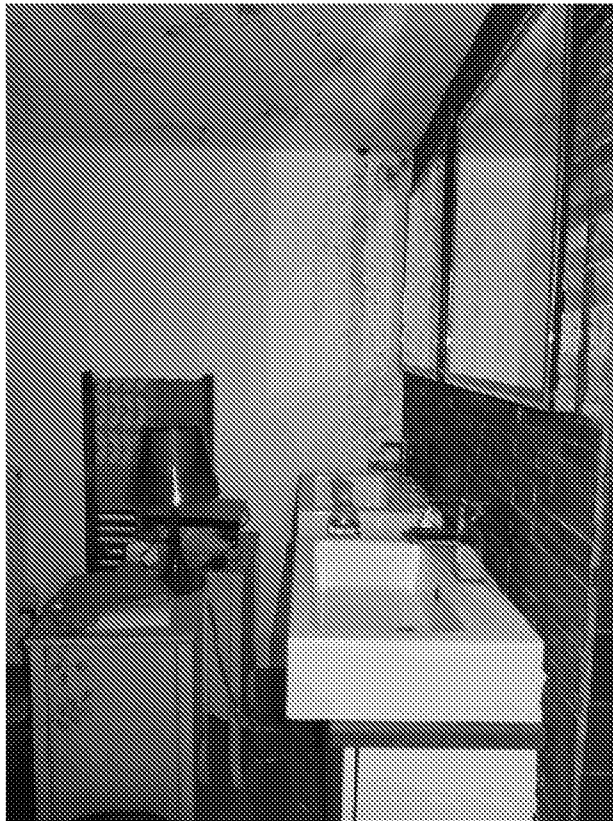
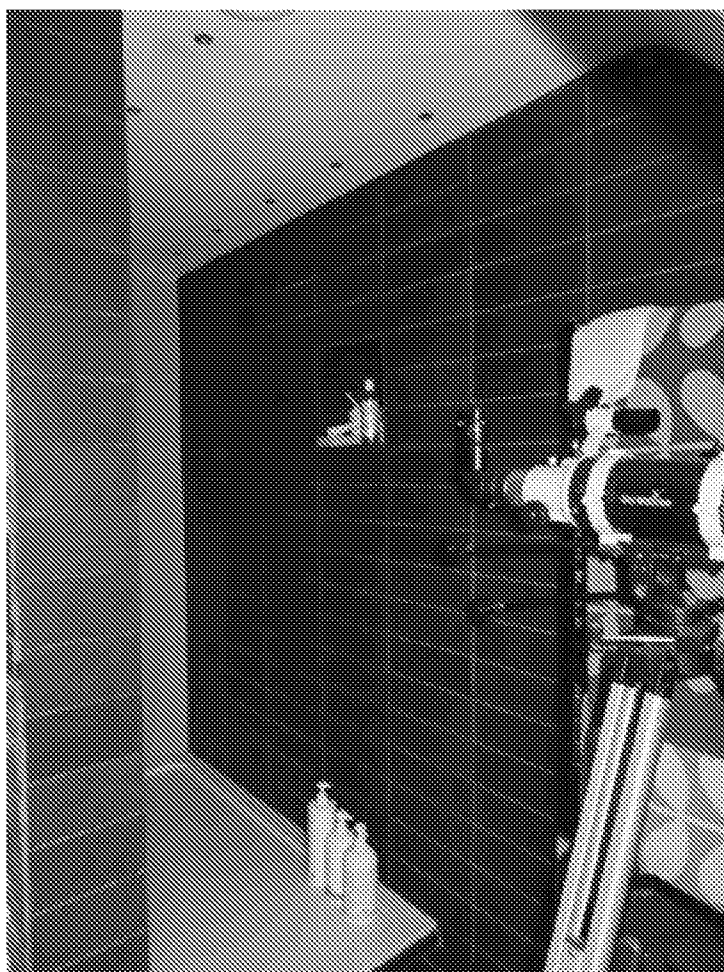
### Attic

Walls: The walls are of masonry and structural studwork with lath and plaster and modern plasterboard, as described. Water damage has resulted in damage to all plaster and papered wall finishes in areas denoted on drawings. Some removal works have occurred prior to my inspection.

There is considerable mould and damage to the structure and fabric of the walls. All finishes should be removed, further drying out confirmed to be sufficient, and repair either by patch repair to lath and plaster or re-boarding and plastering.

The detail of the repair will be the subject of a Listed Building Consent, and the locations are denoted on the attached drawing.

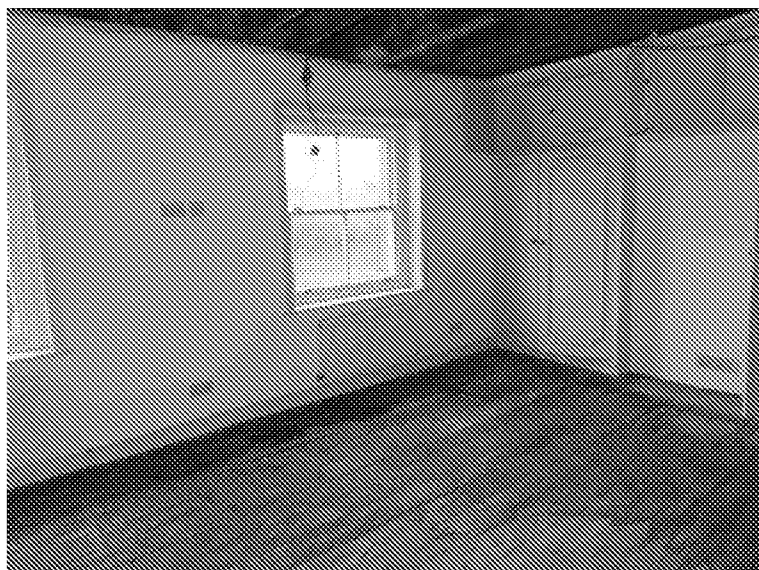
## 2<sup>nd</sup> Floor

Floors: The floors comprise softwood joists, mostly dating from the construction of the building. These are then finished with, mostly, period boarding fixed with blacksmiths nails. Damaged carpets had been removed, although the full, necessary extent of this has not been confirmed.

Much of the boarding, especially around the areas where water has penetrated from the Spine wall, are badly stained, damaged and will require removal and repair or replacement.

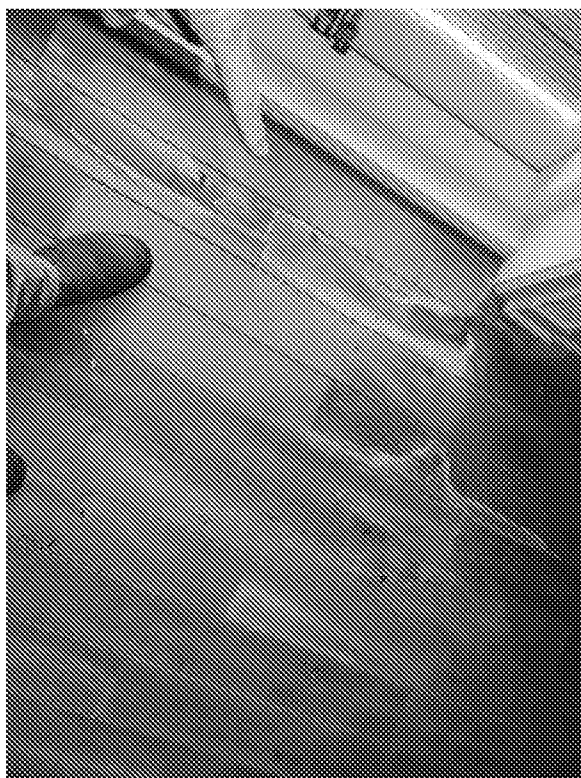
Any tiled or overboarded floors such as the Shower Room and Living Room will need to be removed for drying out beneath and repaired/replaced.

### Overboarded modern floor finish

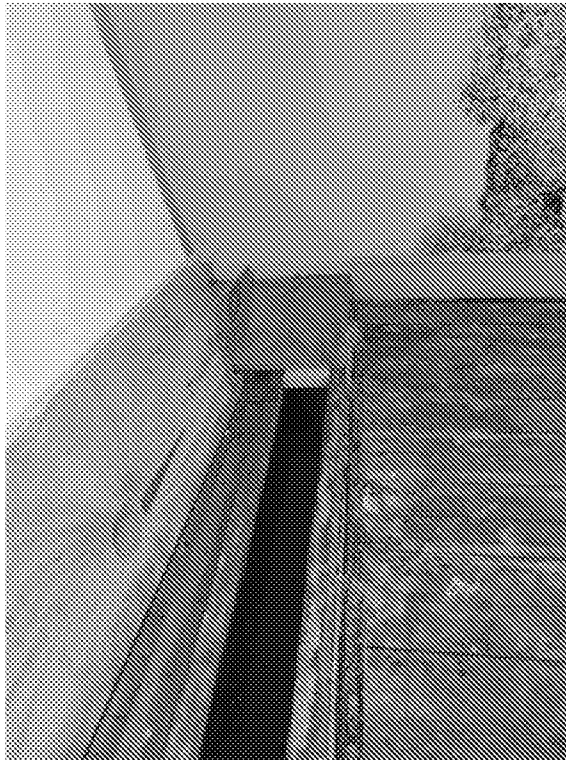
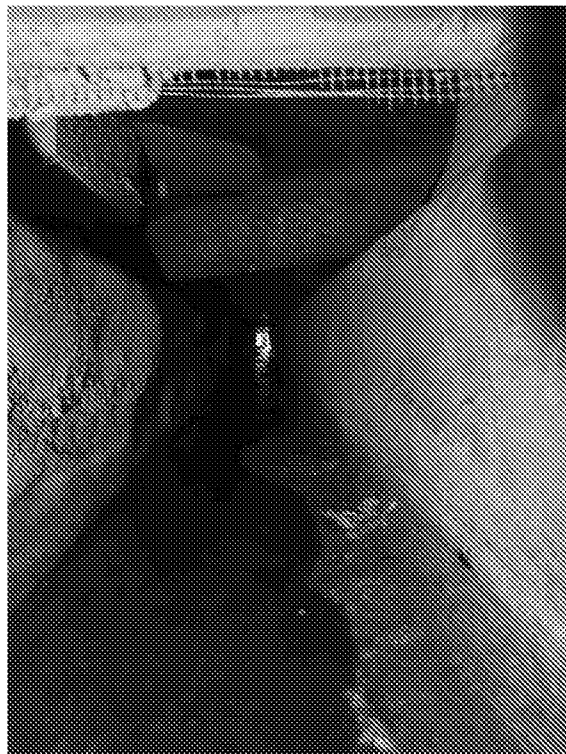
Floor undulating and water stained

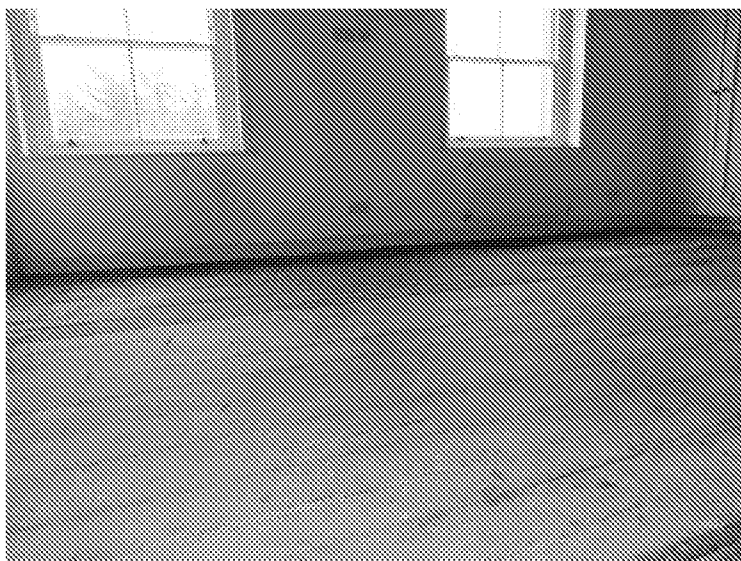
### Original boarding
