# **A1 – A5 Viability Report**

**2 - 13 Duke Street**

**Littlehampton**

**09 March 2017**

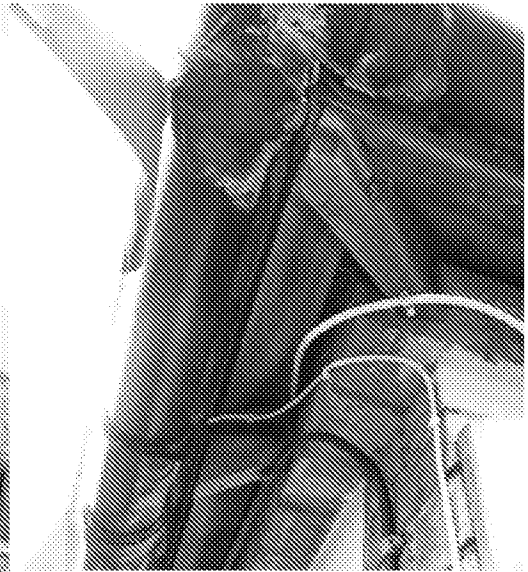
Photo 25

The gutters are in deteriorating condition generally, with evidence of leakage observed to the gutter joints throughout. Evidence of long-standing leakage from the gutter on the West elevation was observed.

A length of bowed gutter was observed at the southern end of the West elevation and it is advised that this should be repaired.

Moss and debris collection was observed within the low level gutters that prevents adequate drainage provision and clearing of this is also advised. The condition within the gutters to the main roof could not be observed, however it is recommended that the gutters should be checked and cleaned out at the same time.

The pipes are in deteriorating condition generally, with evidence of leakage observed to the joints throughout.

The bottom section of the pipe at the North East corner of the main building is missing and it is recommended that this pipe should be extended to discharge directly over the drainage gully below the pipe.

It was also observed that a screw has been inserted to support a pipe joint, puncturing the pipe. It is recommended that additional pipe brackets should be installed to adequately support the pipe joint.

There is a rainwater pipe at the North West corner of the extension that is routed flat at ground level around the corner of the building, to discharge into a drainage gully. The inadequate fall to the pipe is likely to cause blockage within the pipe and it is recommended that the pipe should be modified to ensure adequate drainage.

Repairs to the guttering throughout is advised as a matter of urgency. It is likely to be more economical in the long term to replace the guttering to the main roof.

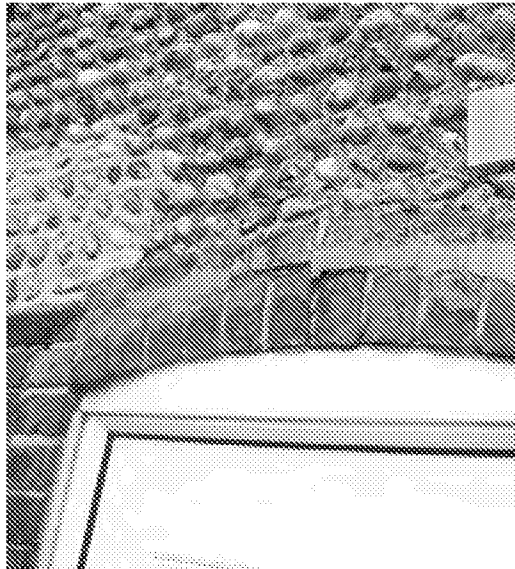
Photo 27

The wall is of coursed flint pebbles with facing brick arch lintels to the window openings and door openings and with facing brick dressings to the windows, doors and at the corners. The flint wall is without a plinth at base level. A damp proof course (dpc) was not observed to the walls.

The wall is in sound condition generally, however the mortar bedding to the flints is in

deteriorating condition generally, with various areas of mortar decay and previous patch repairs observed. It is advised that the mortar bedding to the flints should be repaired as necessary. This is likely to involve extensive mortar repair.

The brick lintels and dressings to the wall are in sound condition generally, however localised brick decay and deterioration of the mortar joints were observed in places. Fractured and dropped key bricks were observed to the brick arch lintel above the infill door panel that is located centrally to the elevation. It is advised that the brick lintels and facing brickwork should be repaired as necessary.
