# RMC Construction

## Report Ref. Flat 9 Wilbury House

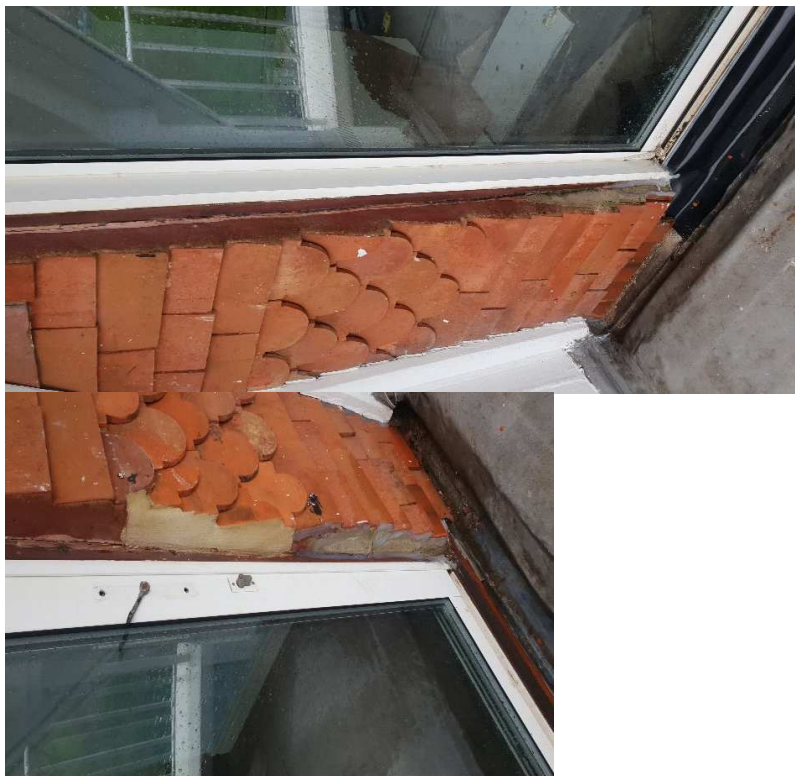
Figure 1-2

Existing benching in a poor state of repair

allowing ingress of water

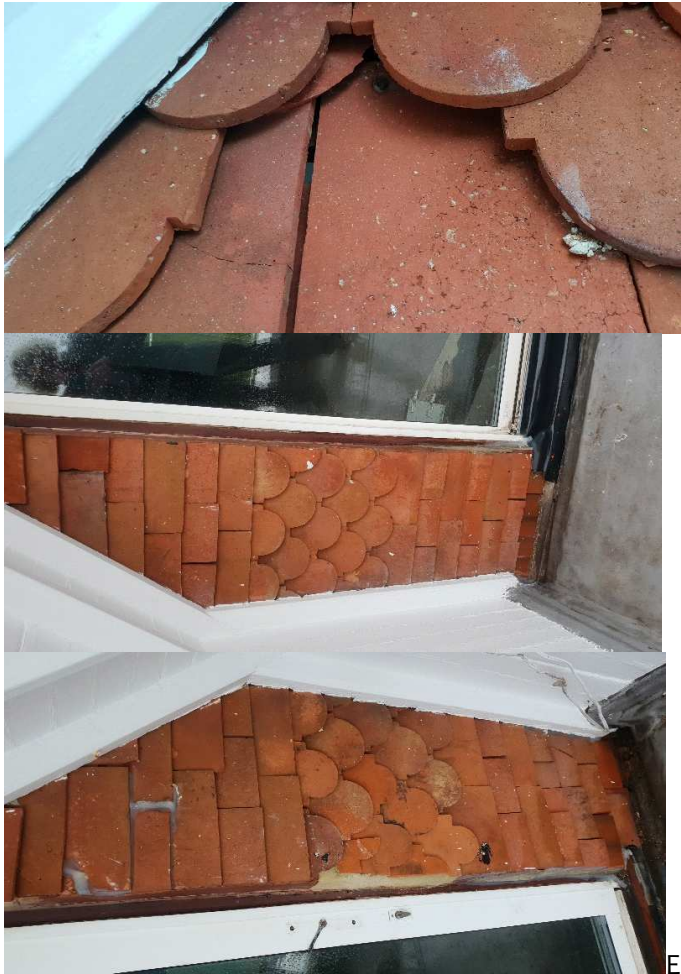
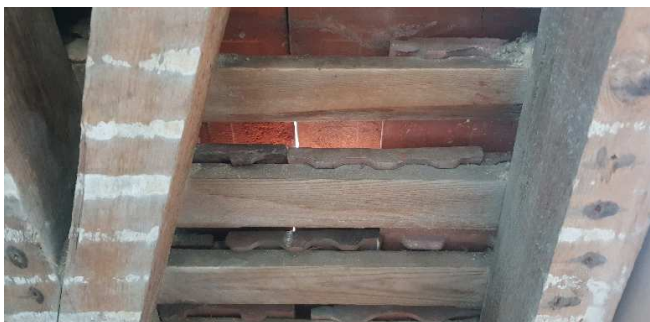
Figure 4-6

Missing tiles, large tile spacing and poor previous repairs contributing to water ingress.

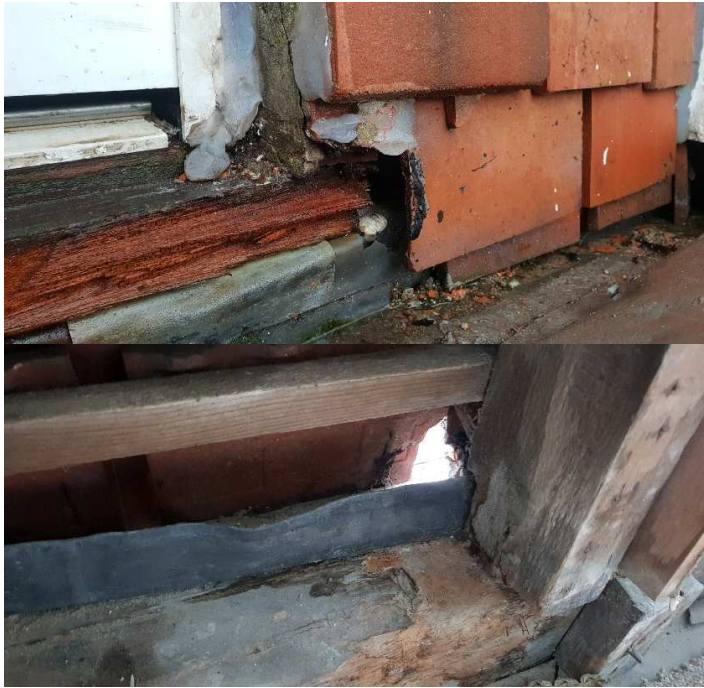
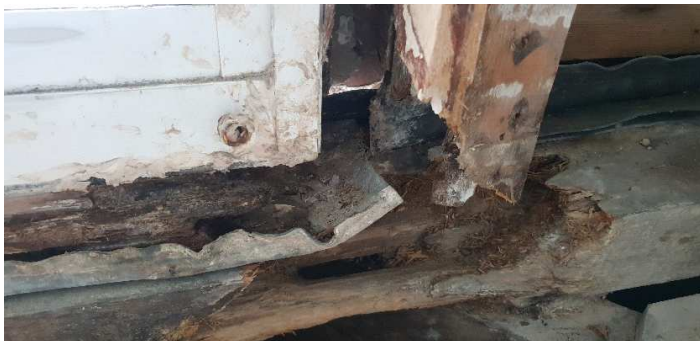
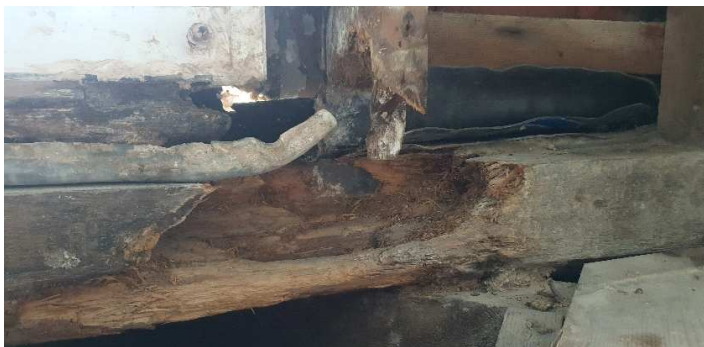
Figure 7-10

Large gaps in cladding and a poor flashing detail

We recommend all the cladding is replaced with the correct flashing and air flow requirements.
