**Heritage Statement**

**Listed Building Consent**

**20**

**Western Road**

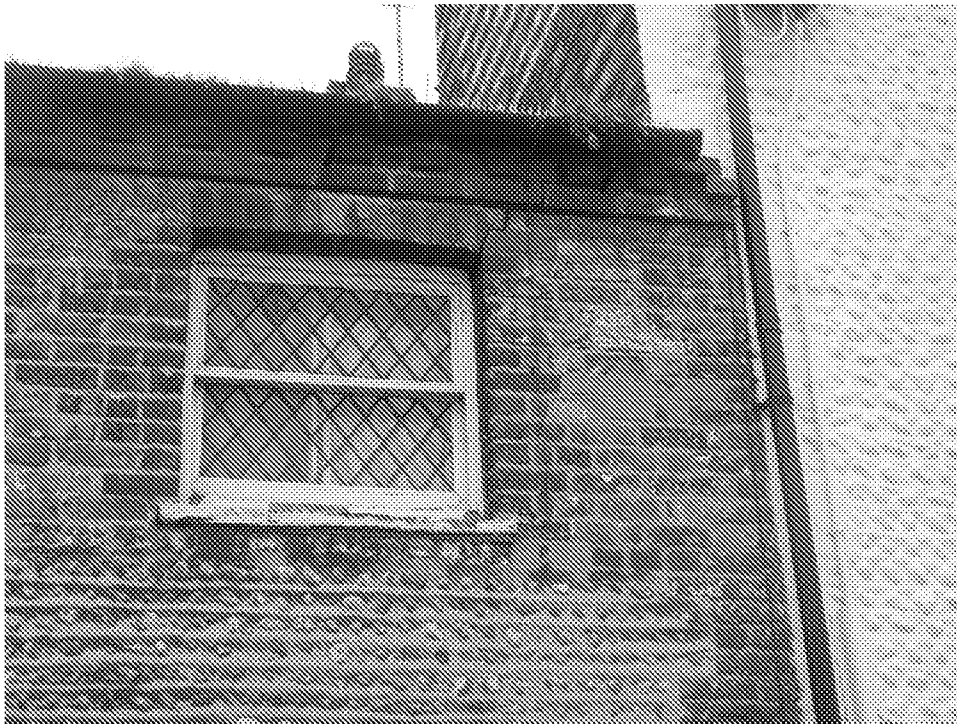
The dwelling has elements of the flint work starting to come away as evident in a number of cracks on the facade. The intention is to stitch the cracks and repoint where necessary. This is quite extensive to parts. Samples of the mortar will be taken and analysed and a similar mix is to be used as part of the works.

*Cracking on brickwork and mortar joints*

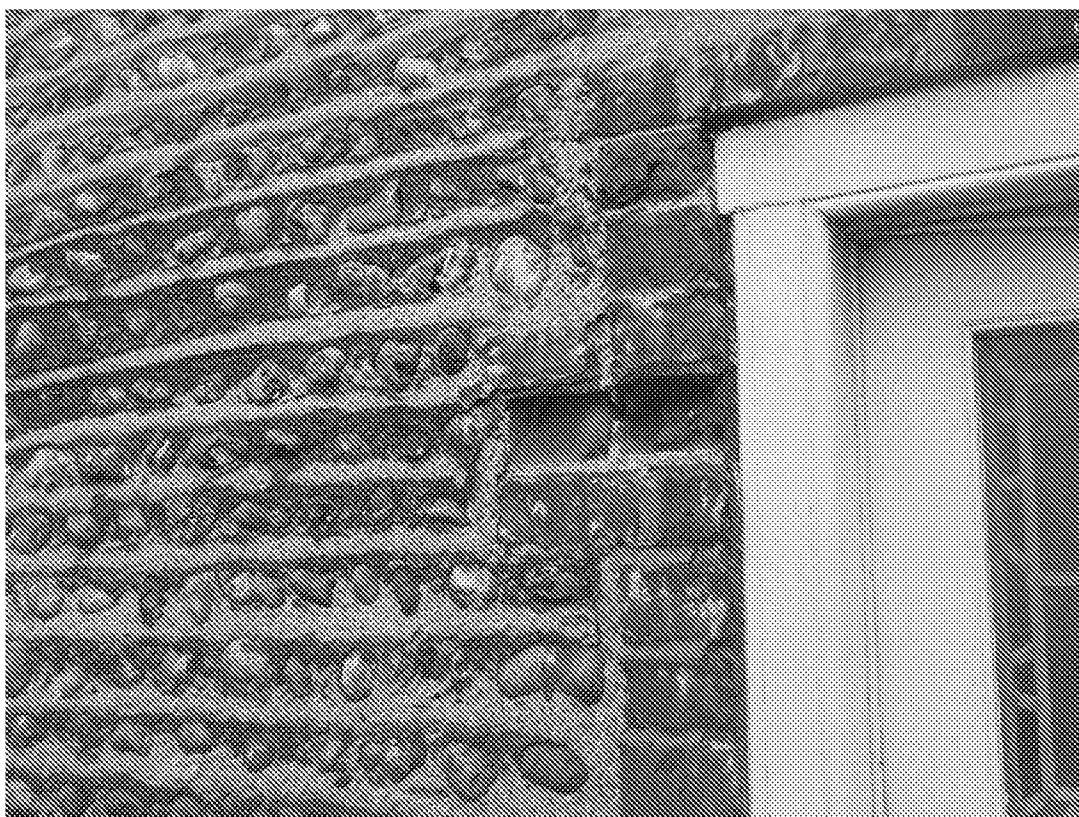
### *Damaged Brickwork*

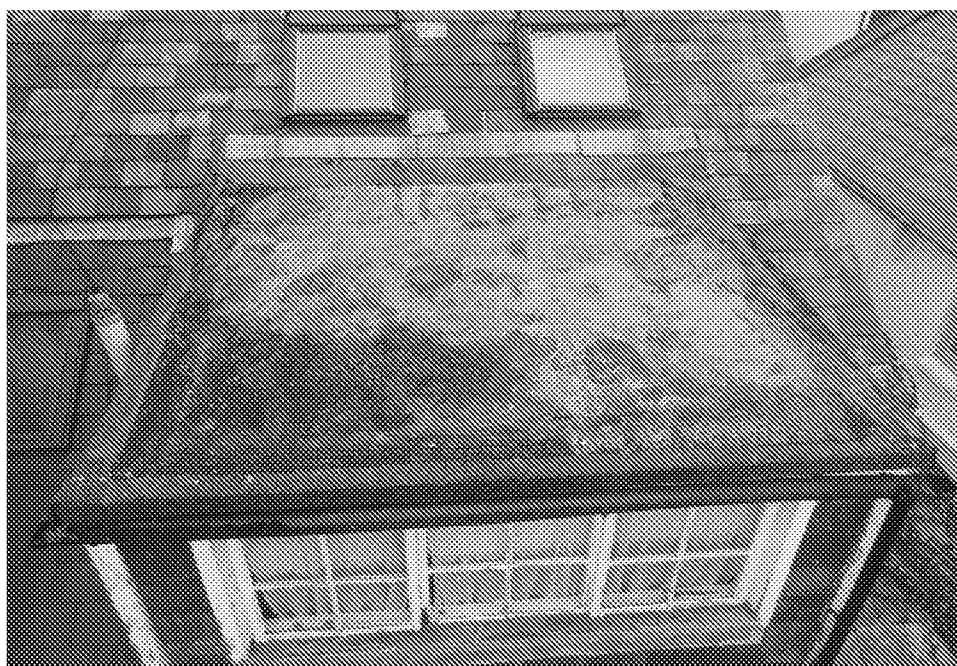
The flat roof and dormer requires replacement, with thermal elements upgraded where possible whilst refurbishment is being undertaken. Where asbestos tiles have been used, these will be replaced with a slate equivalent. Internally, the timber is of tongue and groove which is thought to have been installed in the 1980s and this will be replaced with wainscoted panels.

### *Dormer Roof*

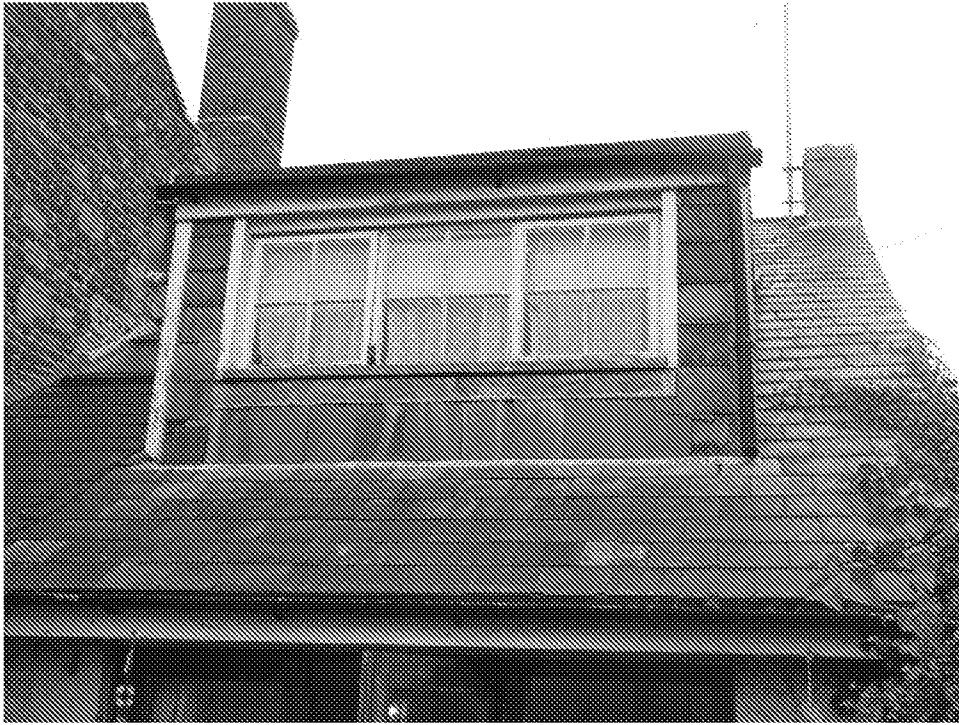
*Dormer Window*

The dormer window will be upgraded at the same time. Internally, the cill will be lifted 50mm. The external appearance will not alter.

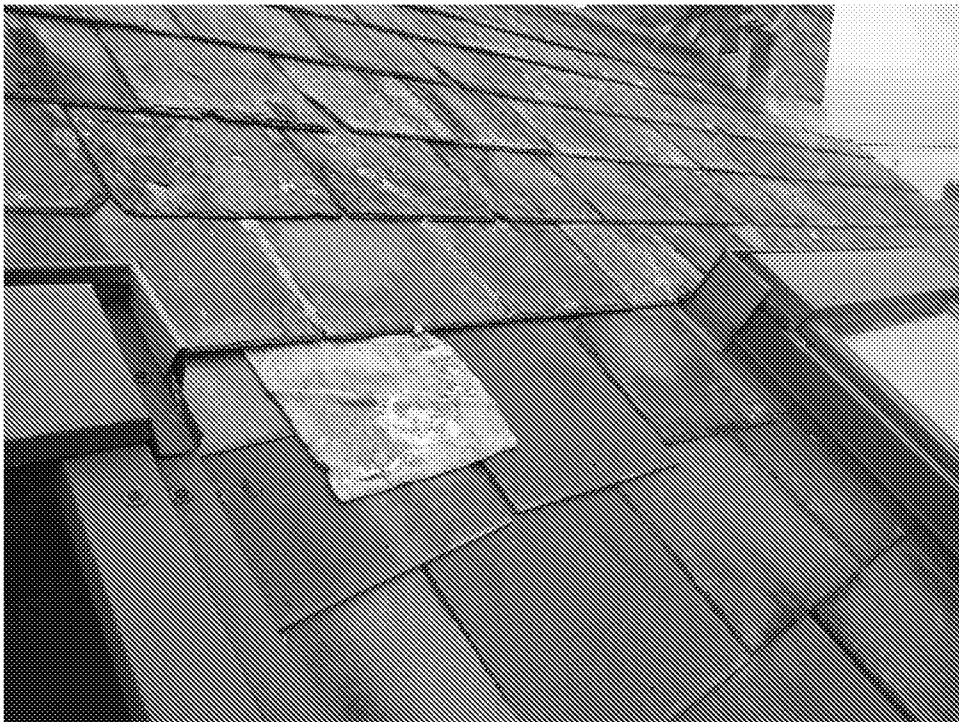
*Loose Tiles*

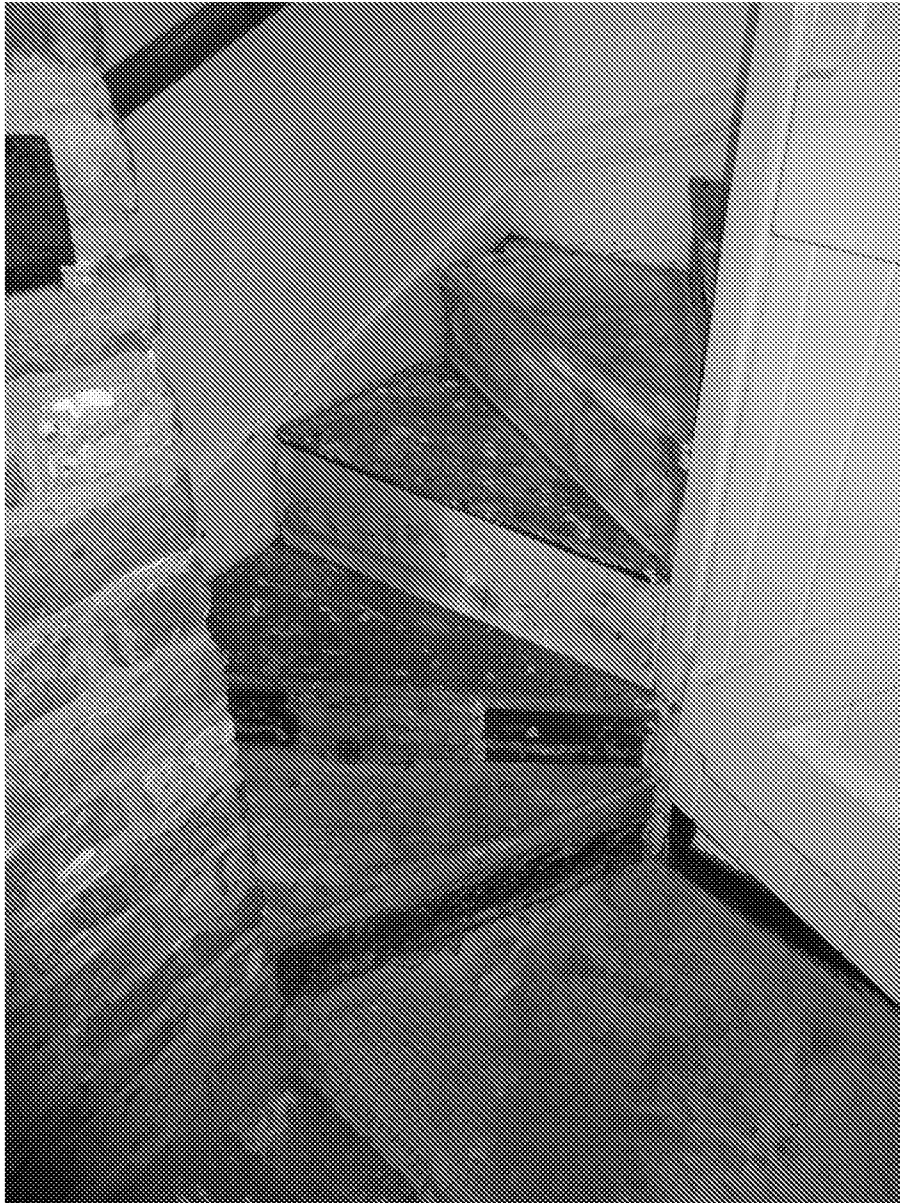
*Stairs to be replaced*

Internally, it appears that part of the stairs require replacement and timber equivalent would be used. As part of the works, a Tudor effect stud wall will need to be taken down along with some solid wood panelling. This will be reinstated once the works are completed. The Kitchen floor will be tiled using natural slate.

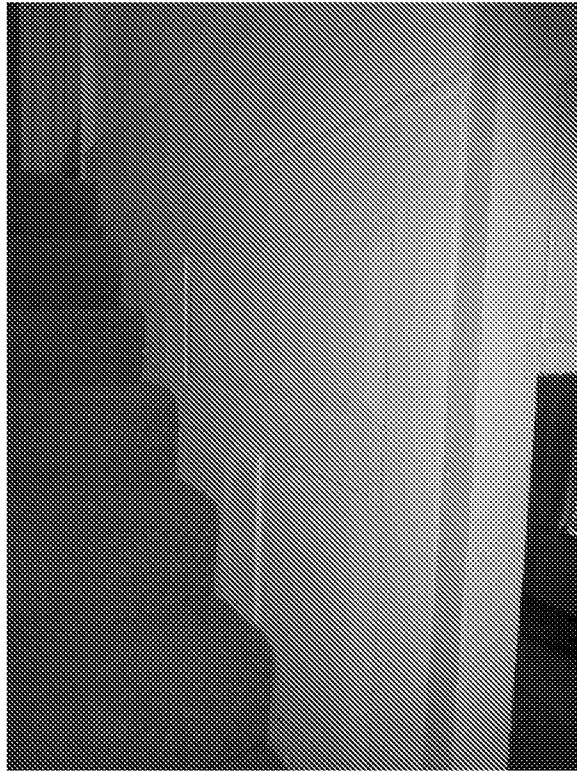
*Internal Timber Stud Wall*

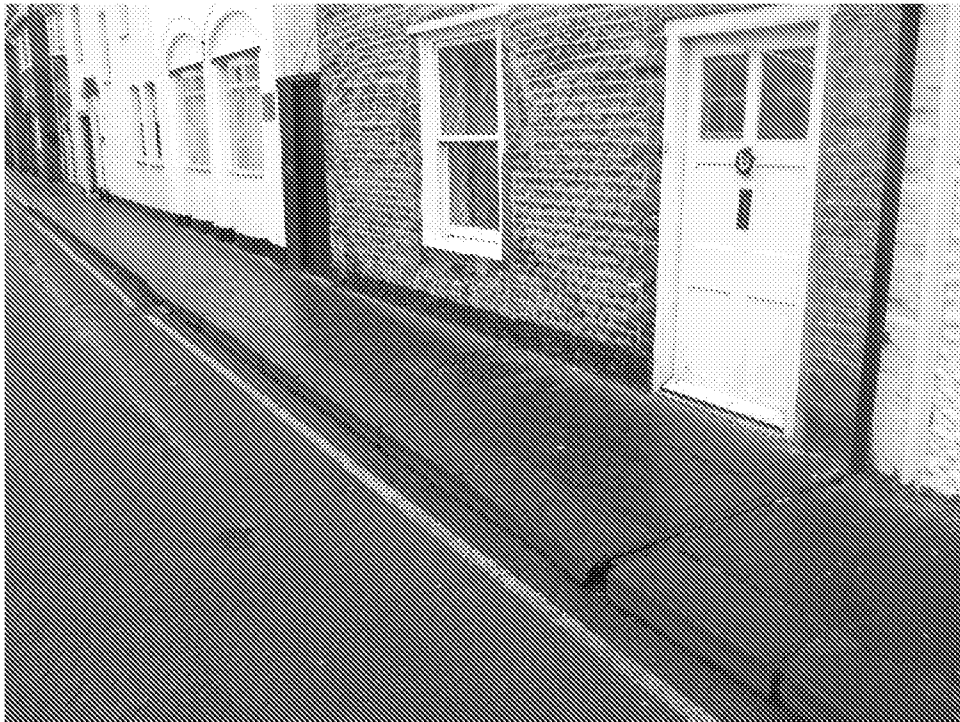
The front door is rotten to parts and where possible, repairs are to be undertaken.

*Timber Panelled Front Door Rotting*

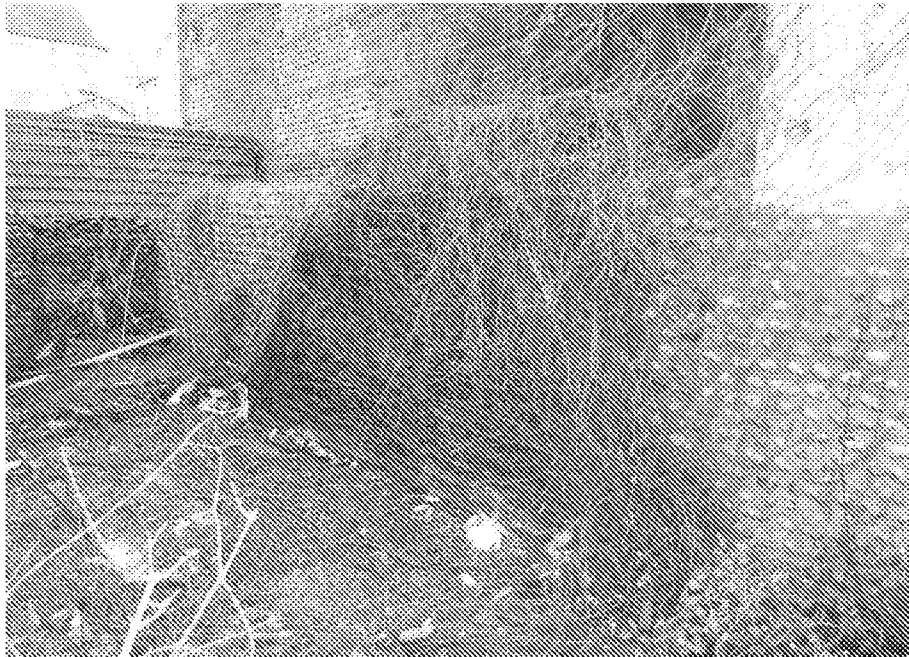
*Vegetation covering Boundary Wall*

Work is to be undertaken to repair the Store and boundary wall, vegetation is to be removed and repointing will be undertaken where required. As with the external walls to the property, the mortar will be tested and similar used.
