## ASBESTOS DEMOLITION SURVEY

**SURVEY REFERENCE NO. J023000**

Littlehampton Swimming & Sports Centre  
Sea Road  
Littlehampton  
West Sussex  
BN16 2NA

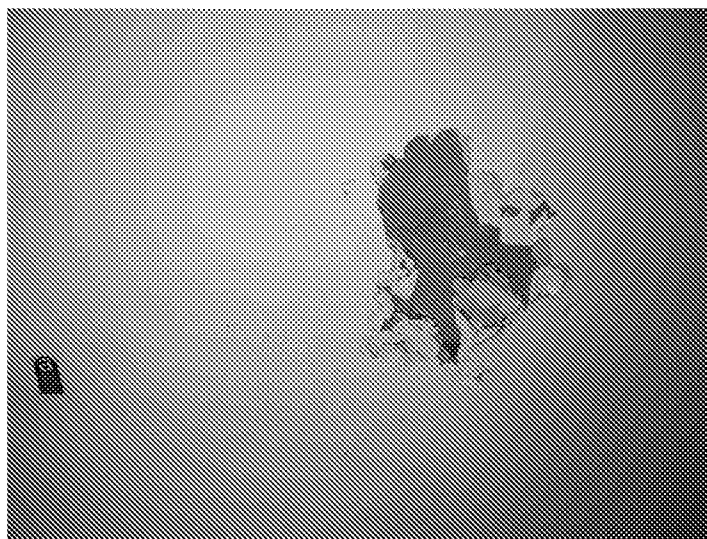
| Material Risk Assessment | Score |
|---|---|
| Material Assessment Score | 6 |
| Material Assessment Category | Low |

| Recommended Actions: |

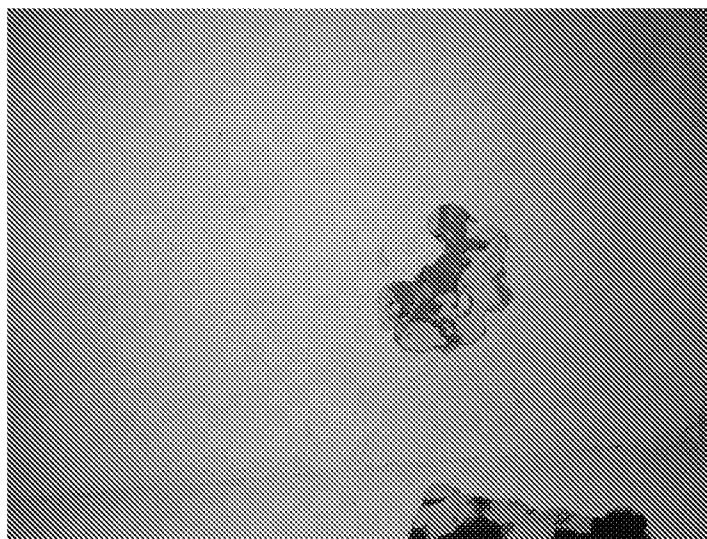
| Material Risk Assessment | Score |
|---|---|
| Material Assessment Score | 6 |
| Material Assessment Category | Low |

| <b>Recommended Actions:</b> |

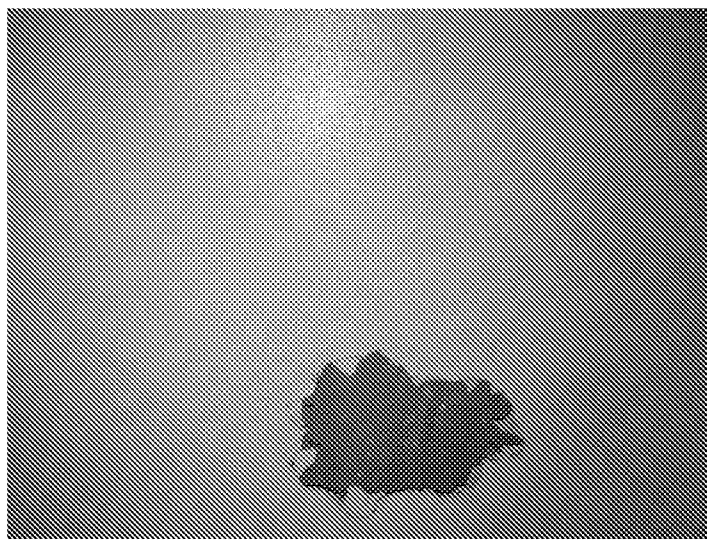
| Material Risk Assessment | Score |
|---|---|
| Material Assessment Score | 6 |
| Material Assessment Category | Low |

| <b>Recommended Actions:</b> |

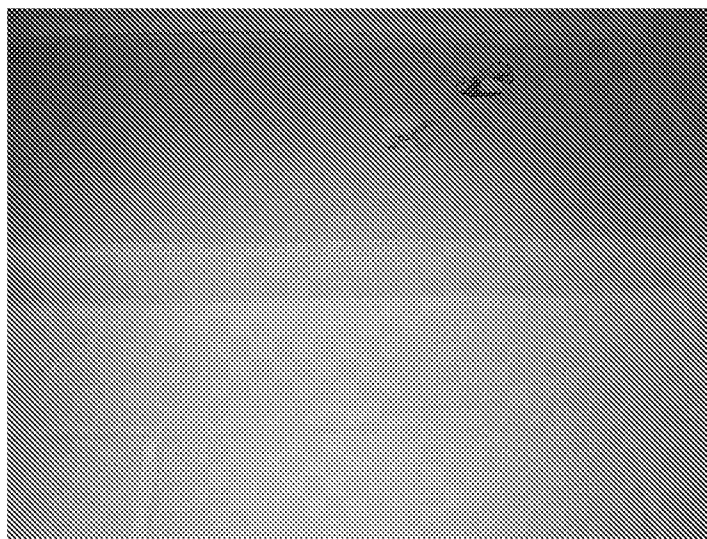
| Material Risk Assessment | Score |
|---|---|
| Material Assessment Score | 3 |
| Material Assessment Category | Very Low |

| <b>Recommended Actions:</b> |

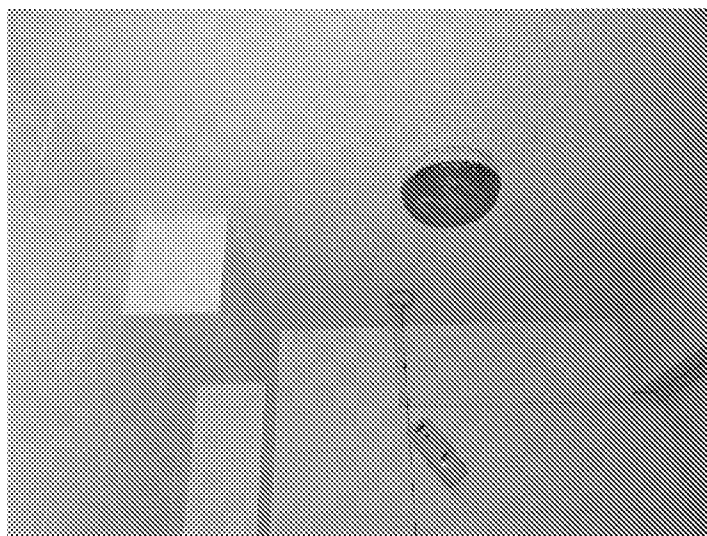
| Material Risk Assessment | Score |
|---|---|
| <b>Material Assessment Score</b> | 3 |
| <b>Material Assessment Category</b> | Very Low |

| <b>Recommended Actions:</b> |

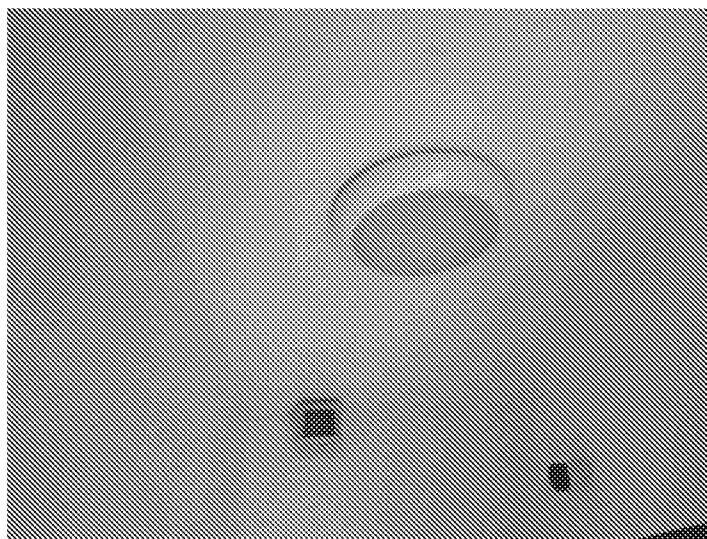
| Material Risk Assessment | Score |
|---|---|
| <b>Material Assessment Score</b> | 3 |
| <b>Material Assessment Category</b> | Very Low |

| <b>Recommended Actions:</b> |

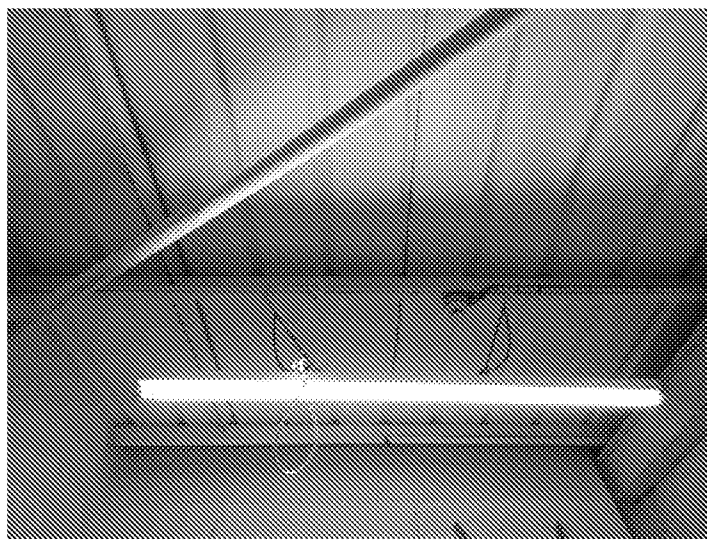
| Material Risk Assessment | Score |
|---|---|
| <b>Material Assessment Score</b> | 3 |
| <b>Material Assessment Category</b> | Very Low |

| <b>Recommended Actions:</b> |

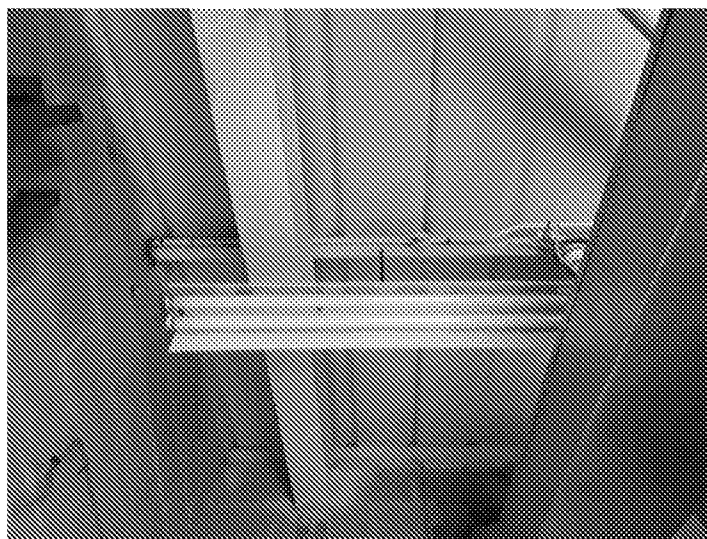
| Material Risk Assessment | Score |
|---|---|
| <b>Material Assessment Score</b> | 3 |
| <b>Material Assessment Category</b> | Very Low |

| Recommended Actions: |

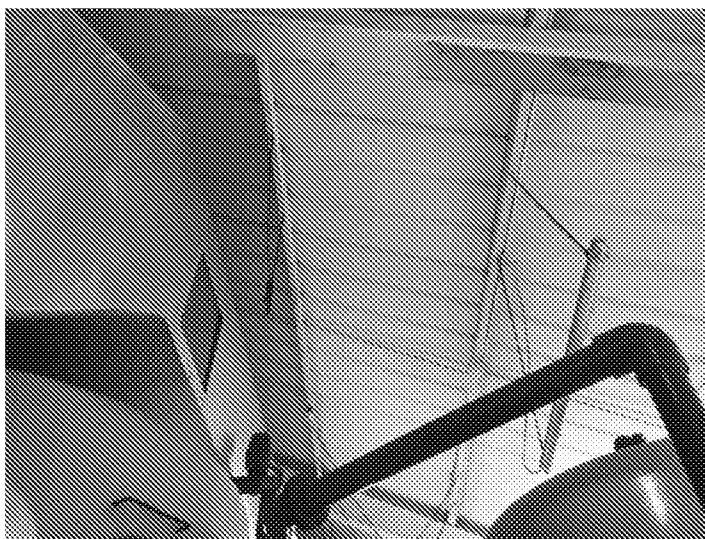
| Material Risk Assessment | Score |
|---|---|
| <b>Material Assessment Score</b> | 3 |
| <b>Material Assessment Category</b> | Very Low |

| Recommended Actions: |

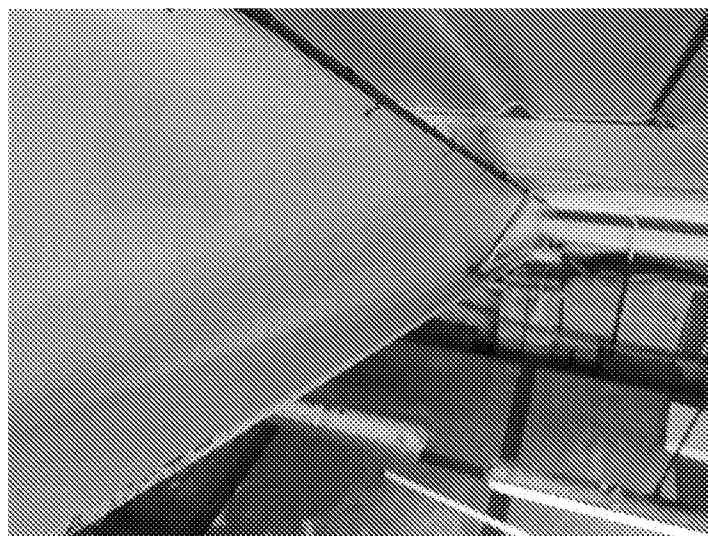
| Material Risk Assessment | Score |
|---|---|
| Material Assessment Score | 6 |
| Material Assessment Category | Low |

| <b>Recommended Actions:</b> |

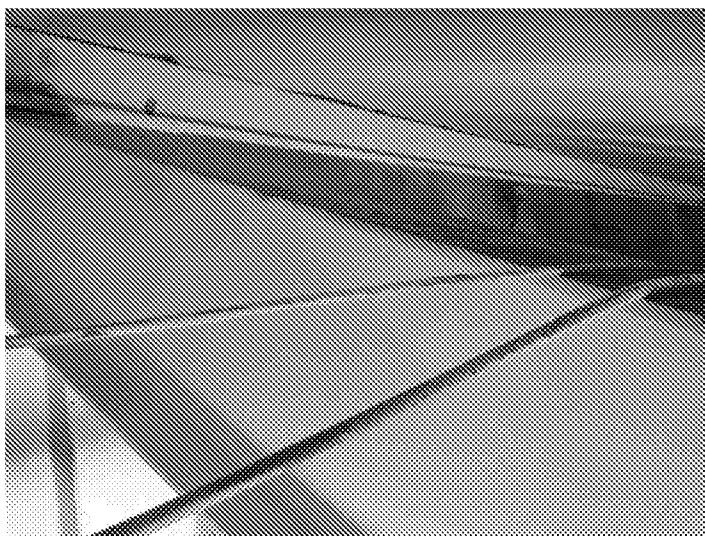
| Material Risk Assessment | Score |
|---|---|
| <b>Material Assessment Score</b> | 6 |
| <b>Material Assessment Category</b> | Low |

| <b>Recommended Actions:</b> |

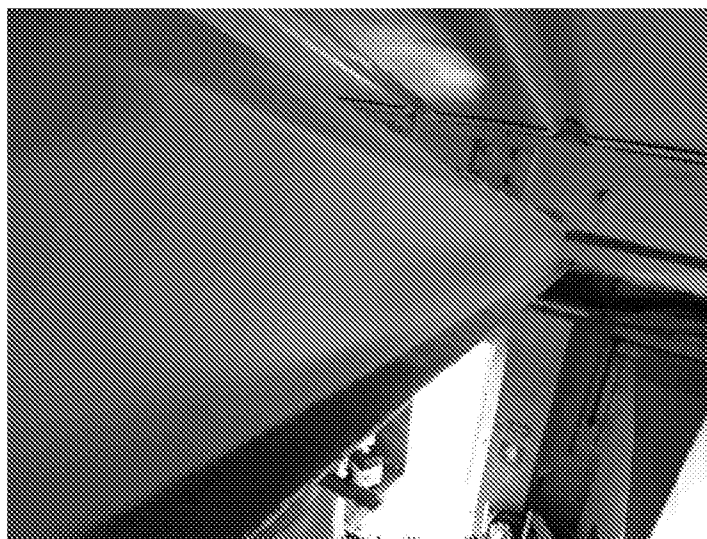
| Material Risk Assessment | Score |
|---|---|
| <b>Material Assessment Score</b> | 6 |
| <b>Material Assessment Category</b> | Low |

| <b>Recommended Actions:</b> |

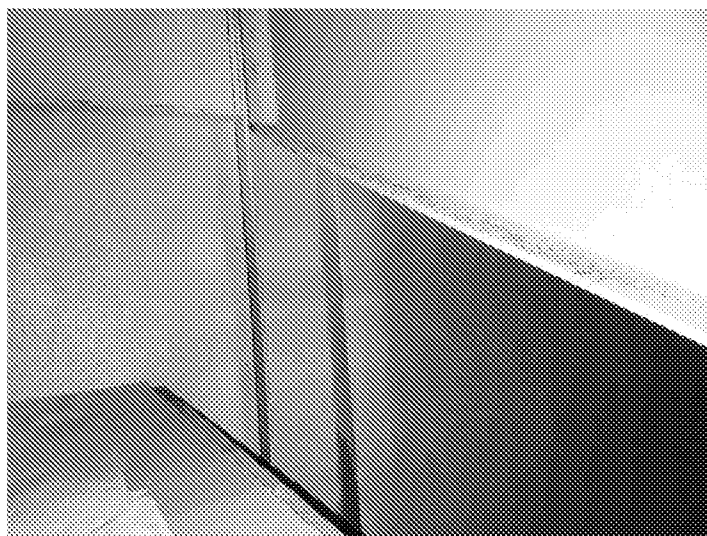
| Material Risk Assessment | Score |
|---|---|
| <b>Material Assessment Score</b> | 6 |
| <b>Material Assessment Category</b> | Low |

| <b>Recommended Actions:</b> |

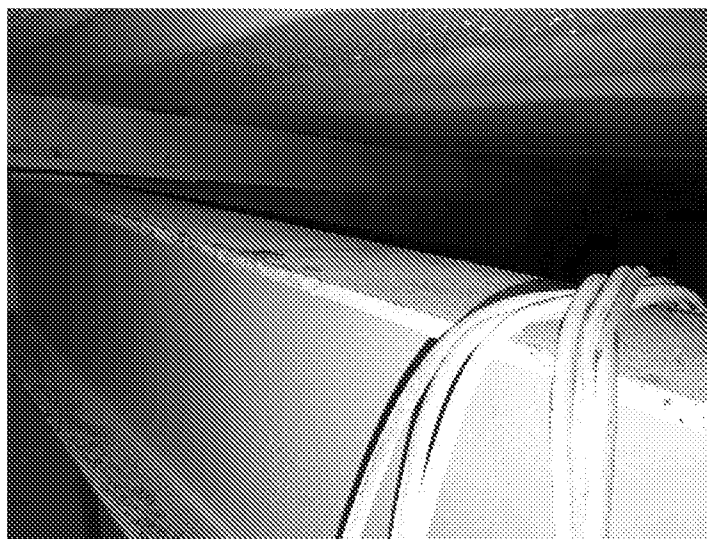
| Material Risk Assessment | Score |
|---|---|
| Material Assessment Score | 6 |
| Material Assessment Category | Low |

| Recommended Actions: |

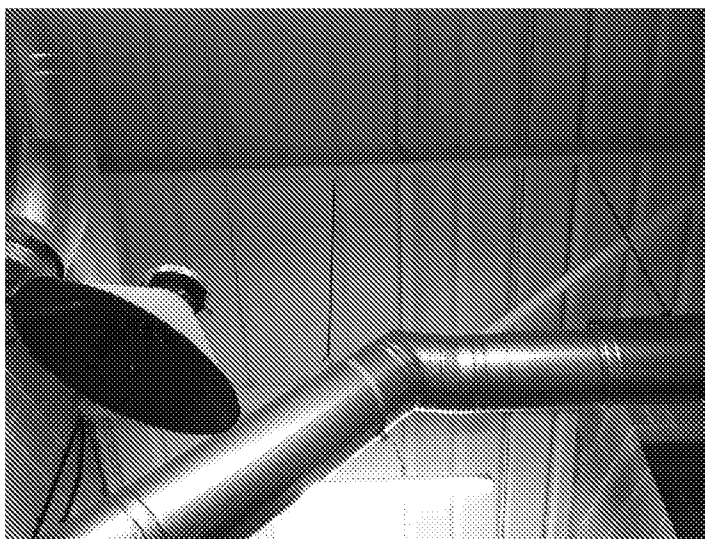
| Material Risk Assessment | Score |
|---|---|
| Material Assessment Score | 3 |
| Material Assessment Category | Very Low |

| Recommended Actions: |

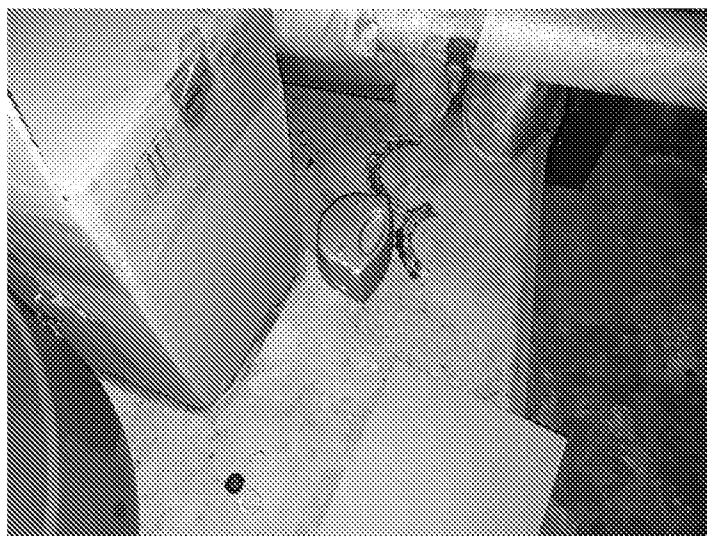
| Material Risk Assessment | Score |
|---|---|
| <b>Material Assessment Score</b> | 4 |
| <b>Material Assessment Category</b> | Very Low |

| Recommended Actions: |

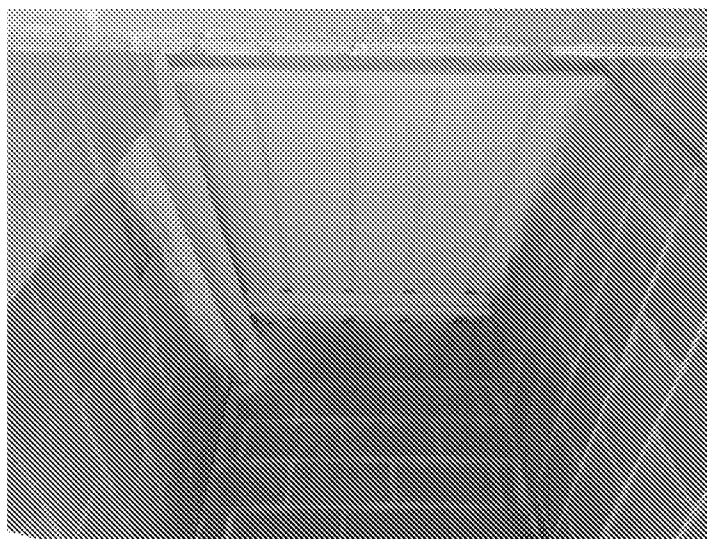
| Material Risk Assessment | Score |
|---|---|
| <b>Material Assessment Score</b> | 3 |
| <b>Material Assessment Category</b> | Very Low |

| Recommended Actions: |

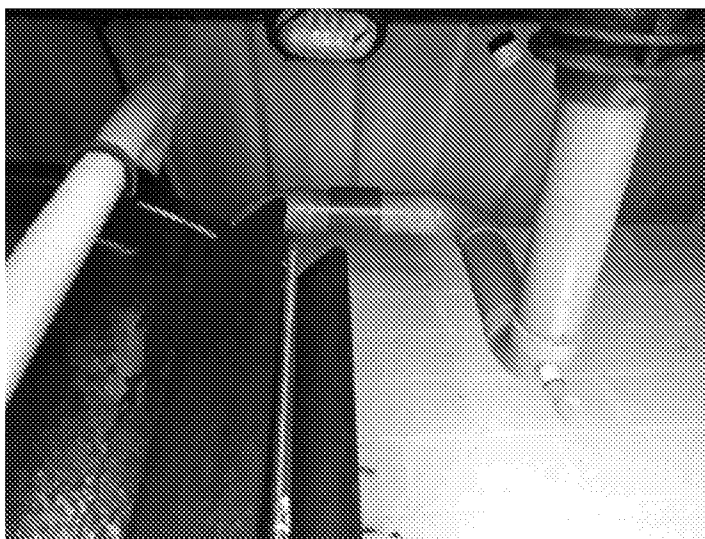
| Material Risk Assessment | Score |
|---|---|
| <b>Material Assessment Score</b> | 3 |
| <b>Material Assessment Category</b> | Very Low |

| Recommended Actions: |

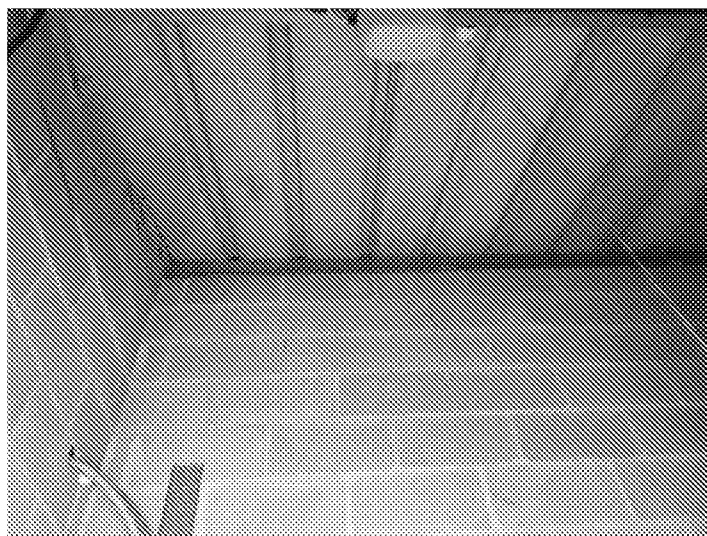
| Material Risk Assessment | Score |
|---|---|
| <b>Material Assessment Score</b> | 3 |
| <b>Material Assessment Category</b> | Very Low |

| Recommended Actions: |

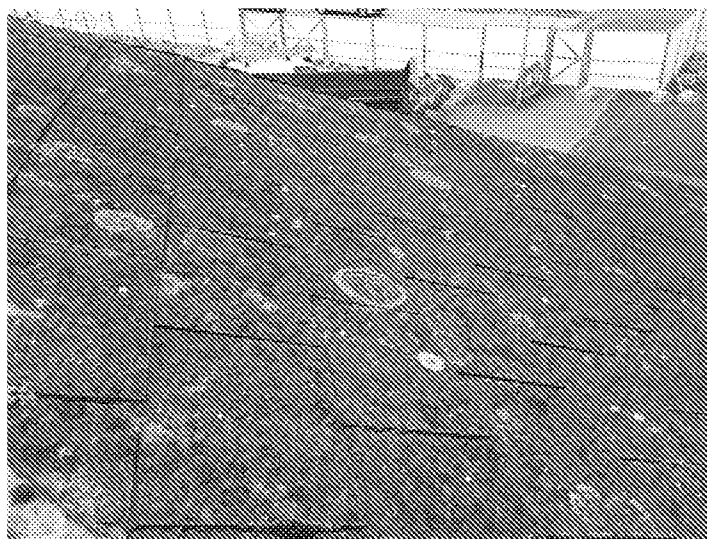
| Material Risk Assessment | Score |
|---|---|
| <b>Material Assessment Score</b> | 3 |
| <b>Material Assessment Category</b> | Very Low |

| <b>Recommended Actions:</b> |

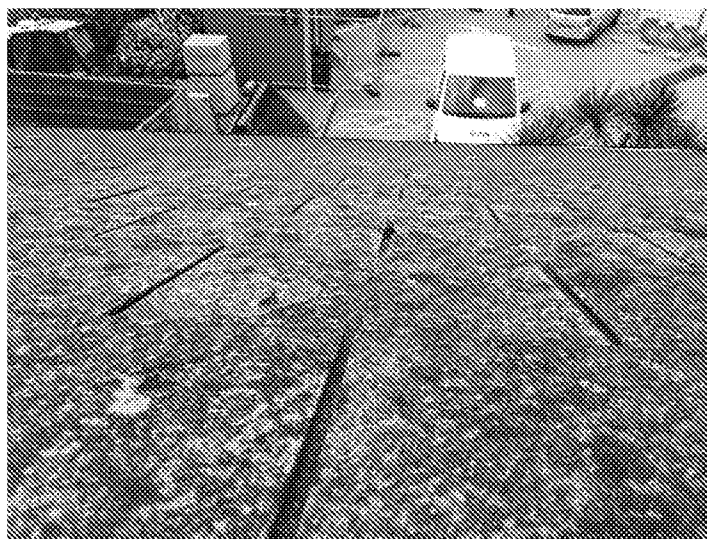
| Material Risk Assessment | Score |
|---|---|
| <b>Material Assessment Score</b> | 3 |
| <b>Material Assessment Category</b> | Very Low |

| <b>Recommended Actions:</b> |

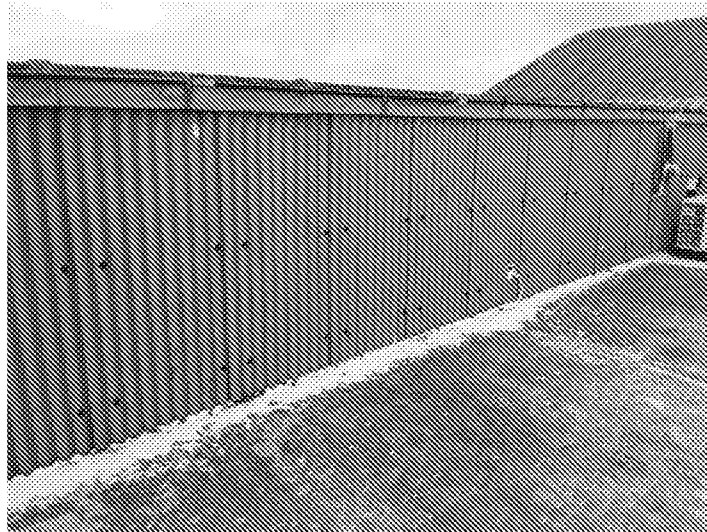
| Material Risk Assessment | Score |
|---|---|
| Material Assessment Score | 3 |
| Material Assessment Category | Very Low |

| <b>Recommended Actions:</b> |

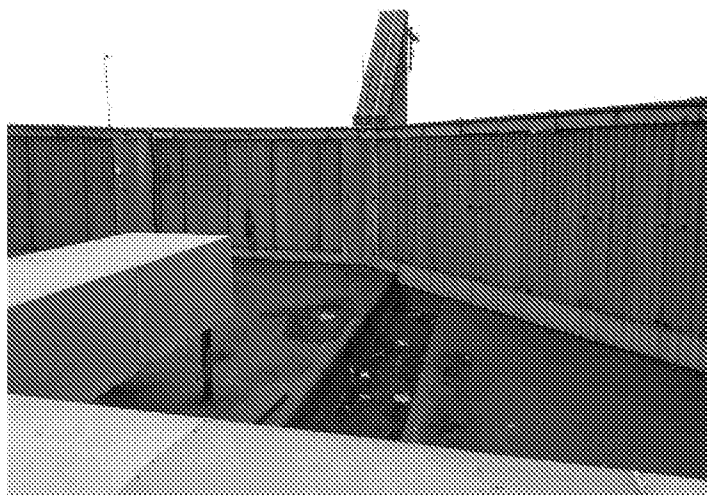
| Material Risk Assessment | Score |
|---|---|
| <b>Material Assessment Score</b> | 3 |
| <b>Material Assessment Category</b> | Very Low |

| <b>Recommended Actions:</b> |

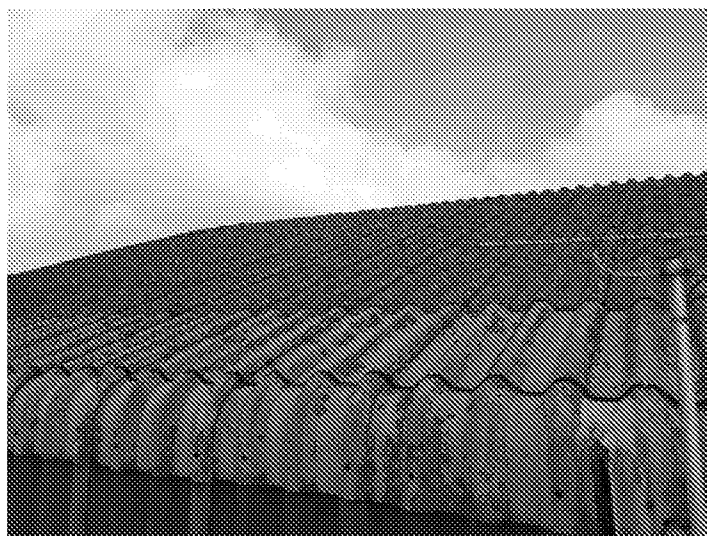
| Material Risk Assessment | Score |
|---|---|
| <b>Material Assessment Score</b> | 3 |
| <b>Material Assessment Category</b> | Very Low |

| <b>Recommended Actions:</b> |

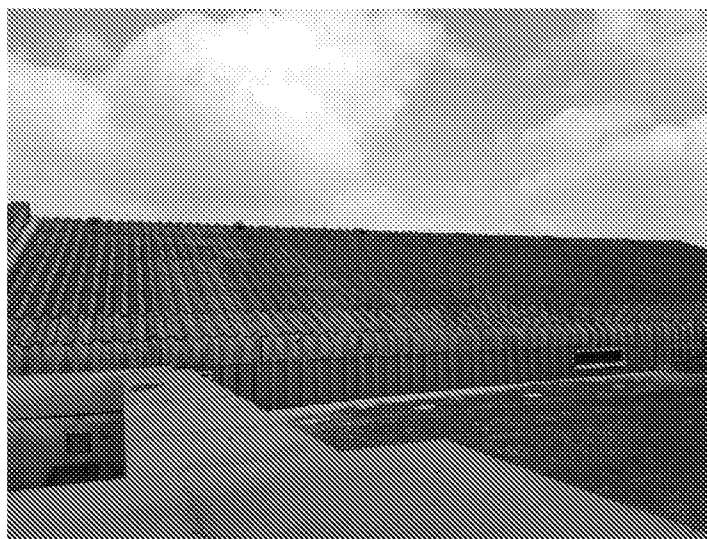
| Material Risk Assessment | Score |
|---|---|
| <b>Material Assessment Score</b> | 3 |
| <b>Material Assessment Category</b> | Very Low |

| <b>Recommended Actions:</b> |

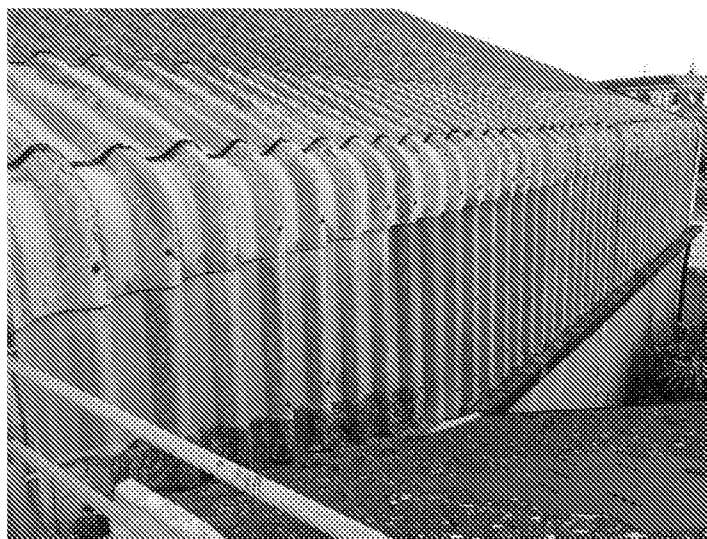
| Material Risk Assessment | Score |
|---|---|
| Material Assessment Score | 3 |
| Material Assessment Category | Very Low |

| <b>Recommended Actions:</b> |

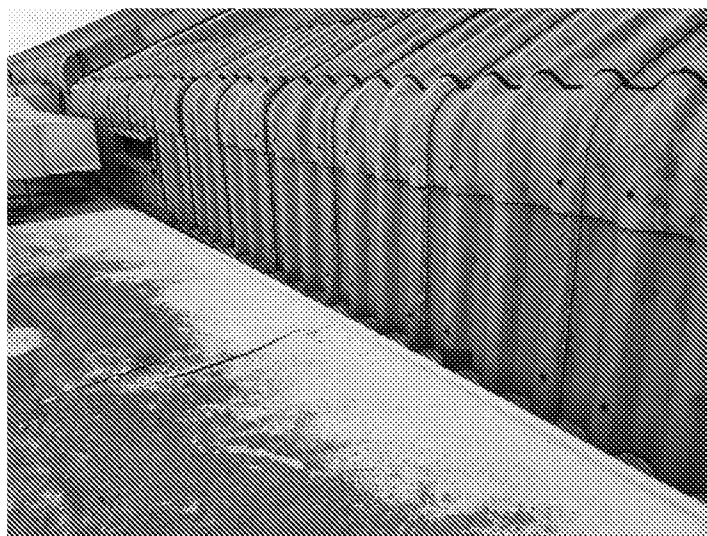
| Material Risk Assessment | Score |
|---|---|
| Material Assessment Score | 3 |
| Material Assessment Category | Very Low |

| <b>Recommended Actions:</b> |

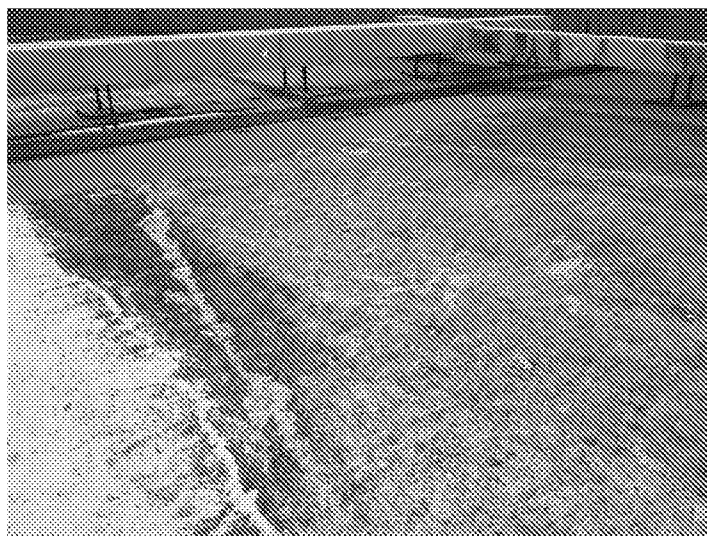
| Material Risk Assessment | Score |
|---|---|
| <b>Material Assessment Score</b> | 2 |
| <b>Material Assessment Category</b> | Very Low |

| <b>Recommended Actions:</b> |

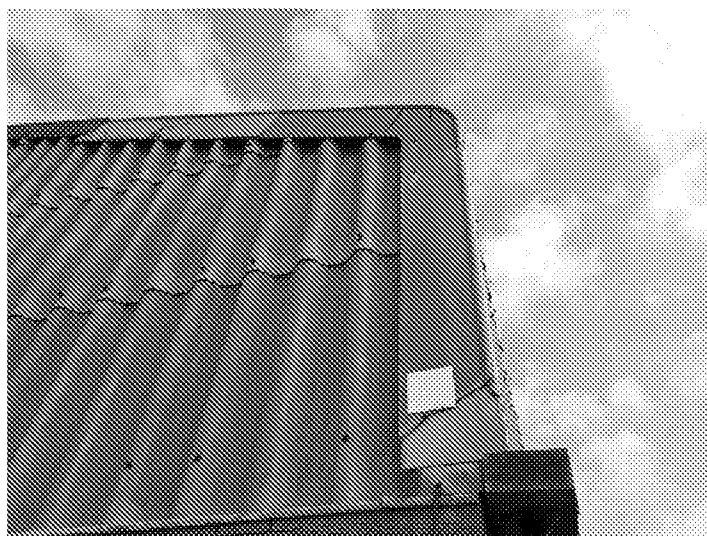
| Material Risk Assessment | Score |
|---|---|
| Material Assessment Score | 3 |
| Material Assessment Category | Very Low |

| Recommended Actions: |

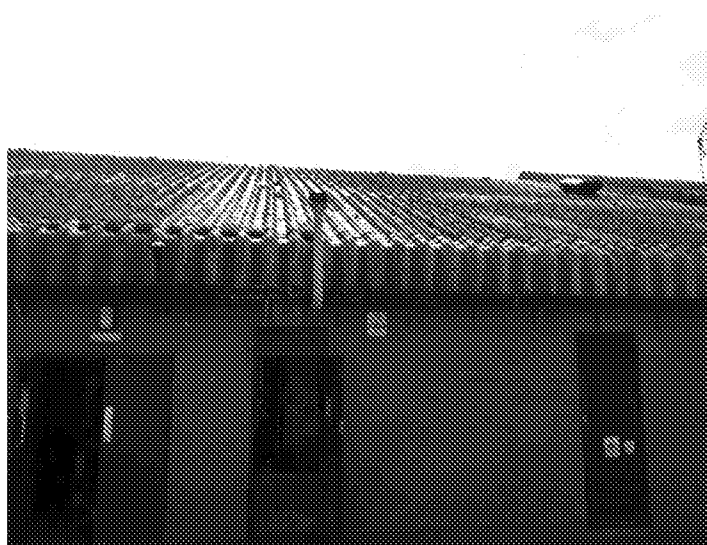
| Material Risk Assessment | Score |
|---|---|
| Material Assessment Score | 3 |
| Material Assessment Category | Very Low |

| <b>Recommended Actions:</b> |

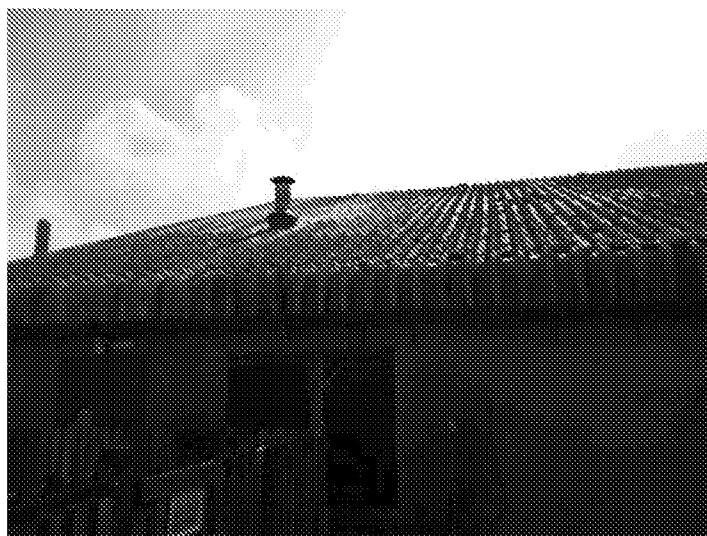
| Material Risk Assessment | Score |
|---|---|
| Material Assessment Score | 3 |
| Material Assessment Category | Very Low |

| <b>Recommended Actions:</b> |

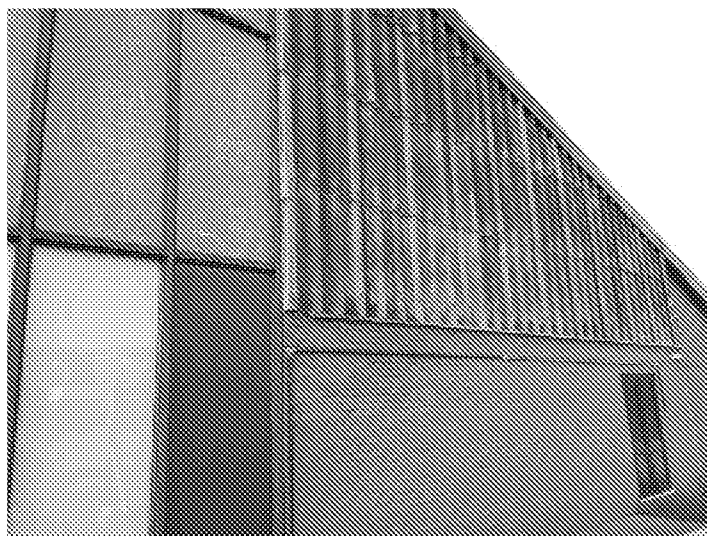
| Material Risk Assessment | Score |
|---|---|
| <b>Material Assessment Score</b> | 3 |
| <b>Material Assessment Category</b> | Very Low |

| <b>Recommended Actions:</b> |

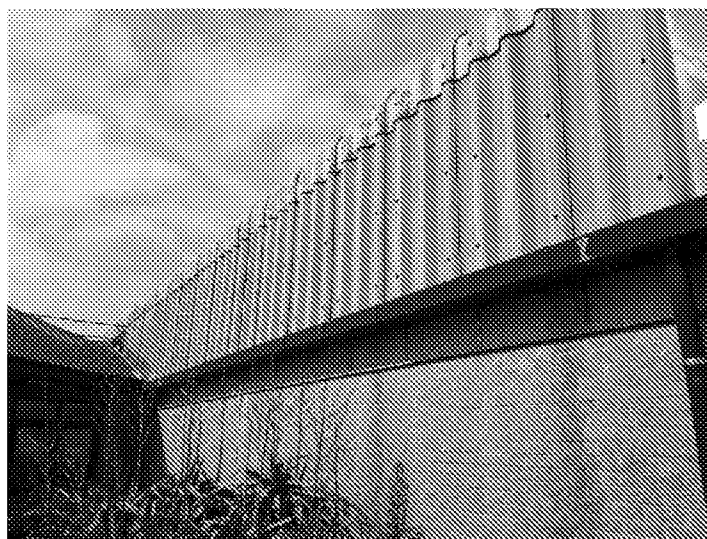
| Material Risk Assessment | Score |
|---|---|
| <b>Material Assessment Score</b> | 3 |
| <b>Material Assessment Category</b> | Very Low |

| Recommended Actions: |

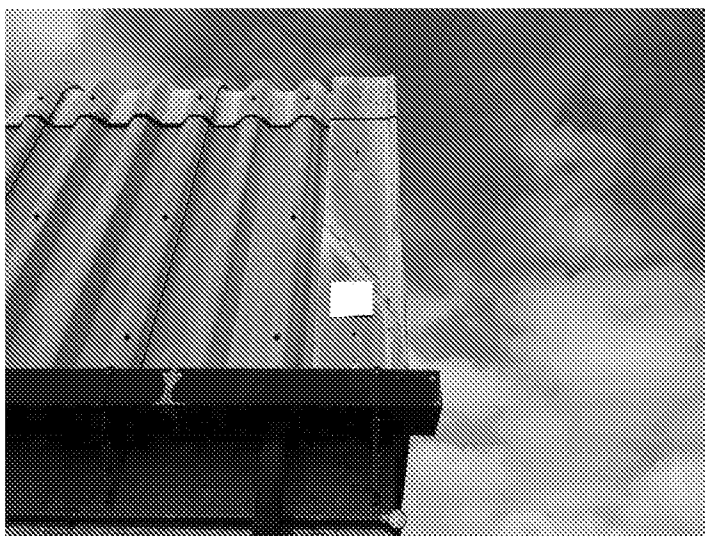
| Material Risk Assessment | Score |
|---|---|
| Material Assessment Score | 3 |
| Material Assessment Category | Very Low |

| <b>Recommended Actions:</b> |

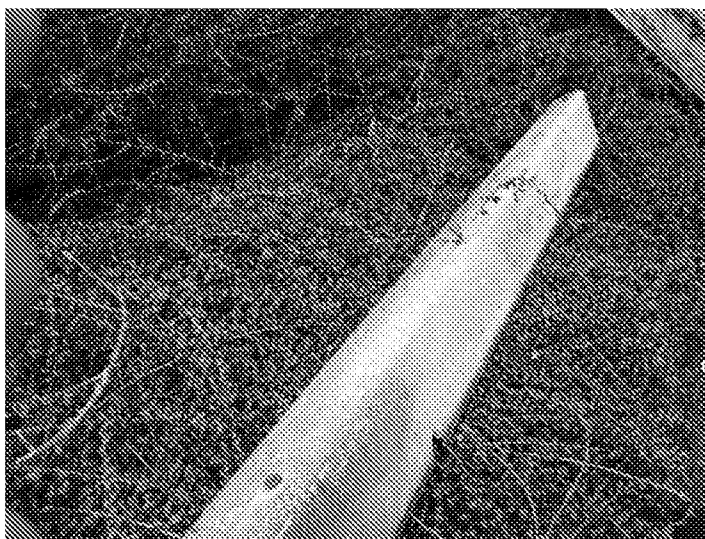
| Material Risk Assessment | Score |
|---|---|
| <b>Material Assessment Score</b> | 4 |
| <b>Material Assessment Category</b> | Very Low |

| Recommended Actions: |
