Sketch plan of tree for maintenance 16 East Street,  
Littlehampton – Ref LU/153/22/TC

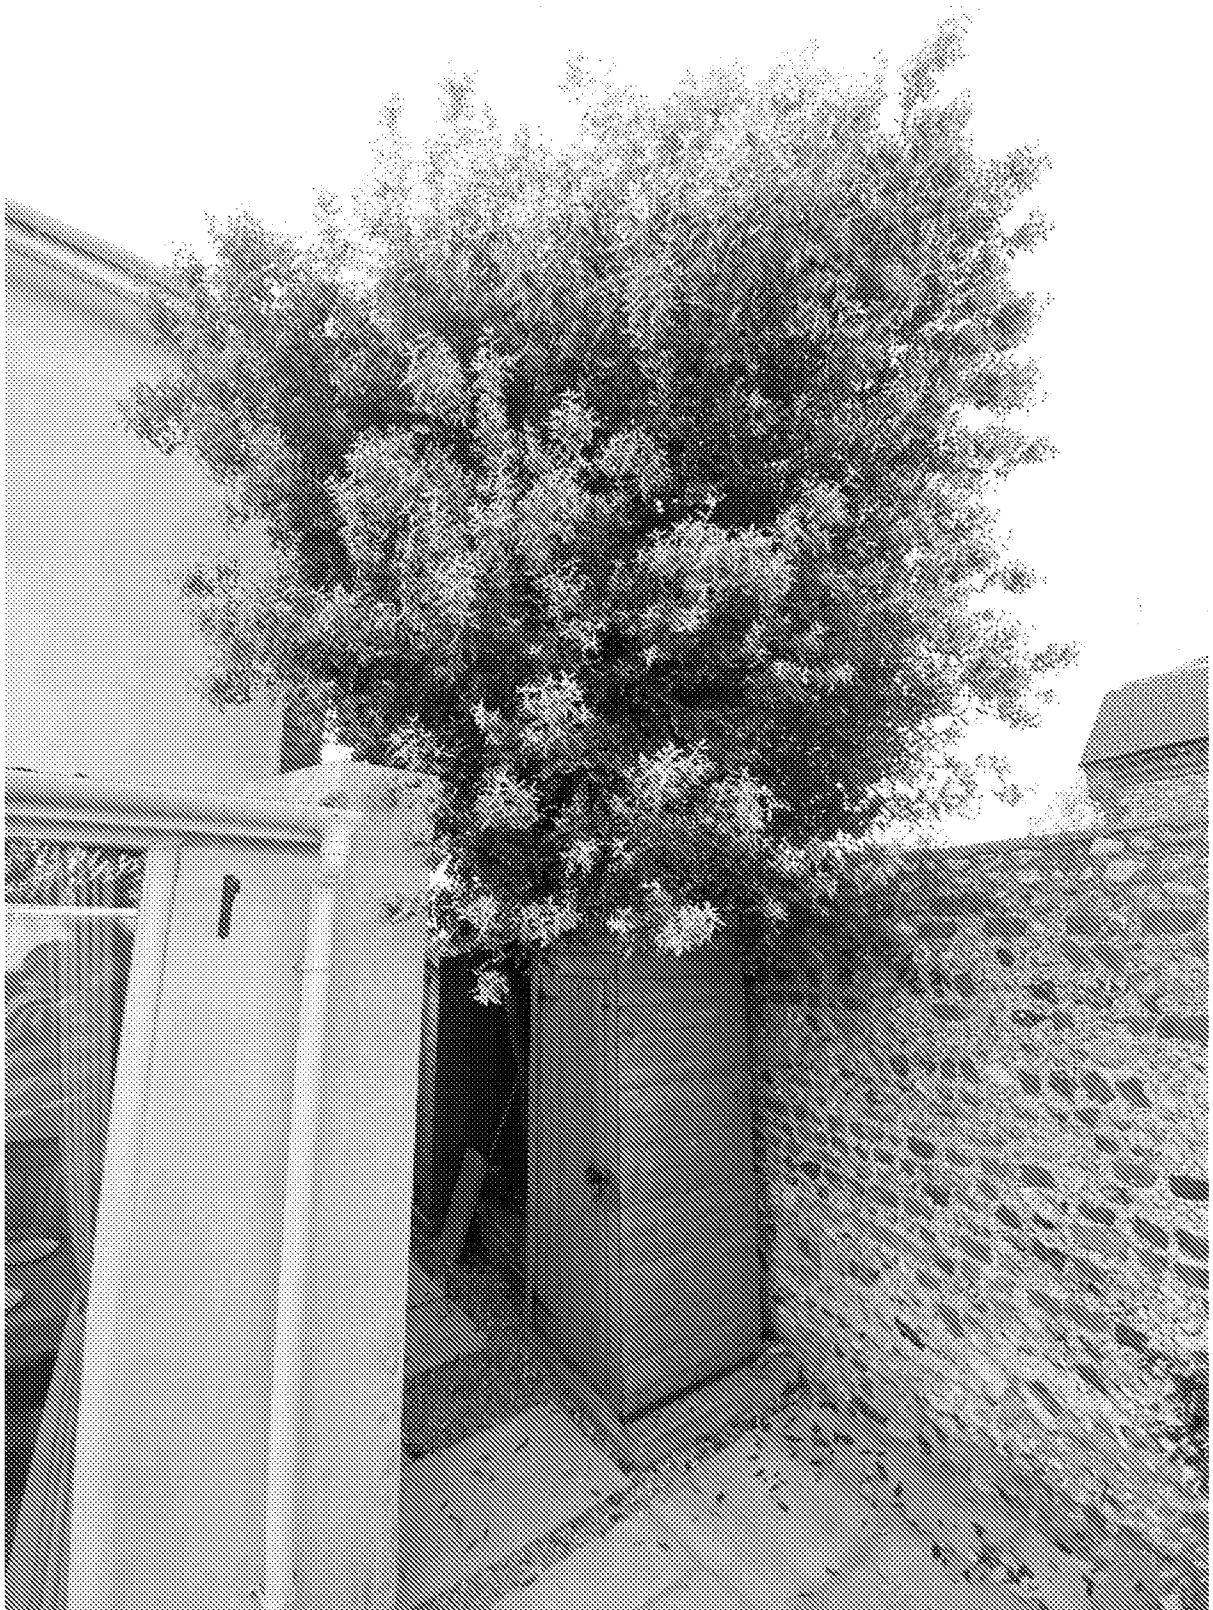
View from rear house

NOTE- The gravel area on the path is a sewer manhole

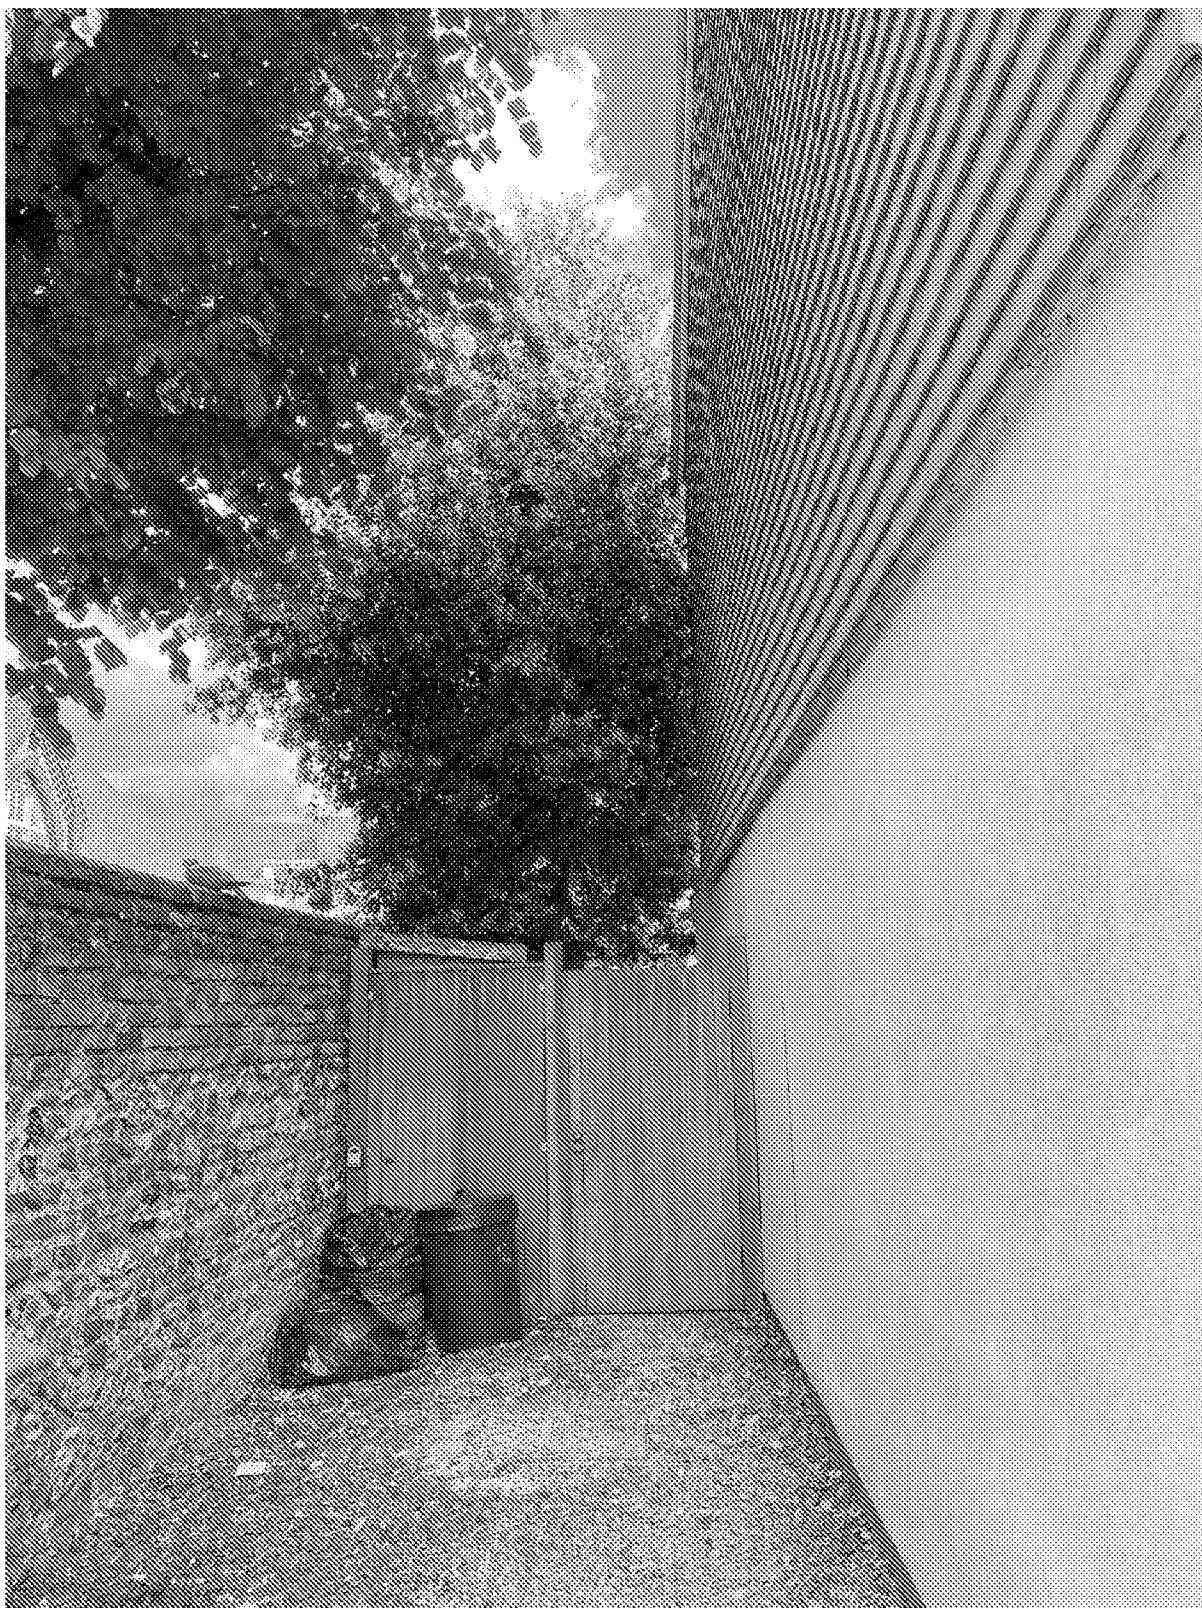
View from Front of house

Note – the branches are interfering with the tiled frontage

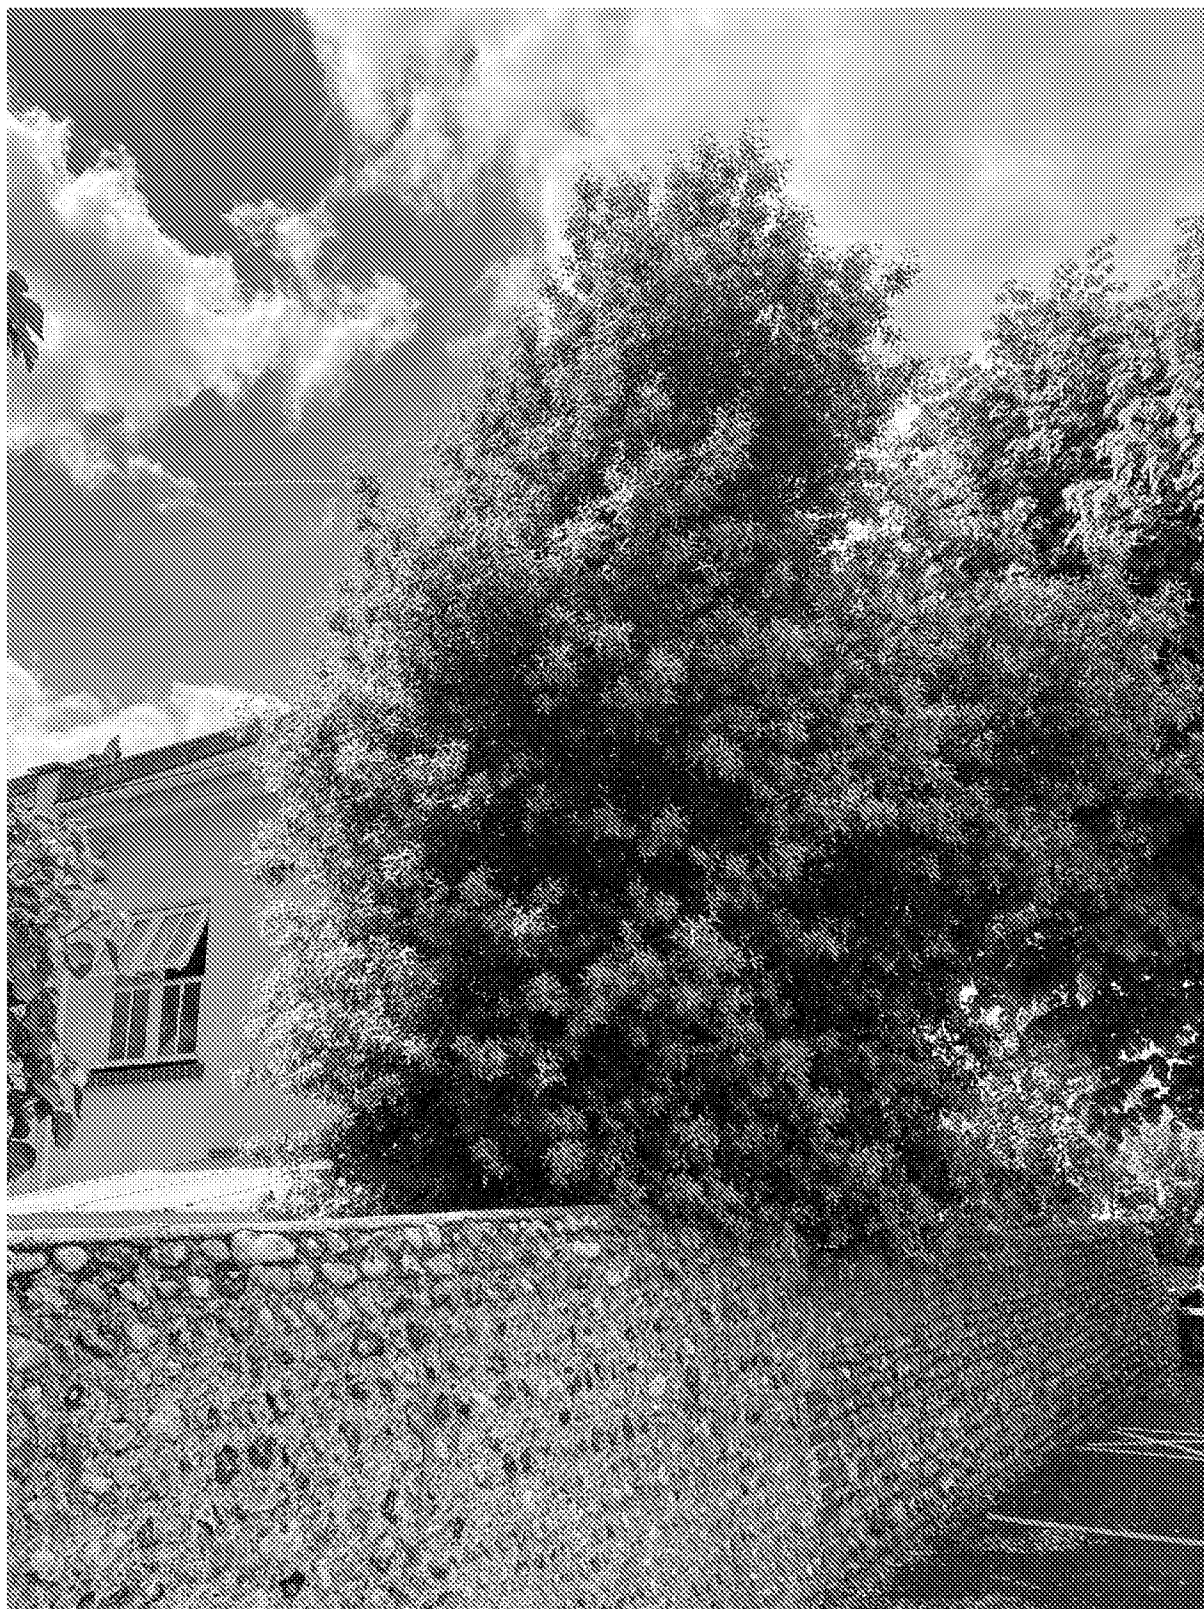
View from the Flintstone Centre

Note – the tree to the right is a lime tree in the Flintstone centre and it is not part of this request.

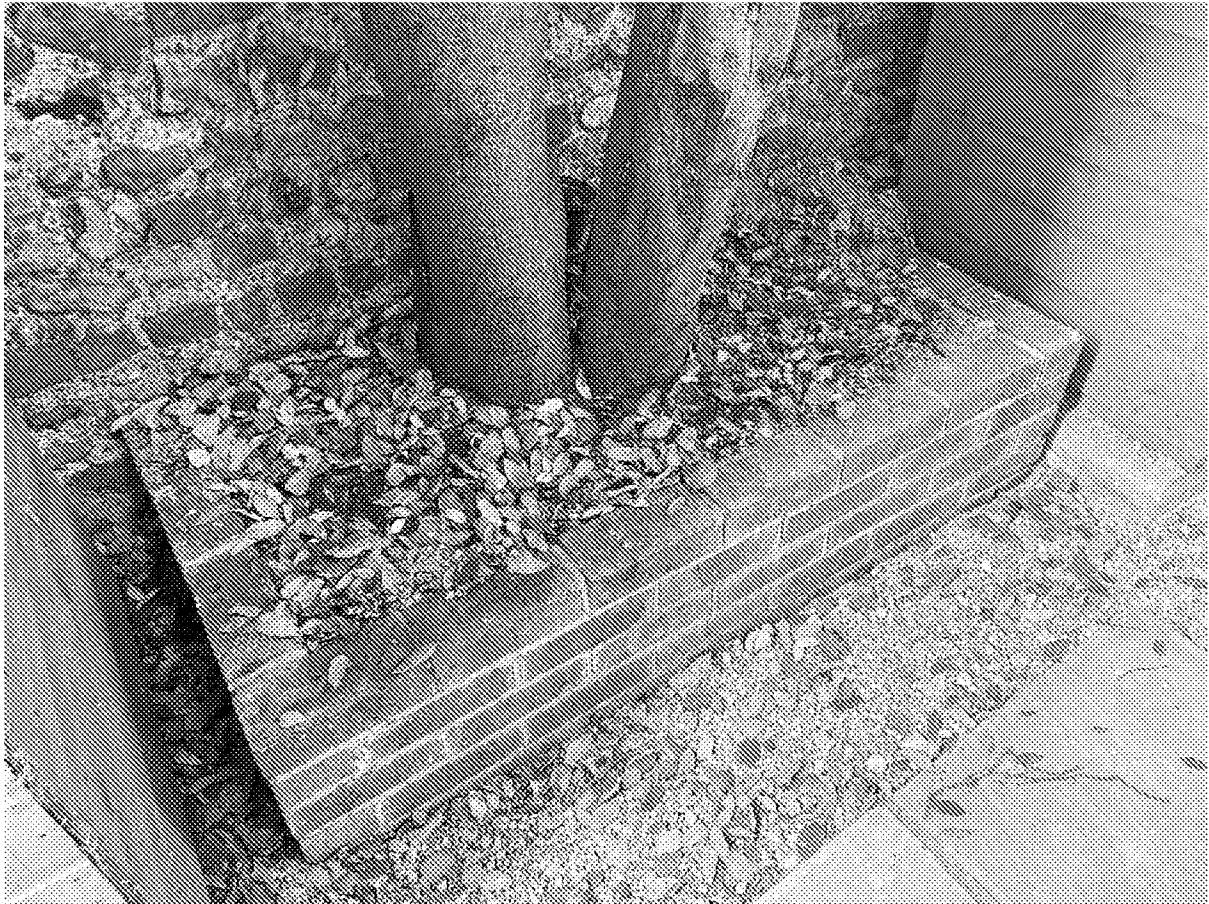
### View of the bund wall around the trunks

Note - After the last storms the surface area of the crown caused considerable movement resulting in the cracks on the bund wall. The Flint wall to the rear belongs to the Flintstone centre; The tree roots and movement must be under the foundations of the wall. They must also threaten the sewer which runs under the slabs to the front of the bund wall and potentially the foundations of the house the other side of the slabs
