**ALL HOURS PLUMBING**

| Project Name:<br><b>468</b> | Contract Number: | Contact:<br><b>Parchow Groundworks</b> | Date:<br><b>05/05/2026</b> |

Client: **Parchow Groundworks**  
Contact:  
Position:  
Road: **Widley Farm, New Down Lane**  
Town: **Purbrook**  
Post Code: **PO7 5SE**  
County: **Hampshire**  
Telephone:

Inspection Report

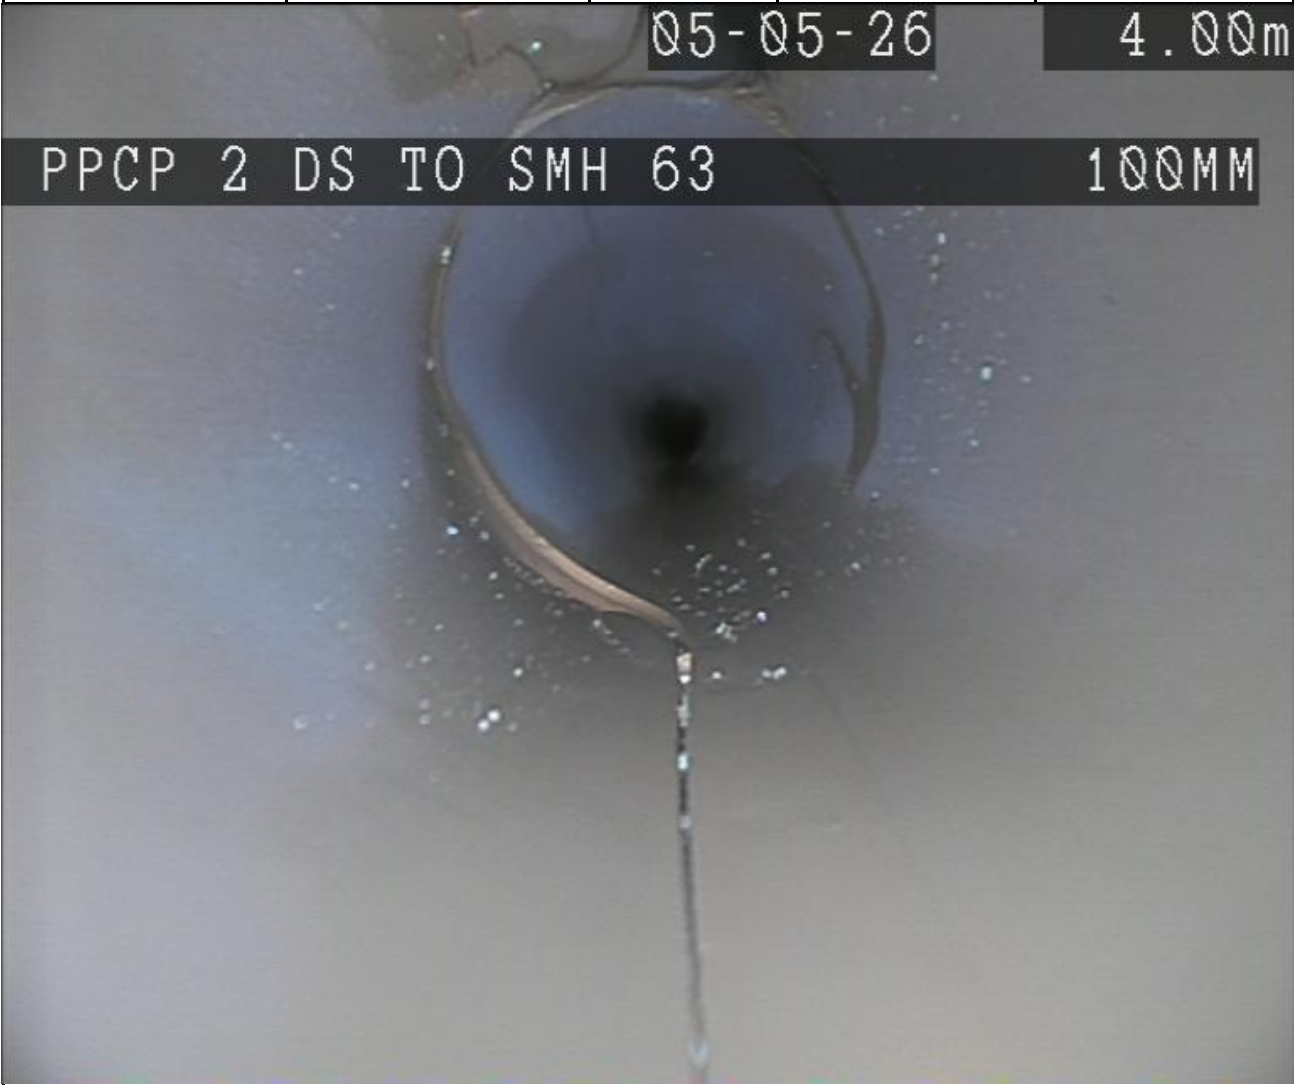
PPCP 2 DS TO SMH 63 100MM

4.0M CR Cracks In Pipe

CRACKS IN PIPE

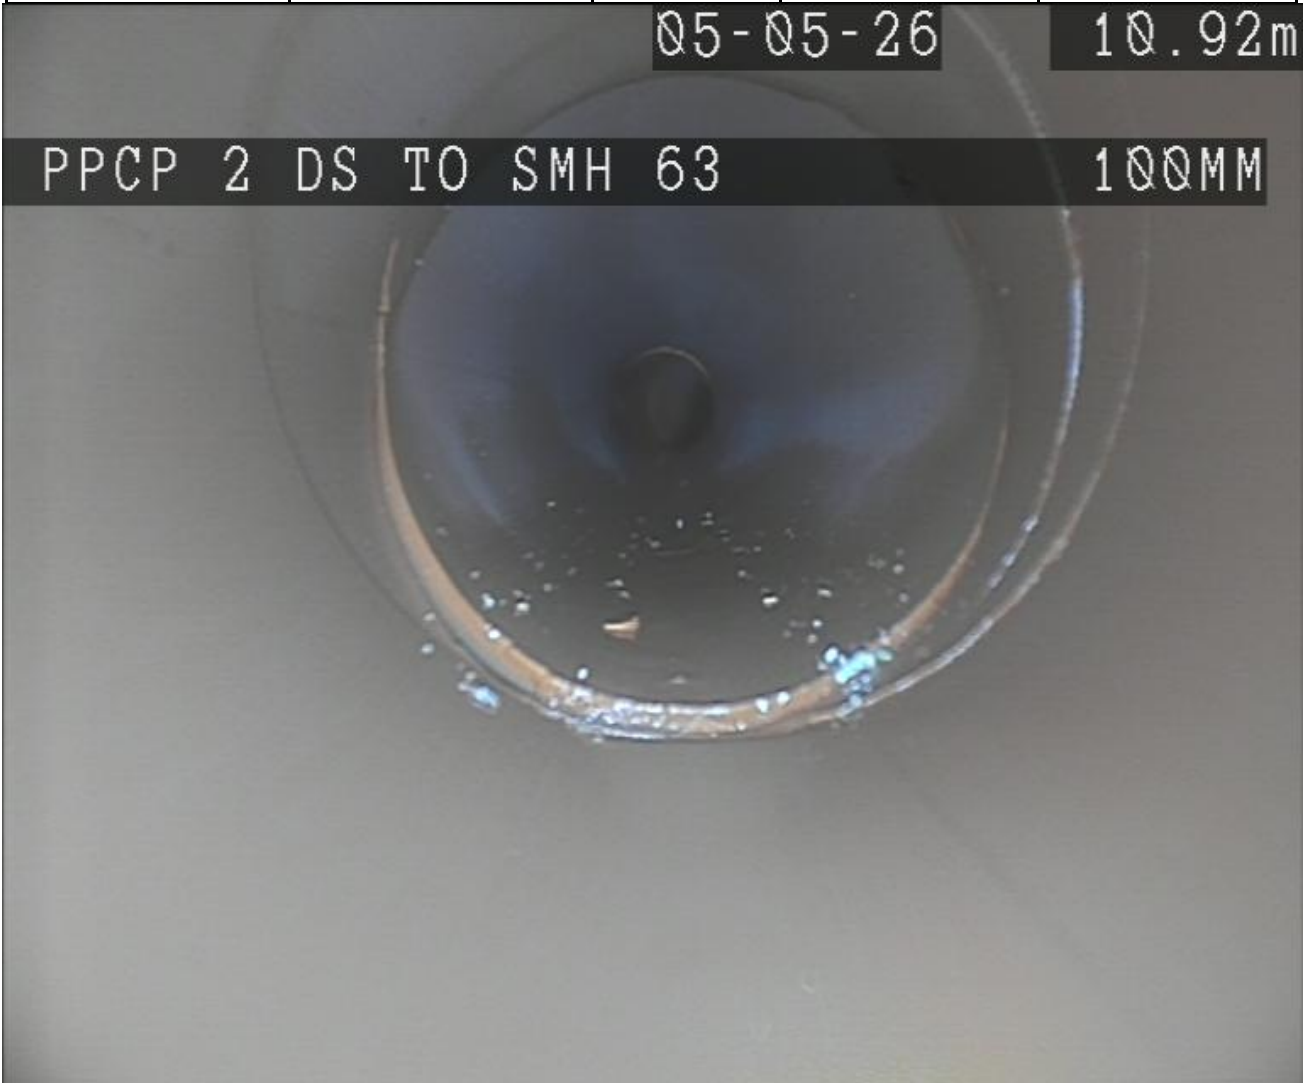
PPCP 2 DS TO SMH 63 100MM

CRACKS IN PIPE

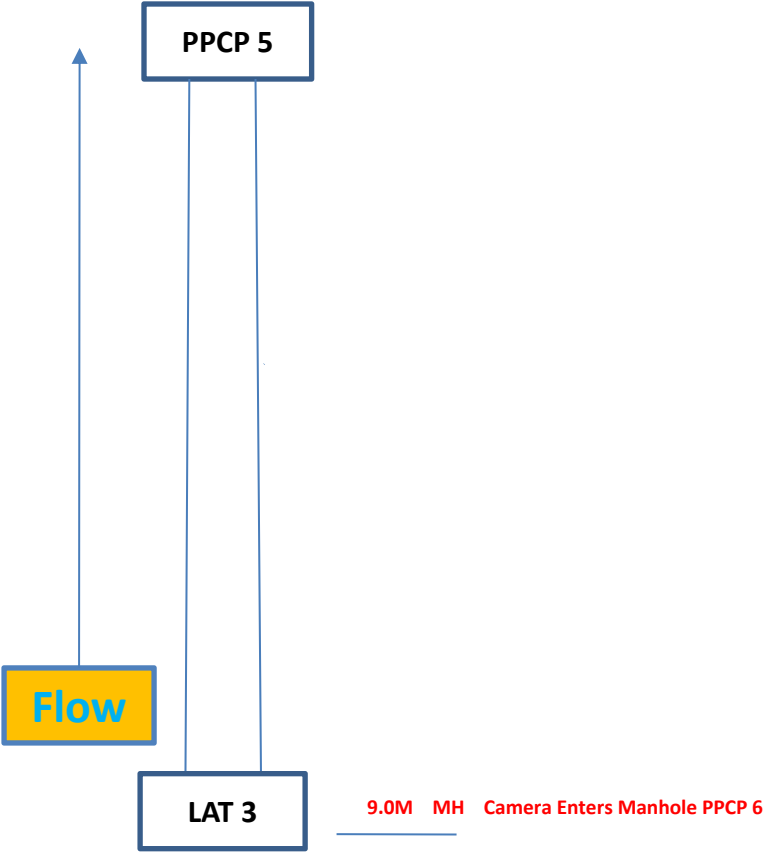
REM ; THERE ARE NO MAJOR DEFECTS WITH THIS SECTION OF PIPE, BUT MANHOLE PPCP 6 HAS SCAFFOLDING OVER IT SO CANT ACCESS
