## Structural Engineering Report

**36 South Terrace, Littlehampton, BN17 5NU:** Report on condition of external fire escape staircase and landings.

**Ref:** 21113

**Date:** 31<sup>st</sup> August 2021

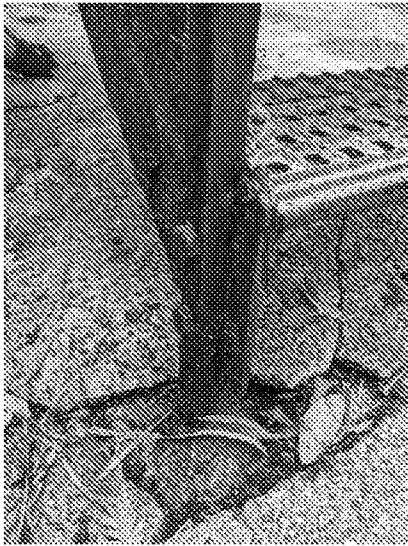
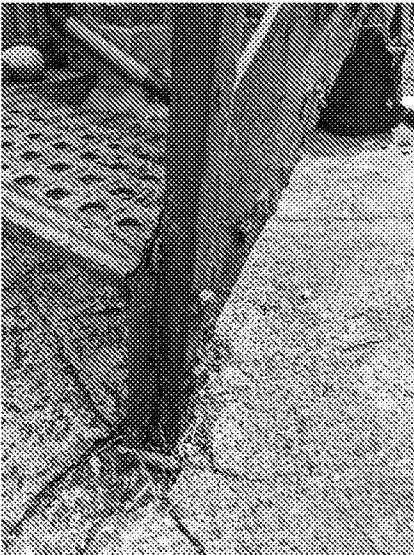
| Ground floor to first floor | Supports | Evidence of corrosion to the single support column below the first floor landing. Foundation arrangement unknown. Stair stringers welded to 25mm x 25mm square final balustrade post bearing on to possible brick spreader below cracked and damaged concrete slab. | 1 & 2 |

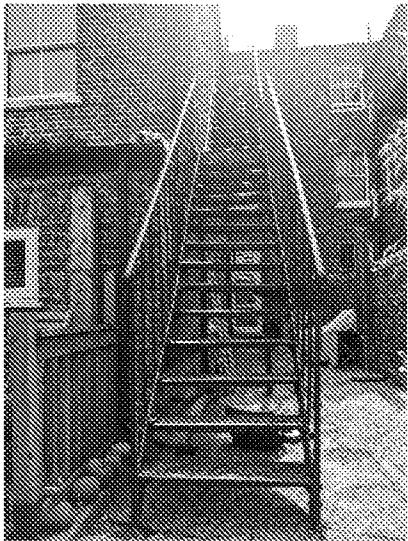
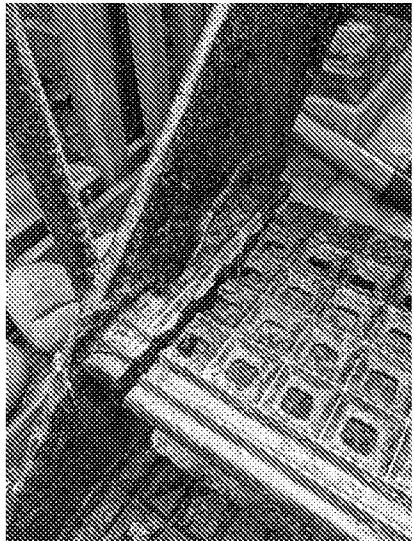
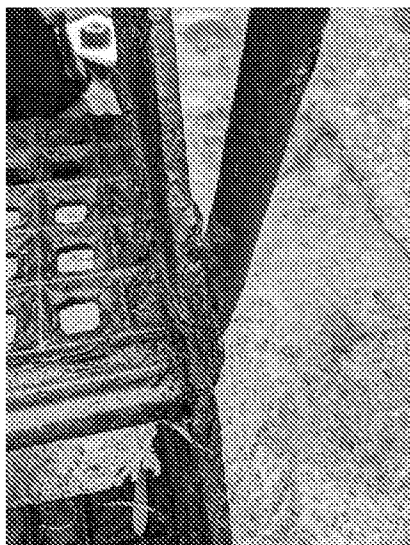
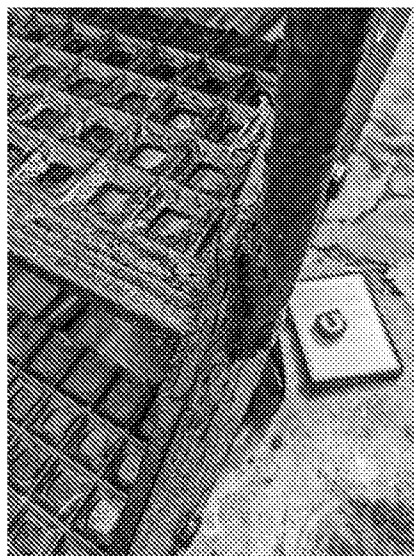
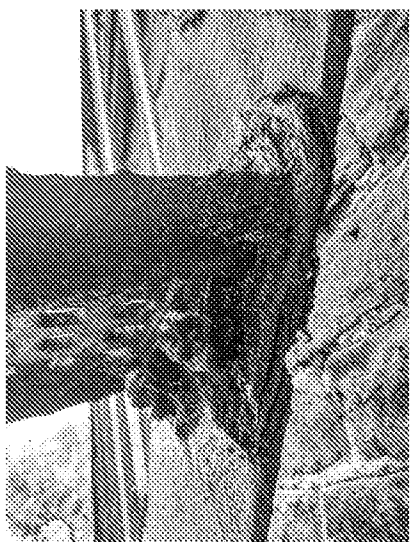
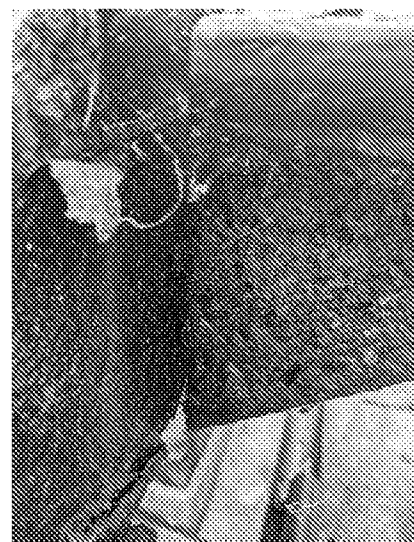
| | Ground to first floor stair flight | Evidence of significant structural damage and deterioration of the stair flight, which was deformed and twisted over its span. 11 of the 14 cast iron stair treads were cracked through their | 3 to 8 |

| | | entire depth, with some un-supported, some supported by rudimentary brackets and some un-supported where such brackets had failed. Structural defects & corrosion noted to the stringers, balustrade infill and bolted connections. Balustrade infill was spaced at 200mm centres. | |

The lower stair flight had numerous cracked and damaged cast iron tread plates forming the structure and which were in a failed condition, with repairs also either inadequate or having failed also. The lower flight is in an unsafe condition.

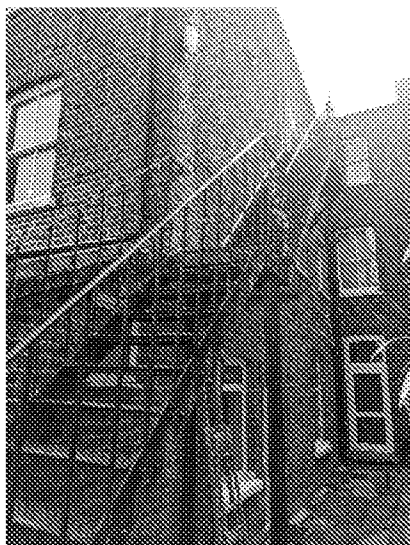
Photo 9

| | Main support column. | The support column appeared to be a more modern addition to the staircase structure, possibly replacing an older, defective column, or potentially replacing cantilevering gallows brackets from the original structure. The column showed signs of corrosion damage but mainly in the form of smaller areas of lifting paint. The column was not plumb and leaned out at first floor landing level. | 9 |

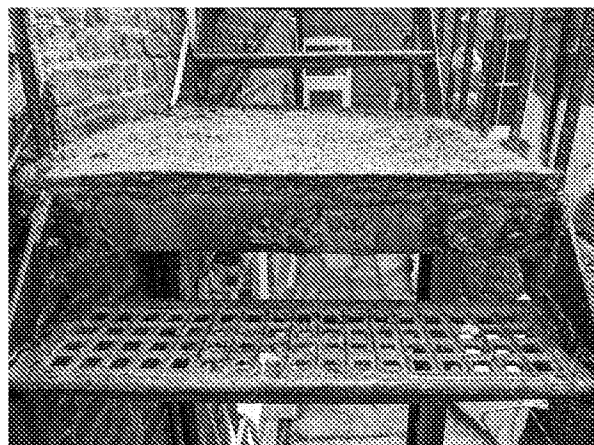
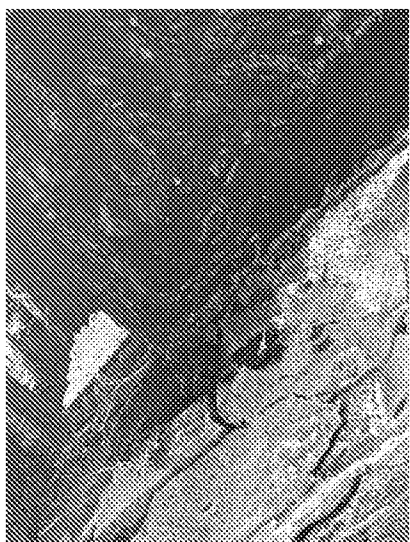
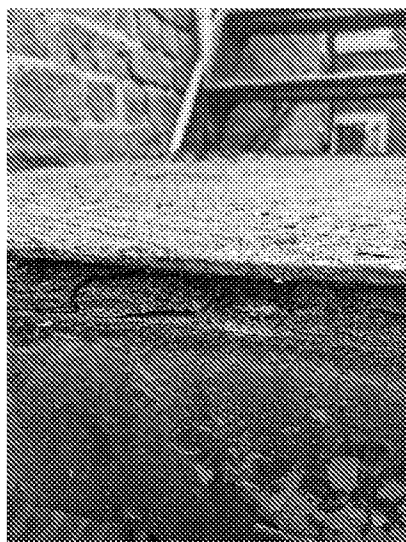
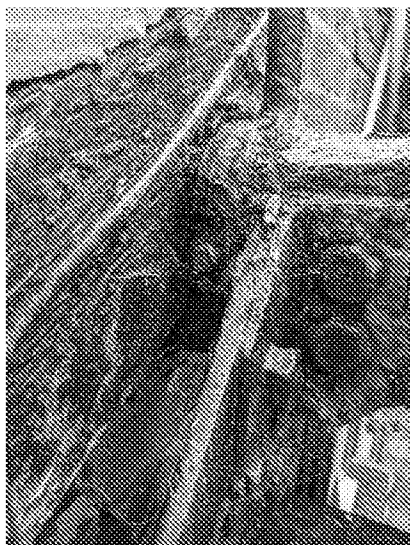
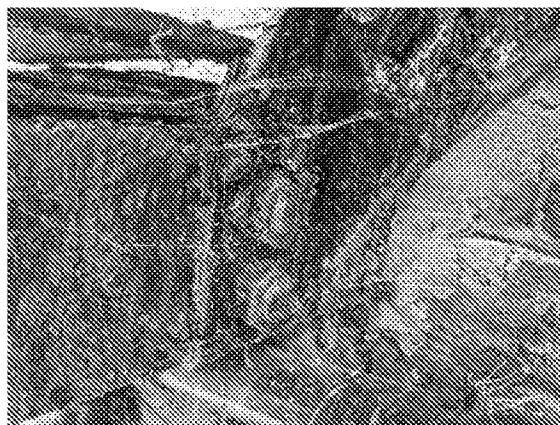
| | First floor landing | Evidence of significant structural defects noted to the landing structure. Surface corrosion, delamination and distortion to the landing floor plate noted. Significant corrosion to the angle section elements forming the framing to the landing, beneath the floor plate. Corrosion to the bolted connections. Corrosion and delamination to the angle sections embedded in the solid brick external wall of the main building, causing cracking and damage to the brickwork. Corrosion noted to the balustrade infill and their bolted connections. | 10 to 14 |

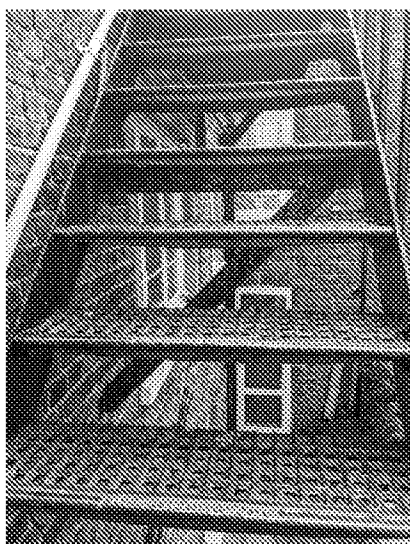
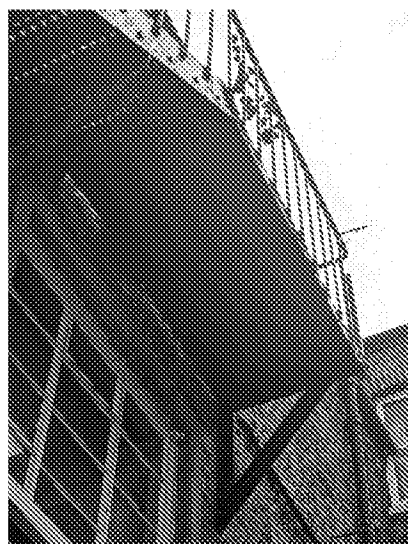
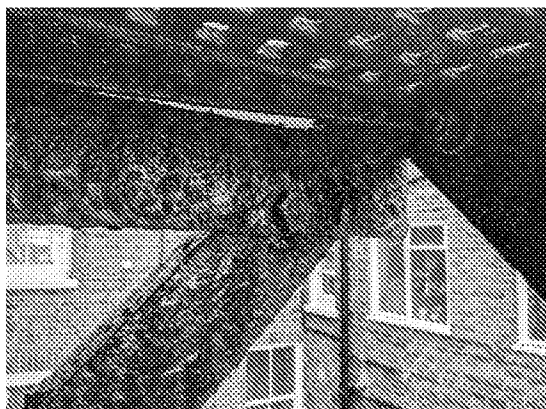
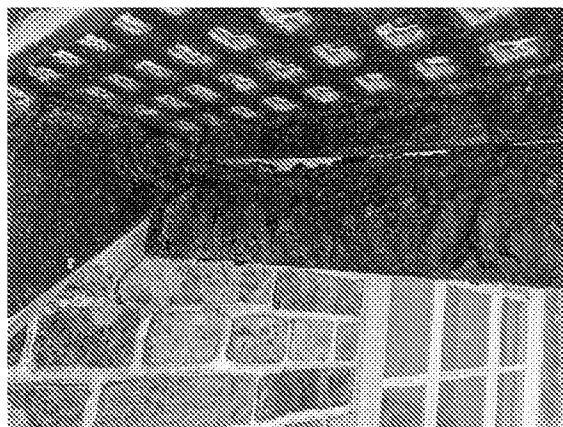
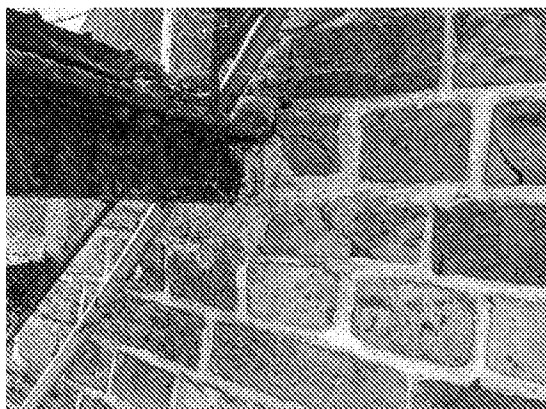
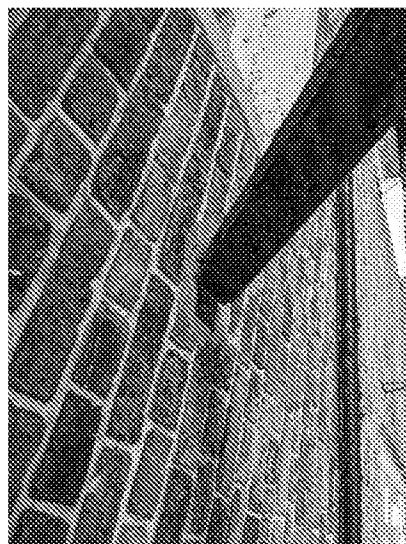
| First to second floor | Cantilevered gallows bracket | Significant corrosion noted to the angle sections forming the triangular gallows brackets and their connections, together with corrosion where embedded in to the external wall of the main building. | 15 to 20 |

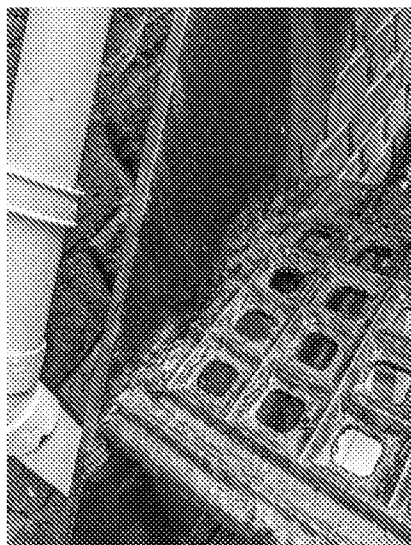
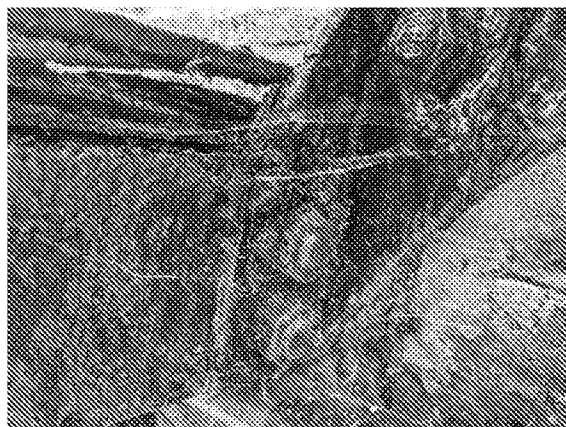
| | First to second floor stair flight. | Evidence of significant structural damage and deterioration of the stair flight, which was deformed and twisted | 21 & 22 |

| | | <p>over its span. Some of the cast iron stair treads were showing signs of potential development of cracks and defects similar to those previously formed to the lower stair flight, though none appeared to have cracked through their entire depth and had not been repaired. Structural defects &amp; corrosion noted to the stringers, balustrade infill and bolted connections, though the extent of damage was less than to the lower flight. Corrosion and damage was noted to the connections to the first floor landing. Balustrade infill was spaced at 200mm centres.</p> | |

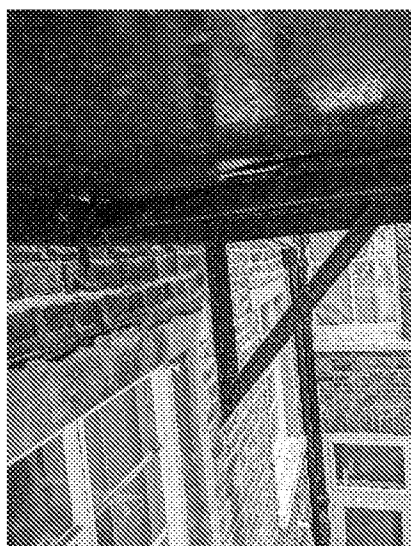
Photo 23

| Second floor | Cantilevered gallows bracket | <p>Significant corrosion noted to the angle sections forming the triangular gallows brackets and their connections, together with corrosion where embedded in to the external wall of the main building.</p> | 23 |

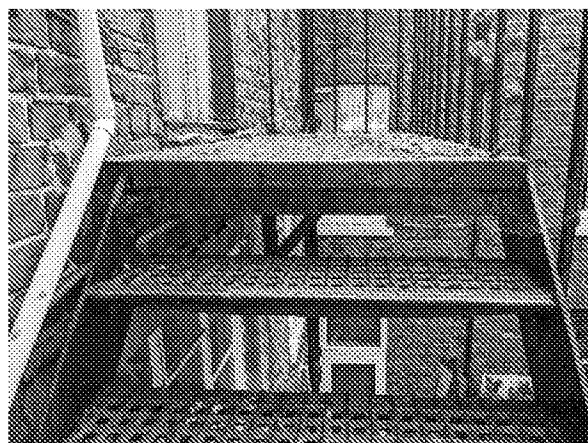
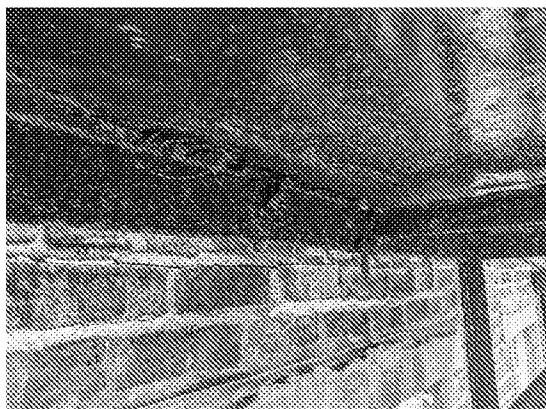
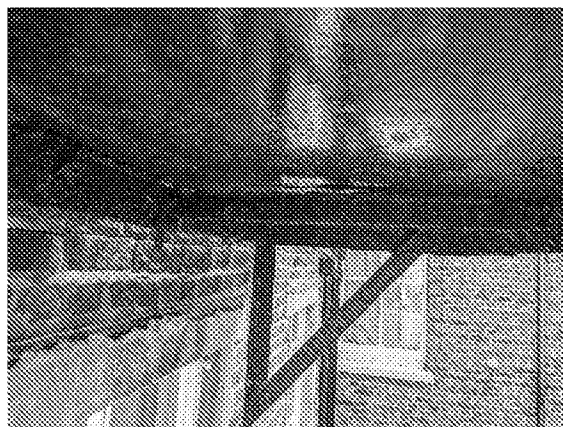
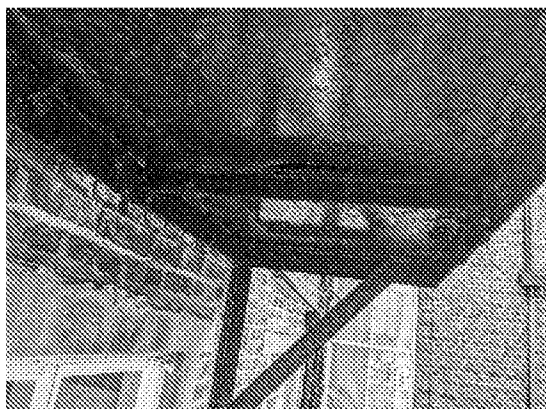
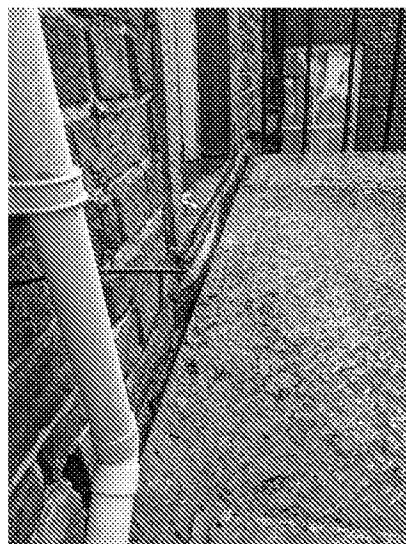
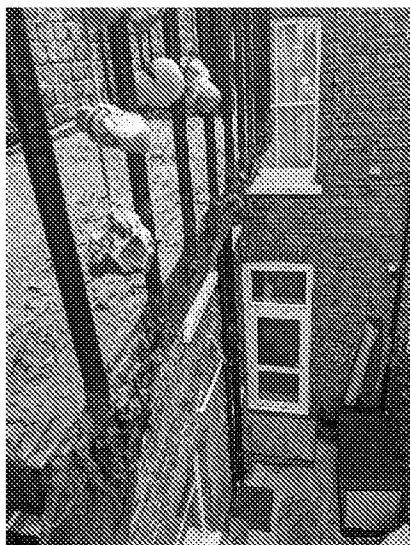
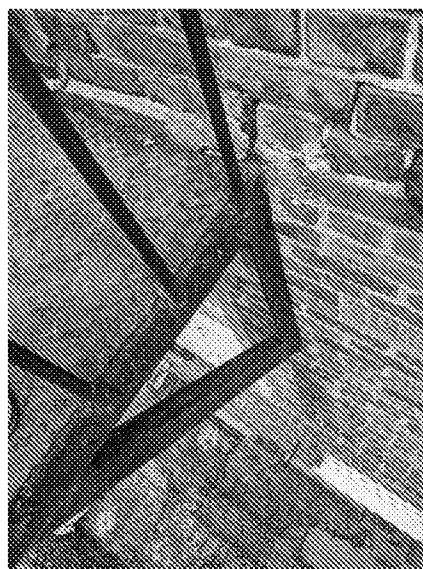
| | Landing | <p>Evidence of significant structural defects noted to the landing structure. Surface corrosion and distortion to the landing floor plate noted, which appeared a more modern element than the rest of the structure, possibly installed to replace a defective landing floor in the past. Significant corrosion to the angle section elements forming the framing to the landing, beneath the floor plate. Corrosion to the bolted connections. Corrosion and delamination to the angle sections embedded in the solid brick external wall of the main building, causing cracking and damage to the brickwork. Corrosion noted to the balustrade infill and their bolted connections. The gallows bracket to the end of the landing appeared to be pulling out of the wall and hand caused cracking in that location.</p> | 24 to 30 |
