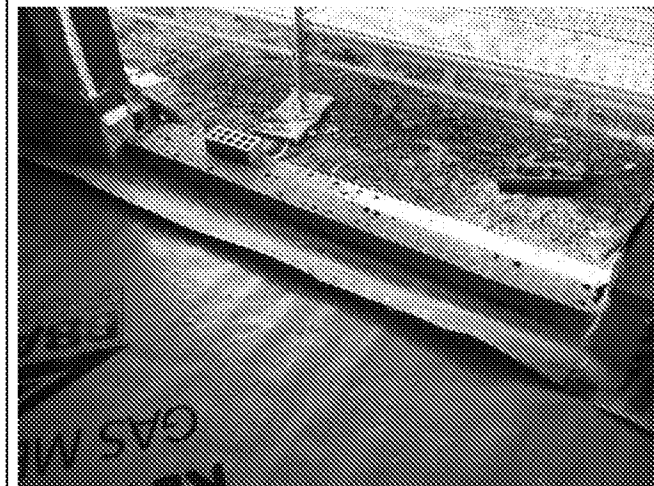
Plot 43 - in progress

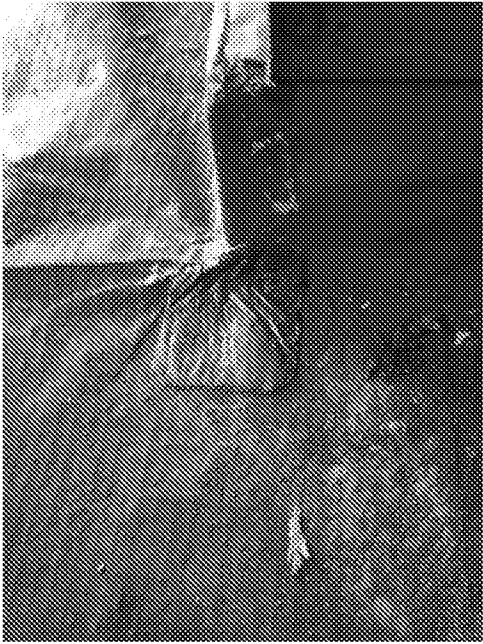
| | <p>Plot 33 patch repair</p> |

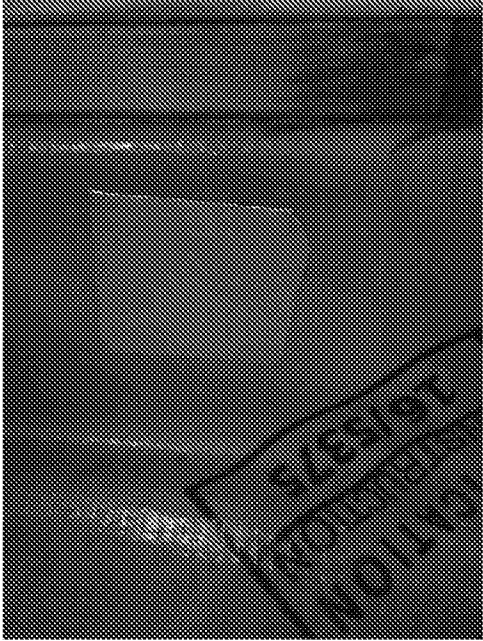
| | Plot 33 repair |

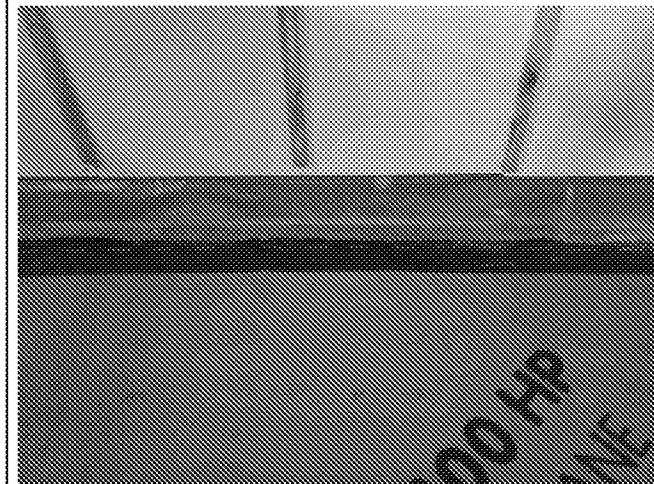
Plot 34 detail extra membrane to protect threshold beneath

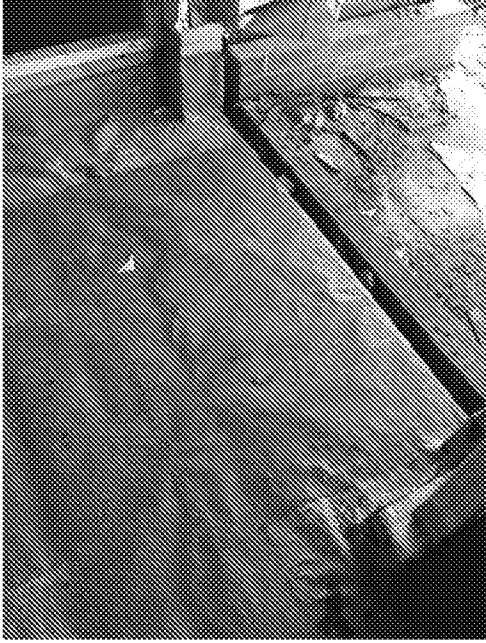
| 1.1 Condition of sub-grade and underside of membrane | Underside of membrane unable to be inspected as fully sealed. Gravel removed from some areas of subgrade and membrane subsequently patched up in Plots 28 and 30. |

| | <p>Plot 28 - Debris visible under membrane in doorway</p> |

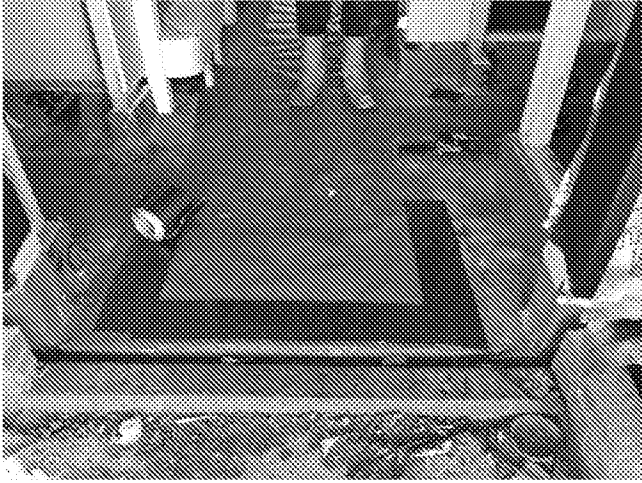
| | <p>Plot 28 - Doorway area with patching after removal of debris from under membrane</p> |

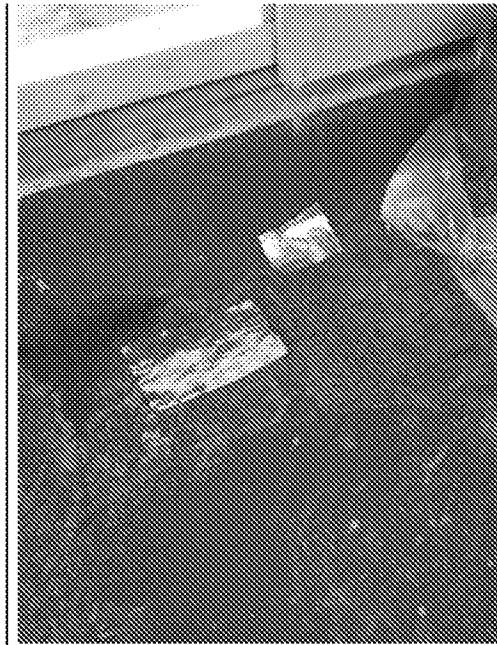
Plot 26 repair

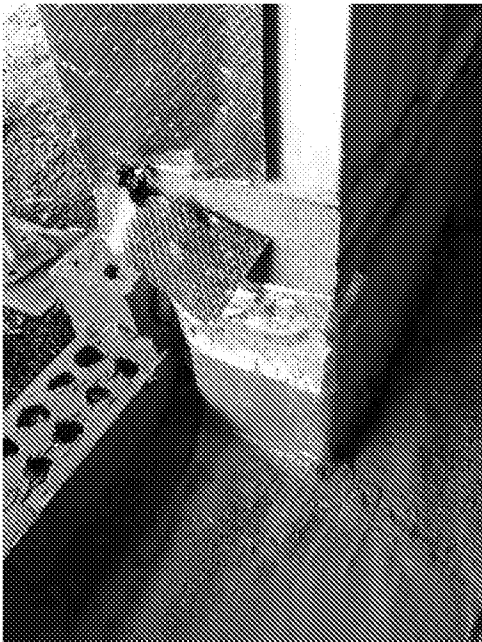
Plot 22 patch repair

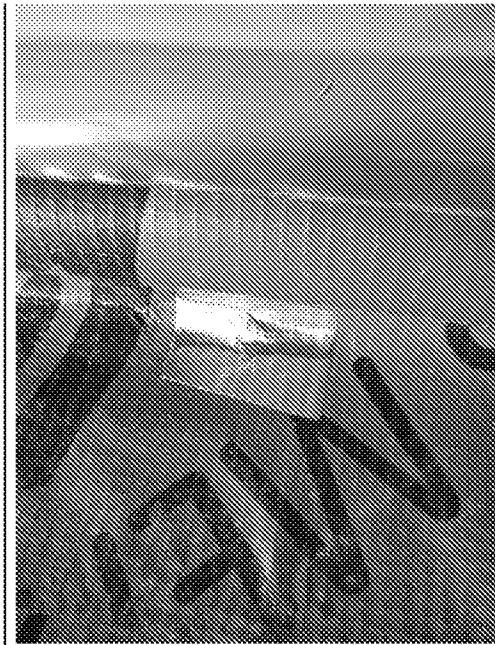
Plot 23 patch repair

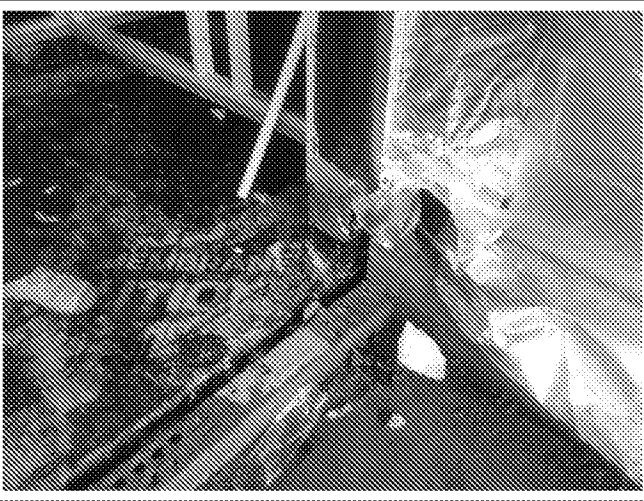
| | <p>Plot 47 patching.</p> |

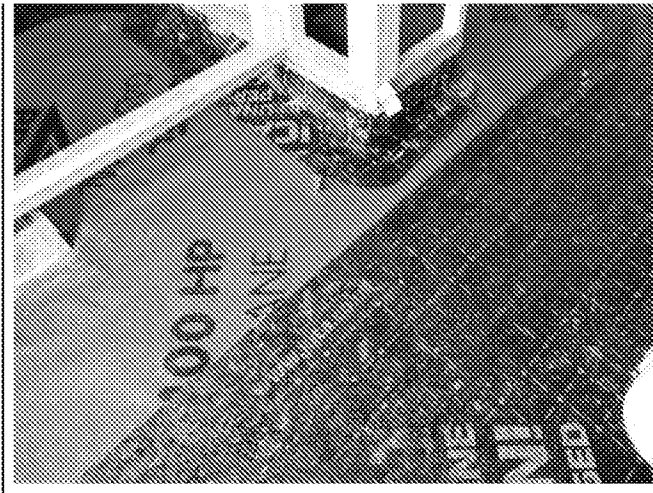
Nail under walkway. Plot 46 fail.

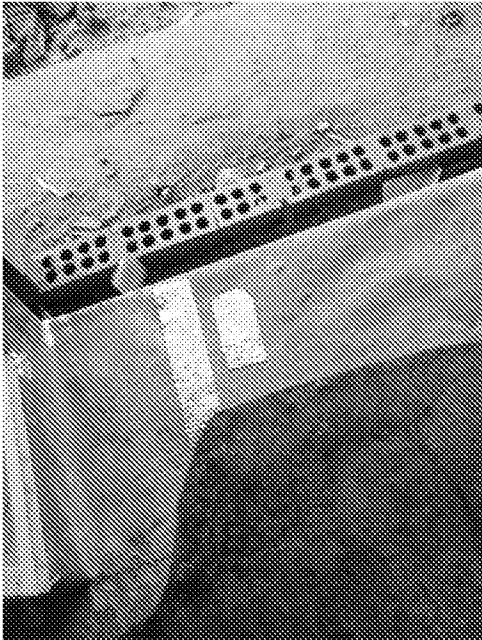
Plot 51 repairs

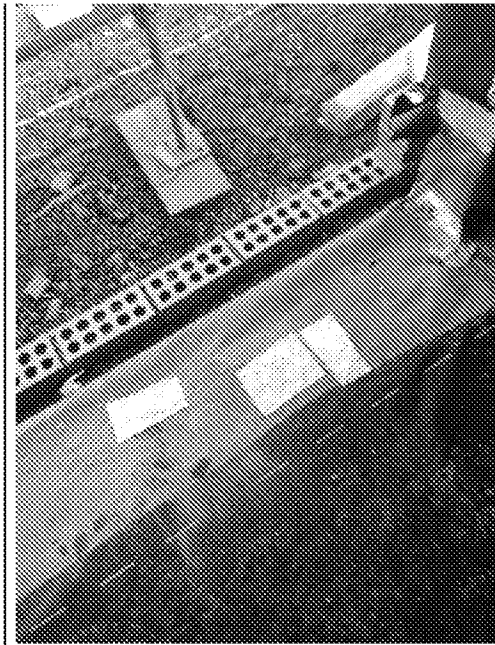
Plot 52 patch repair

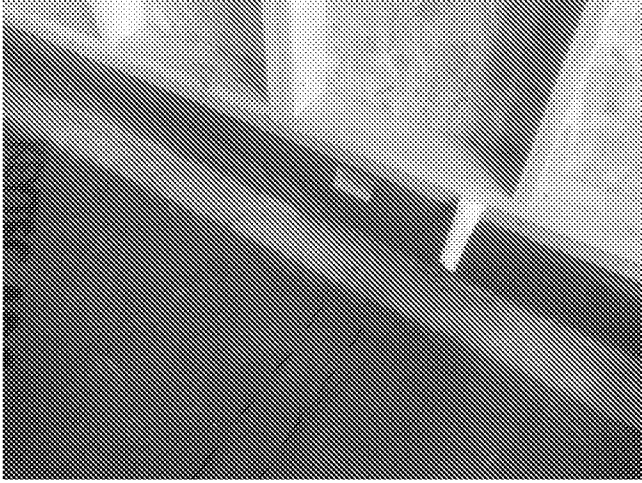
| | Plot 55 patch repair |

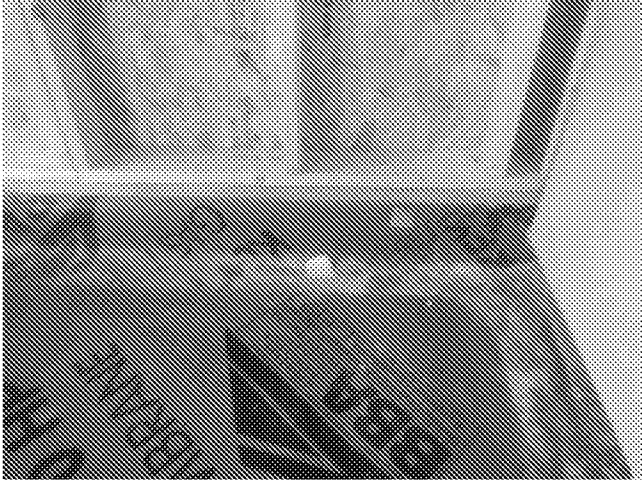
| A black and white photograph showing a close-up of a gas leak repair. A patch is applied to a wall, with the words "GAS" and "REPAIR" visible on the patch material. | Plot 58 patch repair |

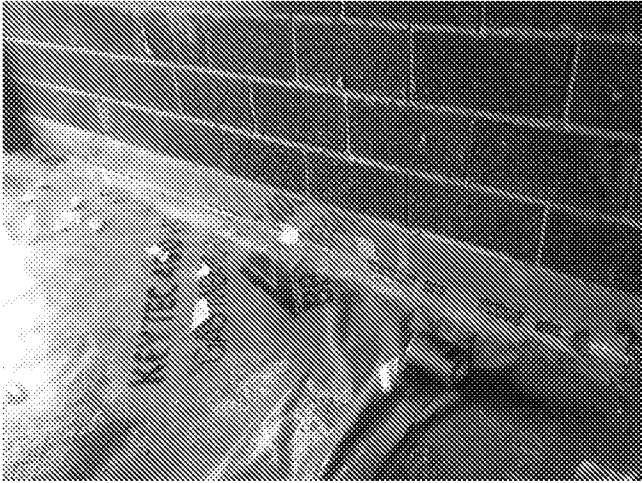
| 1.6 Laps, welds and joints seals | <p>All heat sealed joints.</p> <p>Block B - A large number of patch repairs are required</p> <p>Block A - seal around stairs is not sufficient</p> |

| Photograph | Photograph Title |
|---|---|
| | Block B patch repairs |

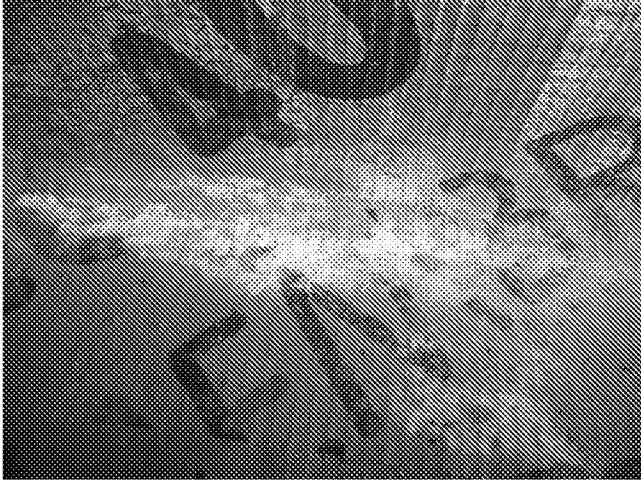
Block B damage

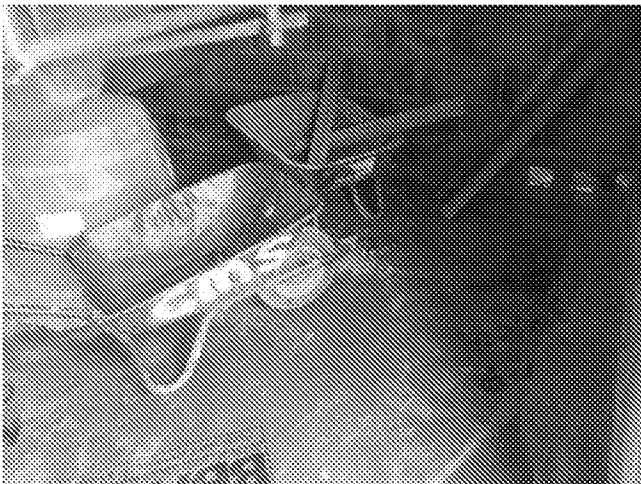
| 1.3 Gas membrane condition | <p>Block B - Main floor area generally clear however membrane did require sweeping. Materials were being stored on top of membrane in stairwell and a lot of rubble and debris on membrane in the smaller rooms</p> <p>Block A membrane needs clearing and materials being stored on it</p> |

Block B materials stored

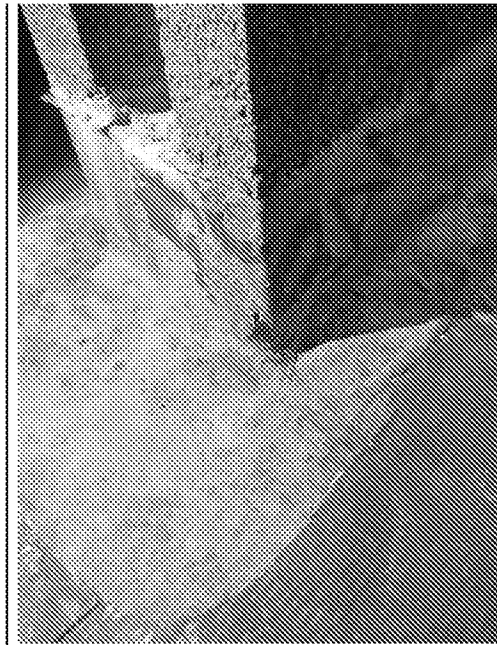
Block B damage

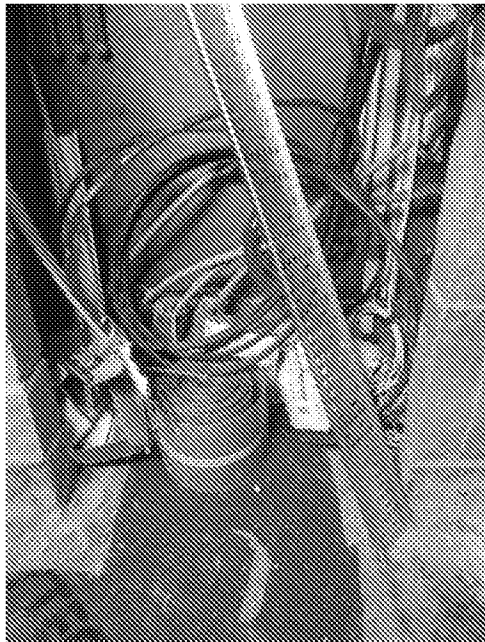
Block A materials

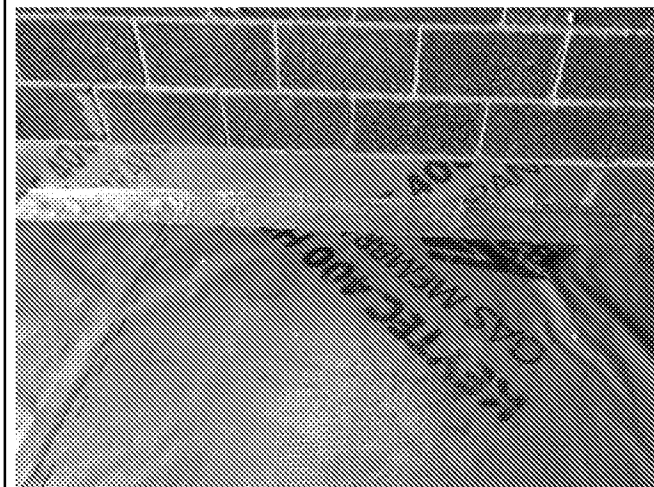
| 1.6 Laps, welds and joints seals | All heat sealed joins and well sealed. Patch repairs over areas of membrane that had been installed as part of the timber frame construction and therefore exposed for sometime |

Block B repairs

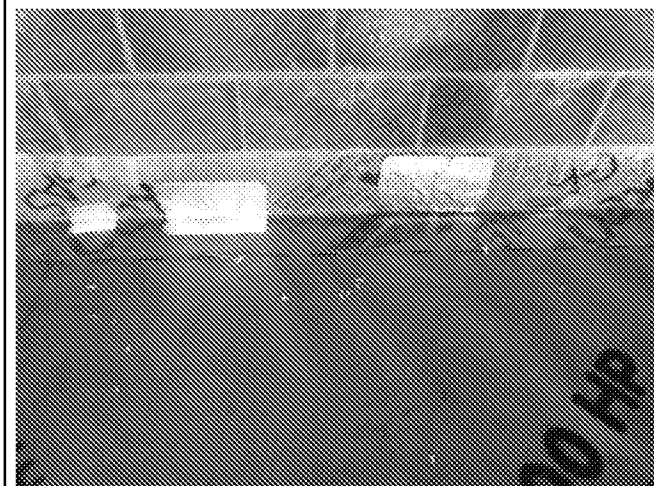
Block B repairs

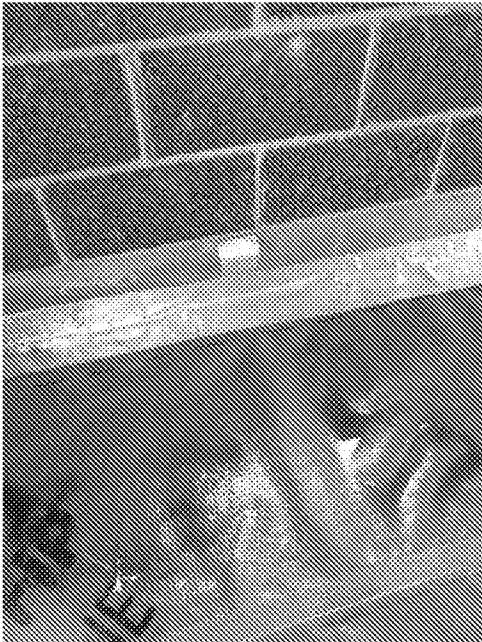
Block B patch repairs
