**VERIFICATION REPORT**  
**for PLOTS 24-29 (SOIL COVER SYSTEMS) &**  
**ALL PLOTS (GROUND GAS) AT**  
**CORNFIELD CLOSE, LITTLEHAMPTON,**  
**WEST SUSSEX, BN17 6LD**  
**on behalf of**  
**THAKEHAM CLIENT LTD**

| <b>Date:</b> | <b>01/06/2021</b> |
| <b>Reference:</b> | <b>GE18103/VR/PLOTS 24-29 (Soil) &amp; All Plots (Gas)/JUN21</b> |

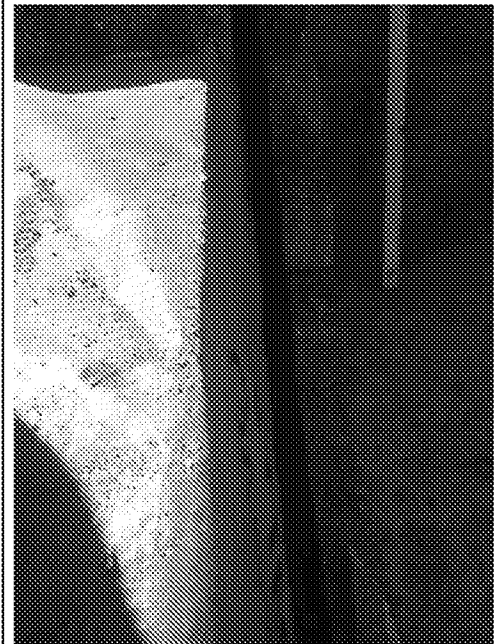
Block B damage

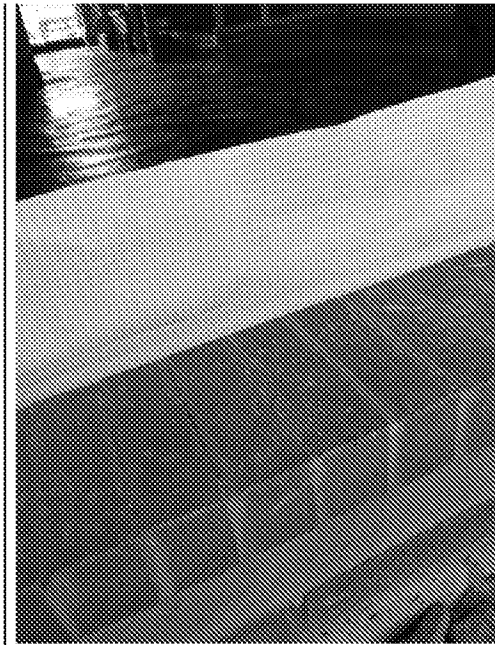
Plot 4 - underside of membrane in good condition

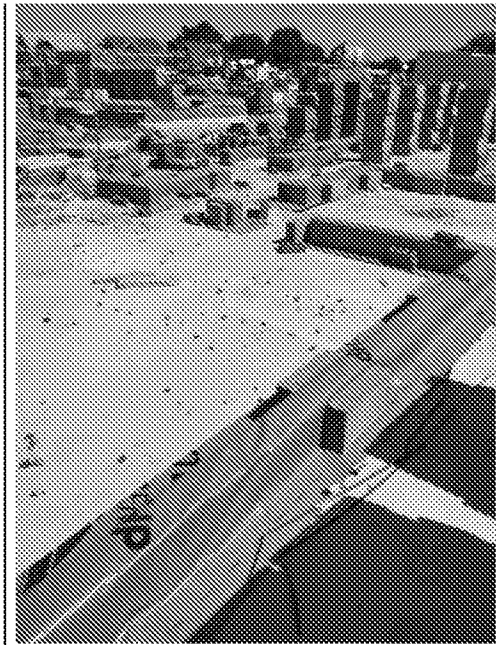
Block B - services not yet sealed

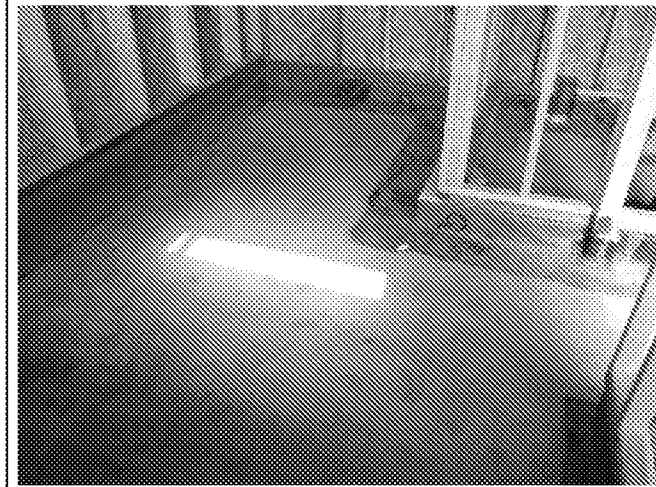
Plot 15 - Floor swept and in good condition

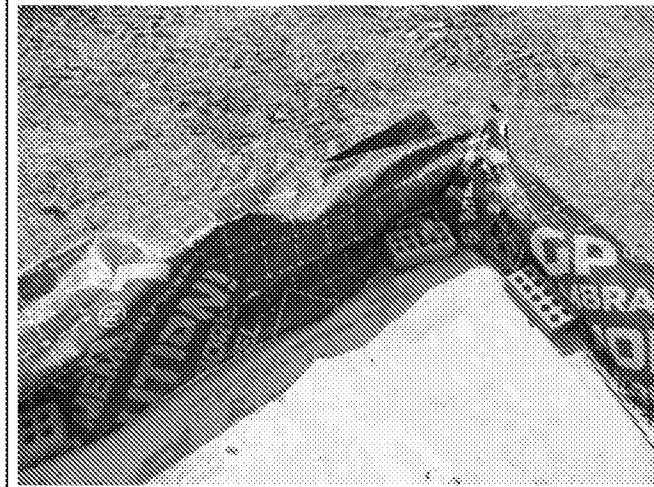
Plot 20-21(Phase 4) - Wind damage

Plot 20-21(Phase 4) - Damaged membrane will be replaced before bitumen tape placement

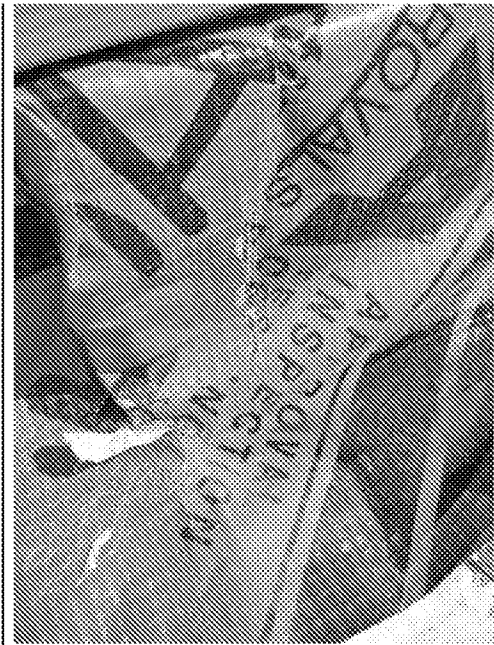
Plot 27 damage

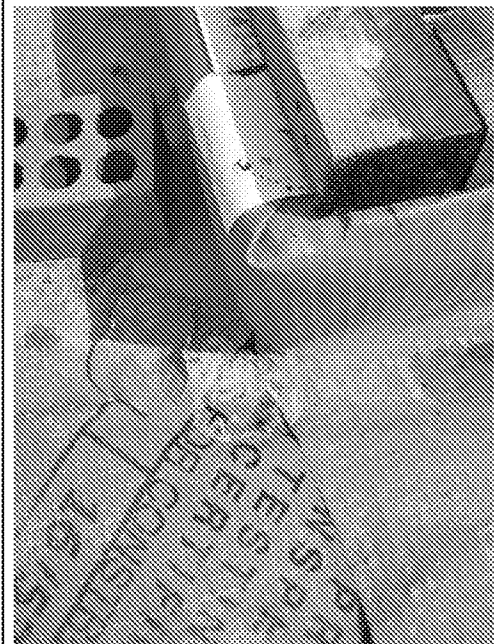
Plot 27 corner damage
