# ALL HOURS PLUMBING

Project Name:  
**468 Plots 88-78**

## Inspection Report

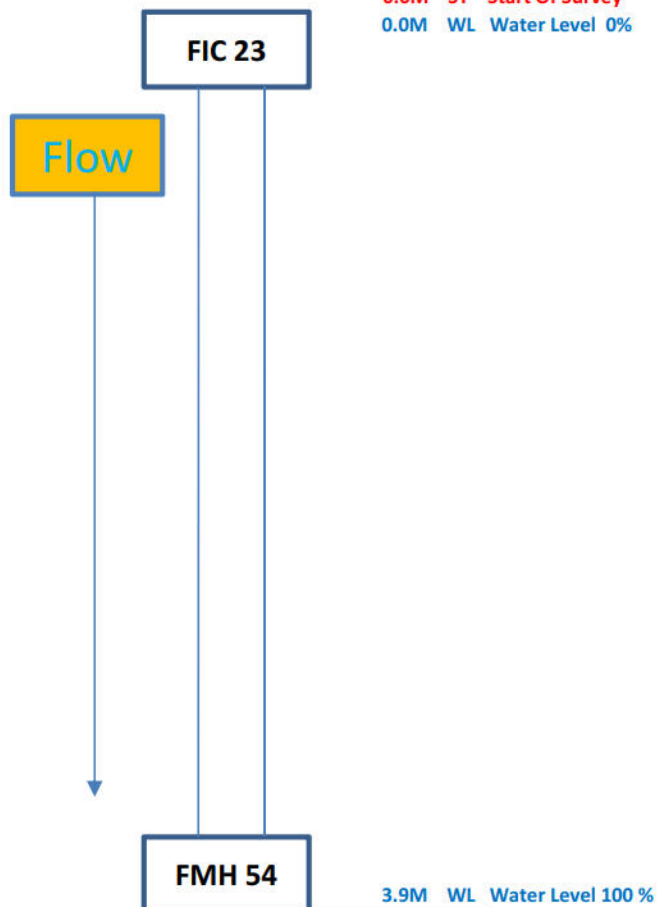
REM; THERE ARE NO MAJOR DEFECTS WITH THIS SECTION OF PIPE BUT THE MAINLINE IS RUNNING HIGH SO THERE IS WATER LAYING IN THE PIPE

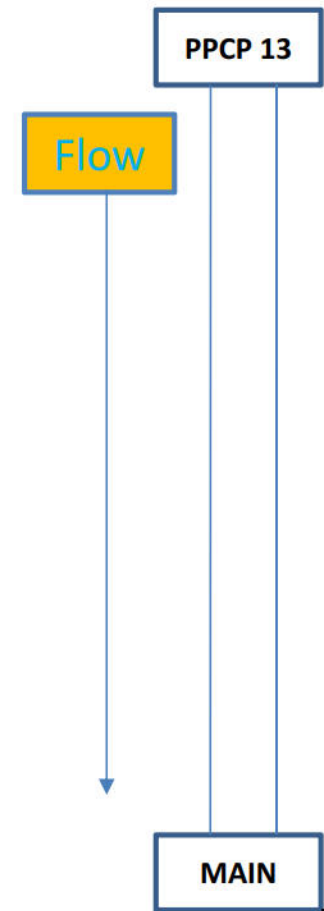
REM; THERE ARE MULTIPLE CRACKS IN THE PIPE AT 1.8 METRES WHICH CAN BE PATCH REPAIRED

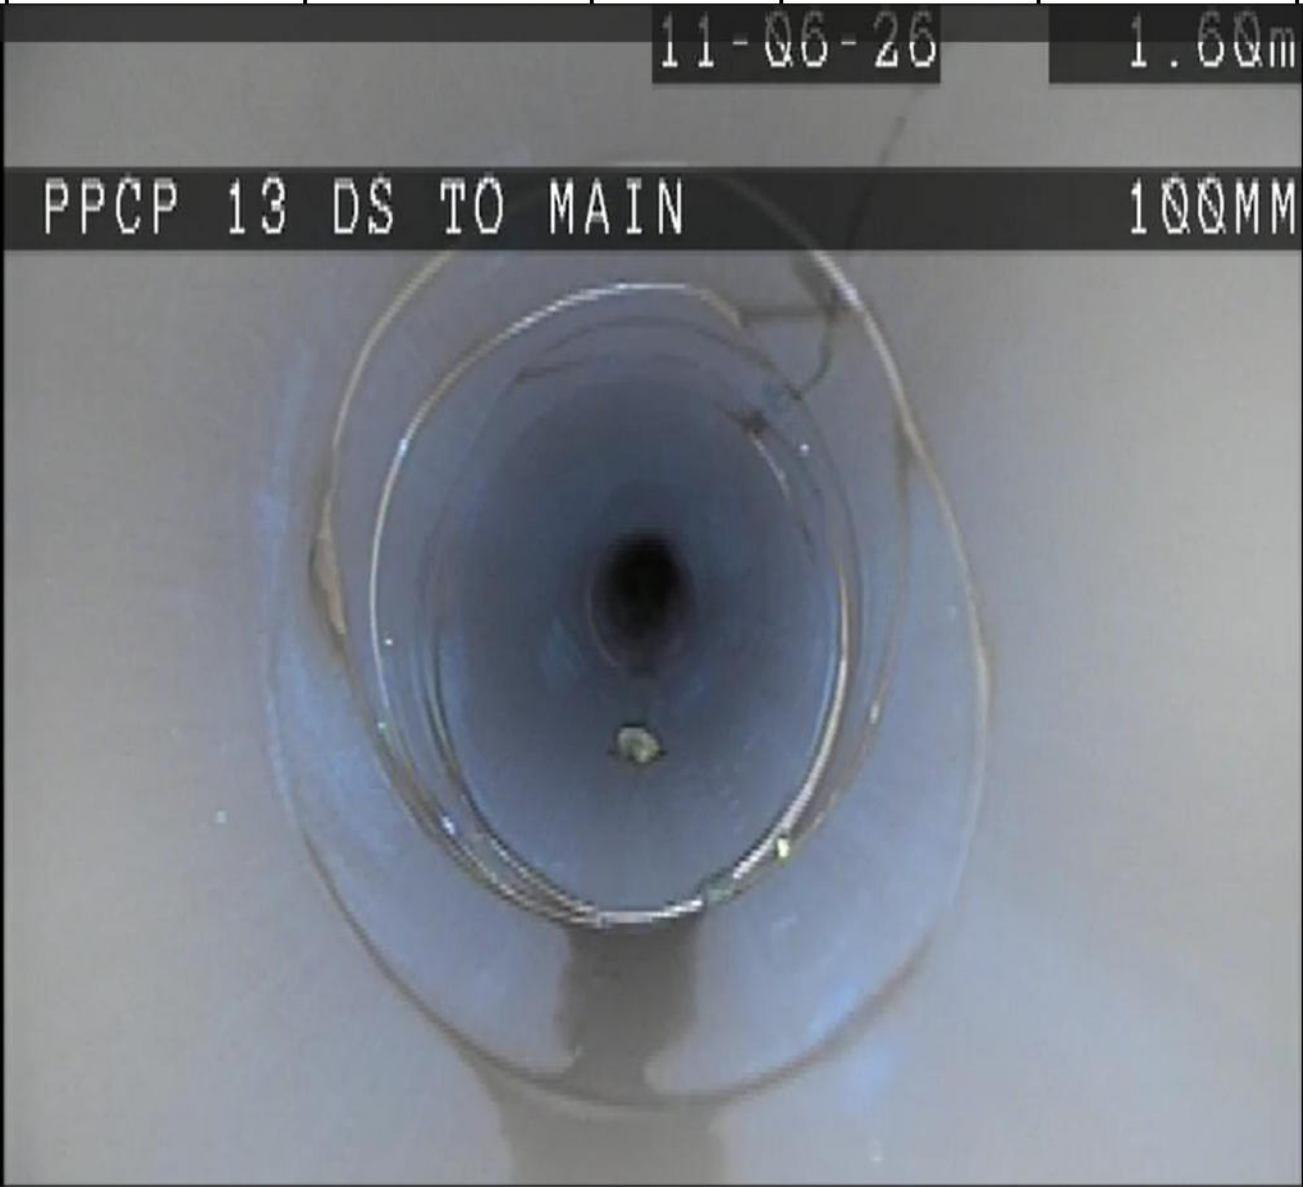
MULTIPLE CRACKS IN PIPE
