**Paul Grinyer Associates Ltd**

## Structural Engineering Report

**36 South Terrace, Littlehampton, BN17 5NU:** Report on condition of external fire escape staircase and landings.

**Ref:** 21113

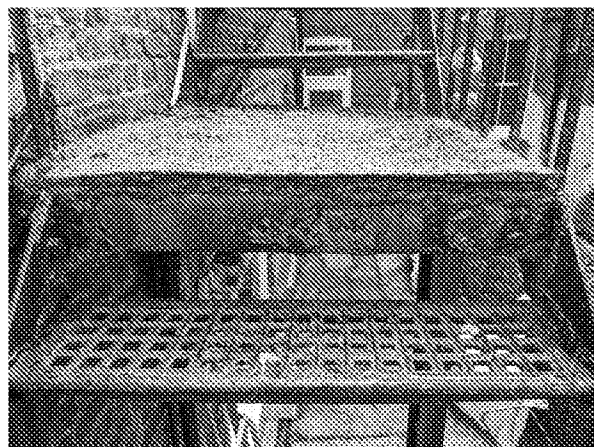
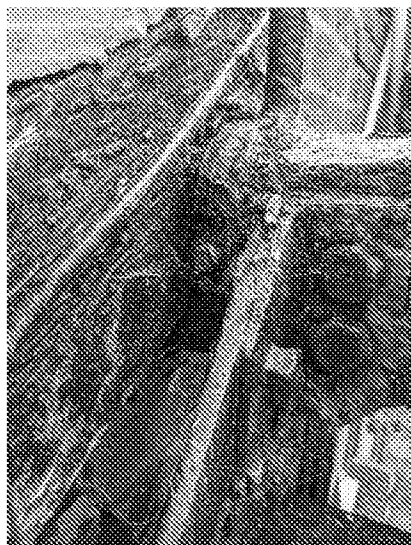
| | First floor landing | Evidence of significant structural defects noted to the landing structure. Surface corrosion, delamination and distortion to the landing floor plate noted. Significant corrosion to the angle section elements forming the framing to the landing, beneath the floor plate. Corrosion to the bolted connections. Corrosion and delamination to the angle sections embedded in the solid brick external wall of the main building, causing cracking and damage to the brickwork. Corrosion noted to the balustrade infill and their bolted connections. | 10 to 14 |

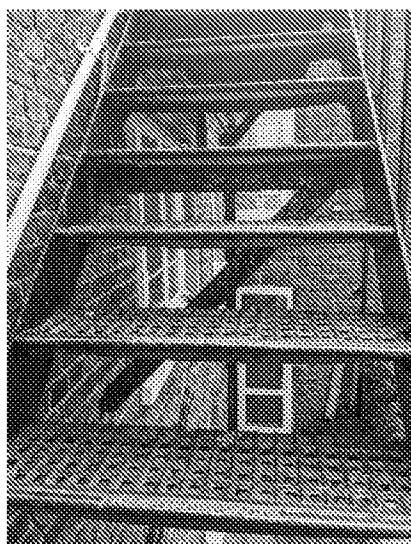
| First to second floor | Cantilevered gallows bracket | Significant corrosion noted to the angle sections forming the triangular gallows brackets and their connections, together with corrosion where embedded in to the external wall of the main building. | 15 to 20 |

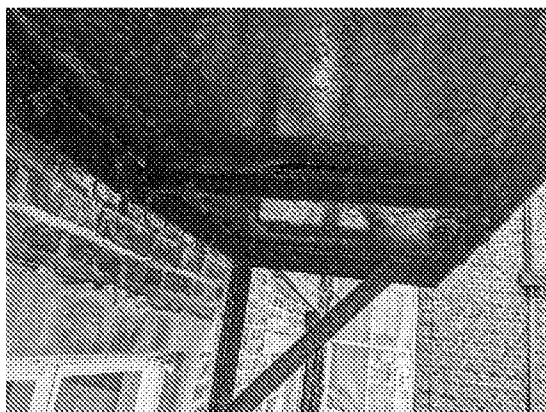
| | Landing | Evidence of significant structural defects noted to the landing structure. Surface corrosion and distortion to the landing floor plate noted, which appeared a more modern element than the rest of the structure, possibly installed to replace a defective landing floor in the past. Significant corrosion to the angle section elements forming the framing to the landing, beneath the floor plate. Corrosion to the bolted connections. Corrosion and delamination to the angle sections embedded in the solid brick external wall of the main building, causing cracking and damage to the brickwork. Corrosion noted to the balustrade infill and their bolted connections. The gallows bracket to the end of the landing appeared to be pulling out of the wall and had caused cracking in that location. | 24 to 30 |
