# **Stage 1 Road Safety Audit Report (Feasibility)**

**Littlehampton S38 highway Works  
(Phase 5)  
Proposed new residential  
development**

**Produced for:  
Persimmon Homes**

**Date: 14<sup>th</sup> March 2021**

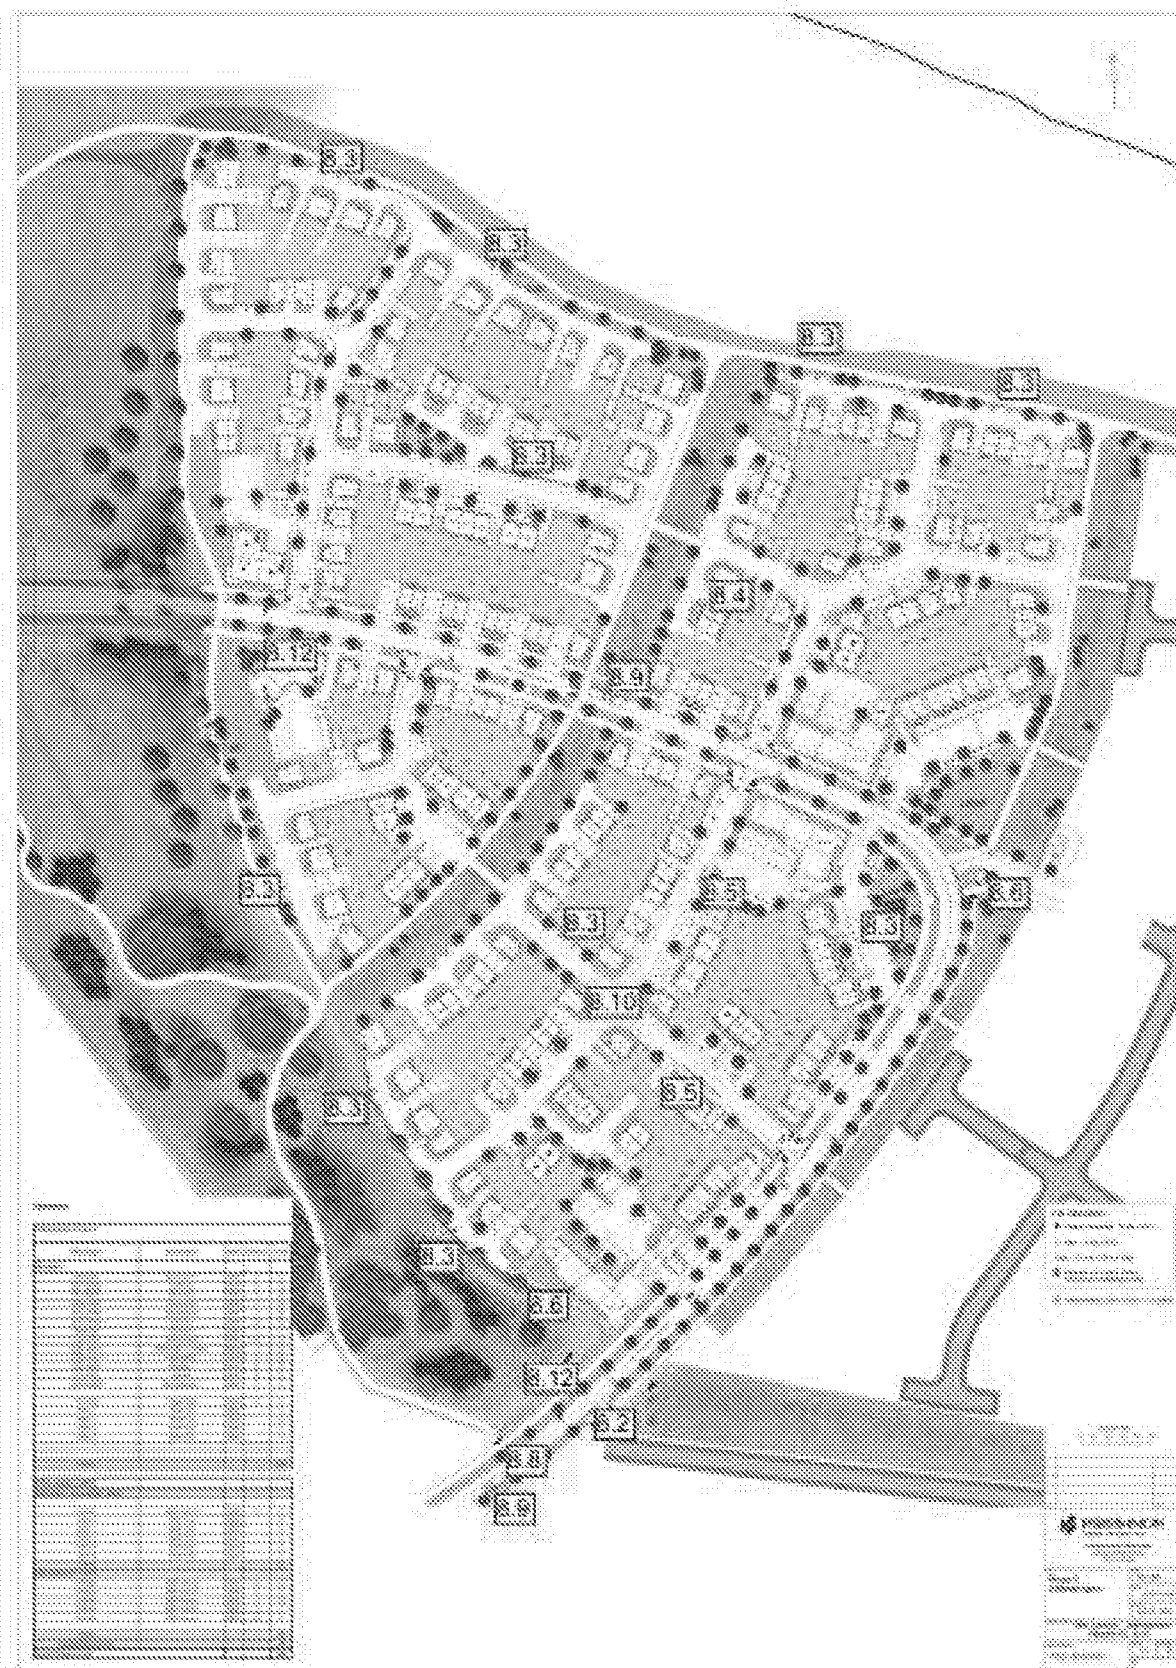
### 13. Identified Road Safety Audit Matters location plan

Identified locations of Road Safety Audit Matters are indicated on drawings within **Appendix A** to the rear of this report.
