# **Stage 1 Road Safety Audit Report (Feasibility)**

**Littlehampton S38 highway Works  
(Phase 5)  
Proposed new residential  
development**

**Produced for:  
Persimmon Homes**

**Date: 14<sup>th</sup> March 2021**

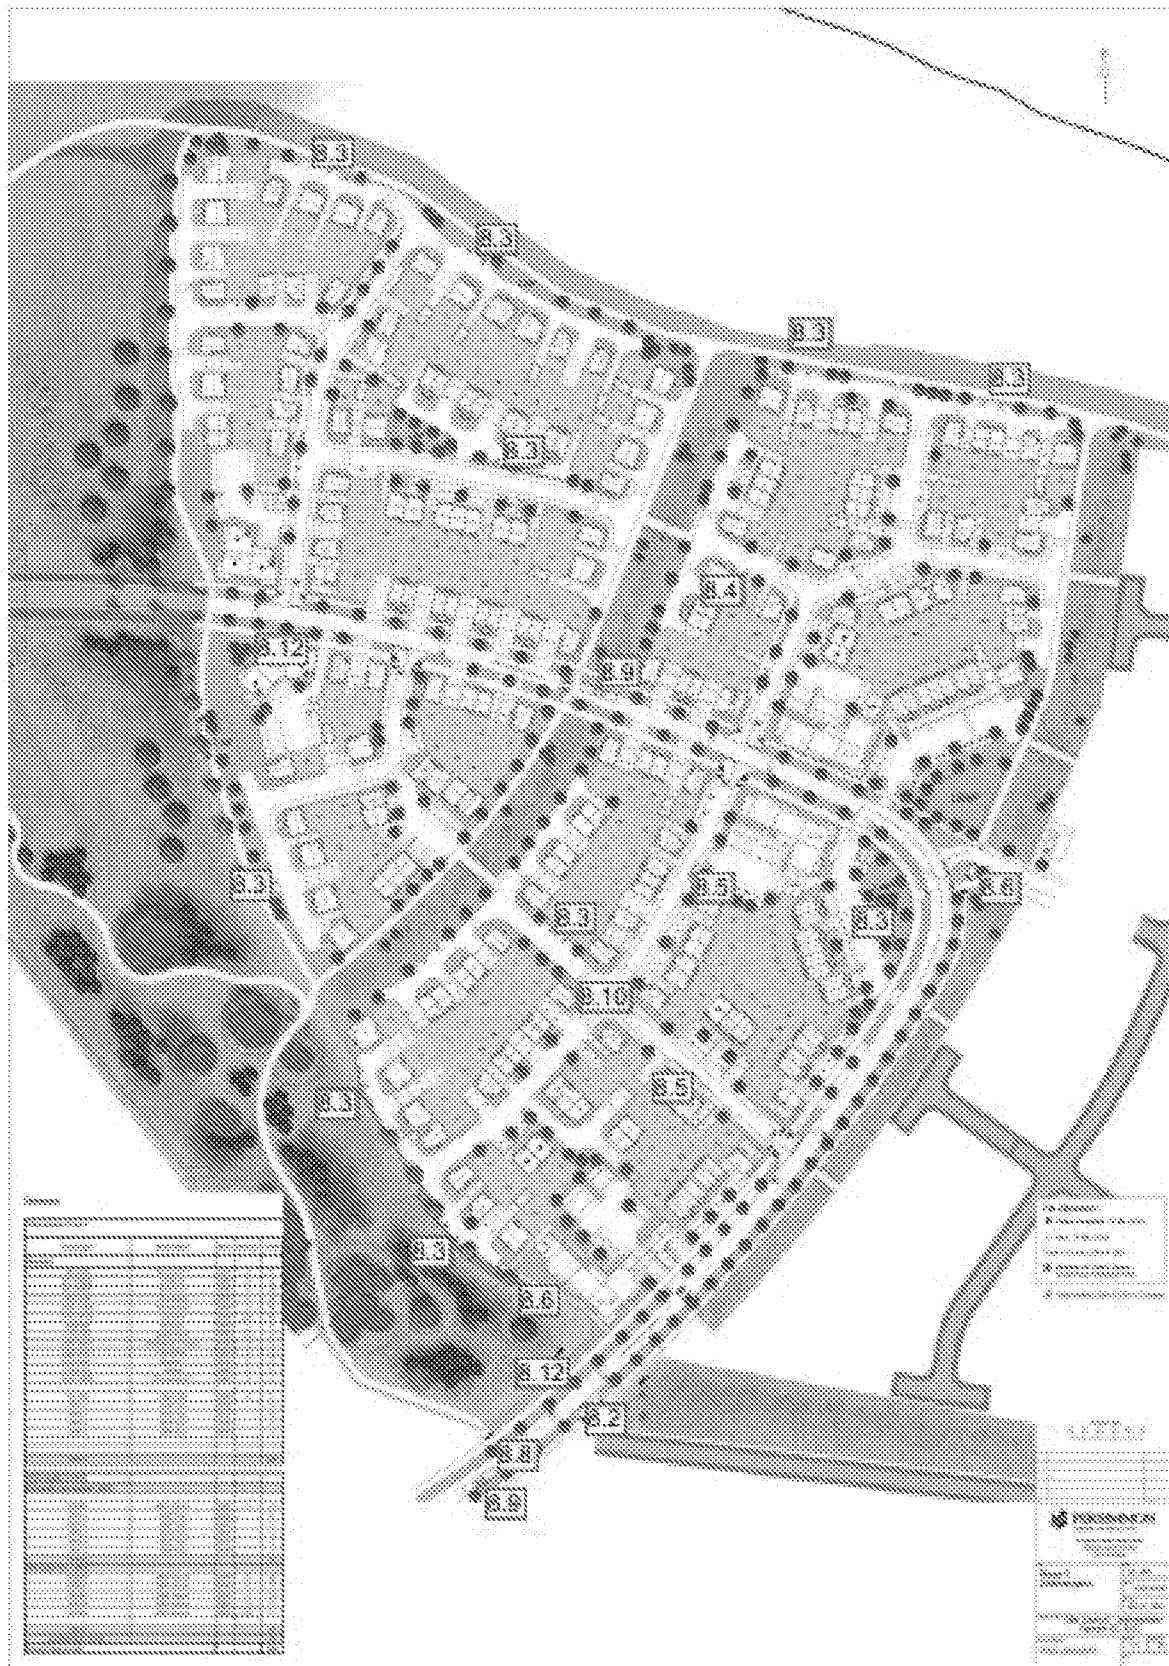
13. Identified Road Safety Audit Matters location plan

Identified locations of Road Safety Audit Matters are indicated on drawings within **Appendix A** to the rear of this report.
