asbestos survey : sample analysis

## Pre Demolition Survey

Site: 46A-47 Pier Road, Littlehampton, West Sussex, BN17 5LW  
Client: TL Homes  
Report No: J017095  
Survey Date: 12th October 2020  
Report Date: 12th October 2020  
Surveyors: Michael Hayward  
Report Produced By: Report Authorised By:

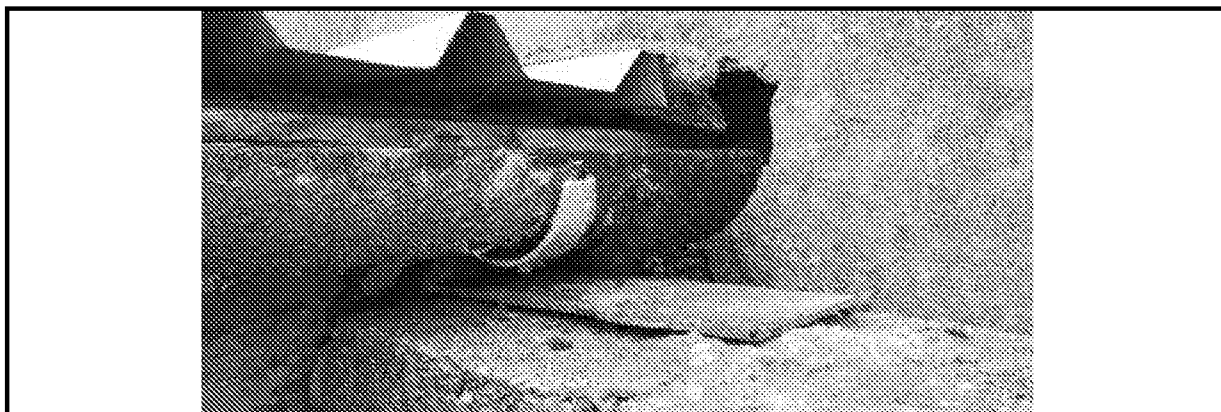
| Risk Category: | D |

| Recommended Action: | Low risk ACM (bound in matrix) remove, repair or encapsulate under controlled conditions. Work on this material does not require a license. Work on this material may be notifiable to the appropriate enforcing authority. Disposal of asbestos waste by a licensed contractor only. All work must conform to the 'Control of Asbestos Regulations 2012'. |

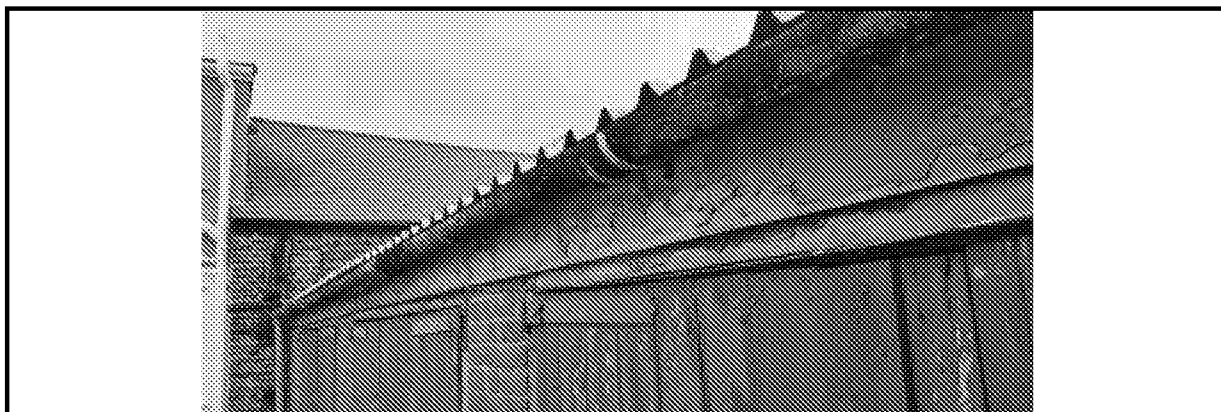
| Risk Category: | D |

| Recommended Action: | Low risk ACM (bound in matrix) remove, repair or encapsulate under controlled conditions. Work on this material does not require a license. Work on this material may be notifiable to the appropriate enforcing authority. Disposal of asbestos waste by a licensed contractor only. All work must conform to the 'Control of Asbestos Regulations 2012'. |

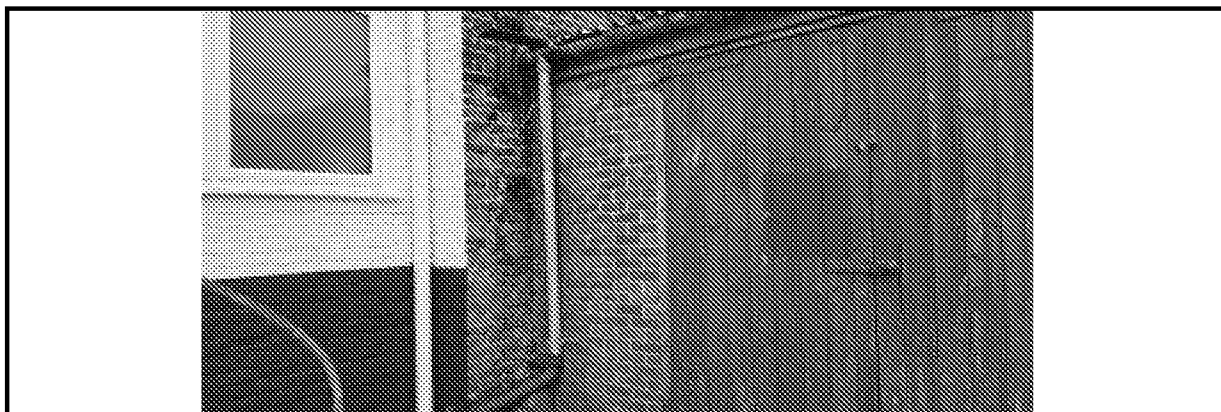
| Risk Category: | D |

| Recommended Action: | Low risk ACM (bound in matrix) remove, repair or encapsulate under controlled conditions. Work on this material does not require a license. Work on this material may be notifiable to the appropriate enforcing authority. Disposal of asbestos waste by a licensed contractor only. All work must conform to the 'Control of Asbestos Regulations 2012'. |

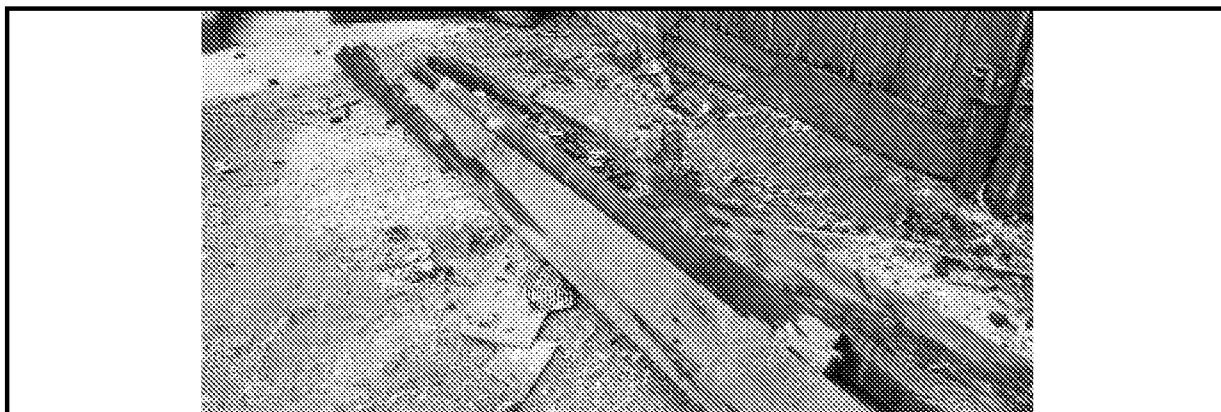
| Risk Category: | C |

| Recommended Action: | Low risk ACM (bound in matrix) remove, repair or encapsulate under controlled conditions. Work on this material does not require a license. Work on this material may be notifiable to the appropriate enforcing authority. Disposal of asbestos waste by a licensed contractor only. All work must conform to the 'Control of Asbestos Regulations 2012'. |

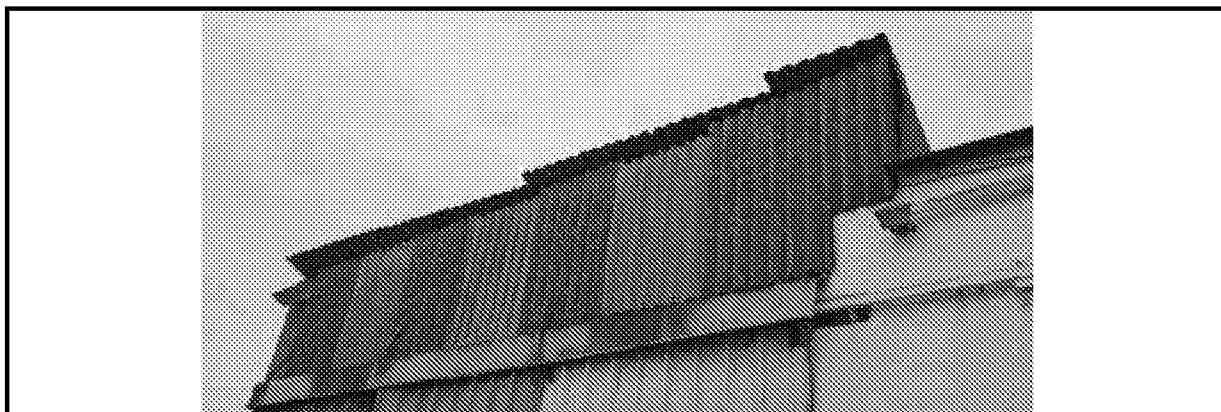
| Risk Category: | D |

| Recommended Action: | Low risk ACM (bound in matrix) remove, repair or encapsulate under controlled conditions. Work on this material does not require a license. Work on this material may be notifiable to the appropriate enforcing authority. Disposal of asbestos waste by a licensed contractor only. All work must conform to the 'Control of Asbestos Regulations 2012'. |

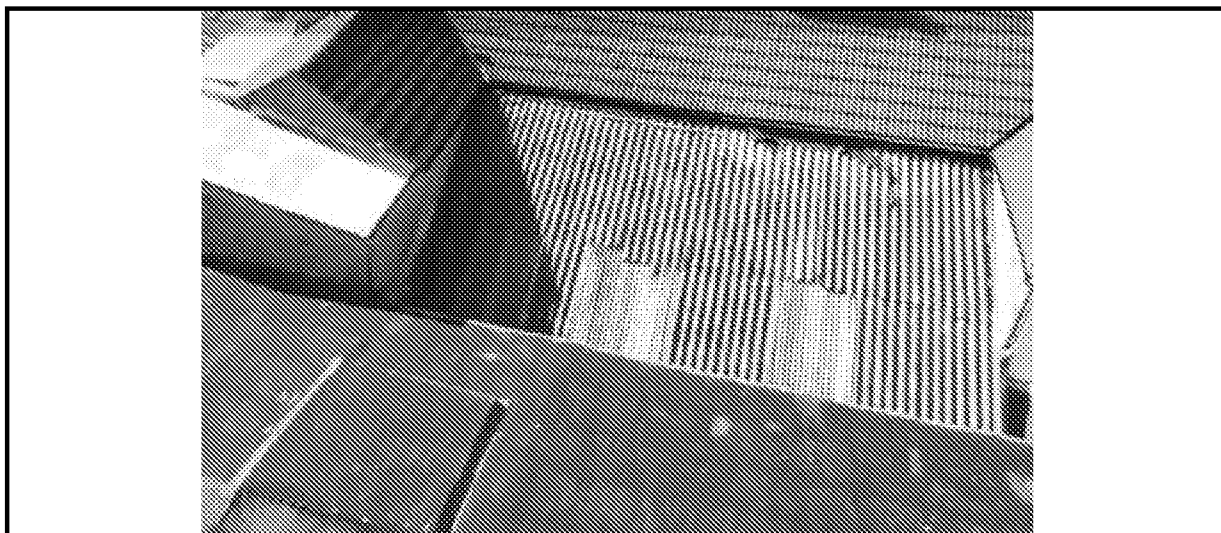
| Risk Category: | D |

| Recommended Action: | Low risk ACM (bound in matrix) remove, repair or encapsulate under controlled conditions. Work on this material does not require a license. Work on this material may be notifiable to the appropriate enforcing authority. Disposal of asbestos waste by a licensed contractor only. All work must conform to the 'Control of Asbestos Regulations 2012'. |

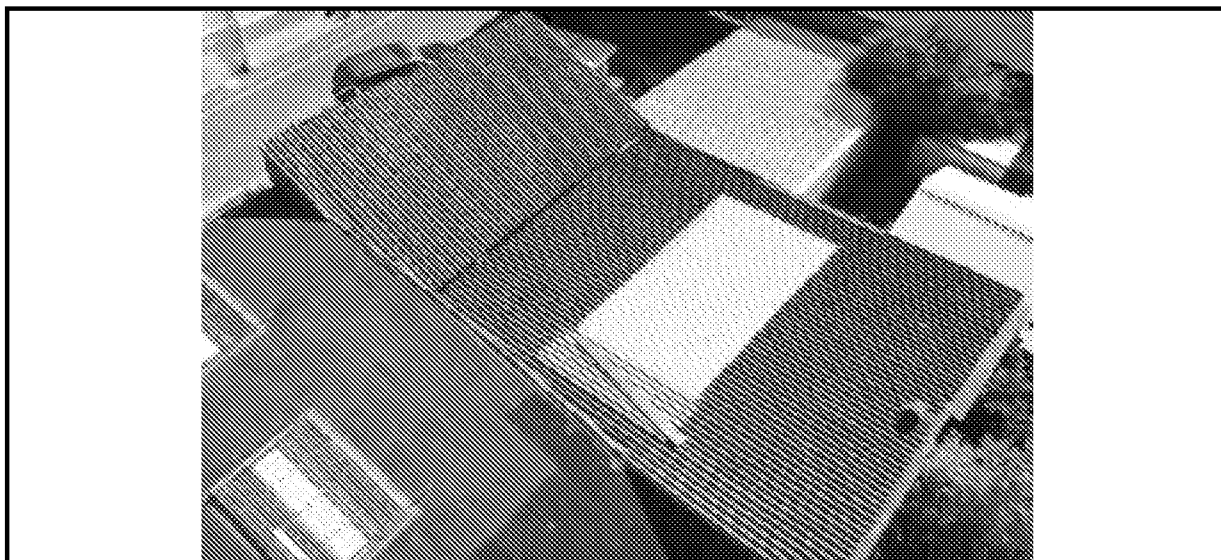
| Risk Category: | D |

| Recommended Action: | Low risk ACM (bound in matrix) remove, repair or encapsulate under controlled conditions. Work on this material does not require a license. Work on this material may be notifiable to the appropriate enforcing authority. Disposal of asbestos waste by a licensed contractor only. All work must conform to the 'Control of Asbestos Regulations 2012'. |

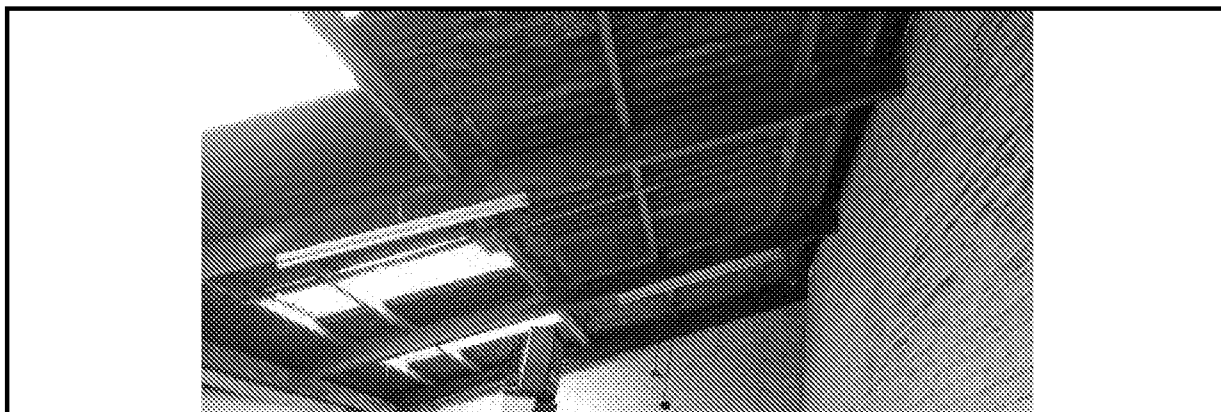
| Risk Category: | D |

| Recommended Action: | Low risk ACM (bound in matrix) remove, repair or encapsulate under controlled conditions. Work on this material does not require a license. Work on this material may be notifiable to the appropriate enforcing authority. Disposal of asbestos waste by a licensed contractor only. All work must conform to the 'Control of Asbestos Regulations 2012'. |

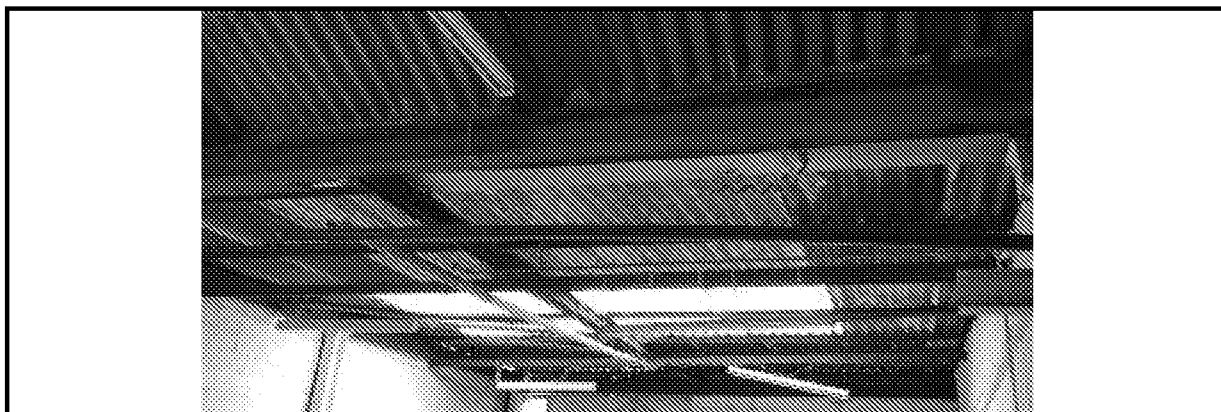
| Risk Category: | D |

| Recommended Action: | Low risk ACM (bound in matrix) remove, repair or encapsulate under controlled conditions. Work on this material does not require a license. Work on this material may be notifiable to the appropriate enforcing authority. Disposal of asbestos waste by a licensed contractor only. All work must conform to the 'Control of Asbestos Regulations 2012'. |
