# ALL HOURS PLUMBING

Project Name:  
**468 Plots 88-78**

Inspection Report

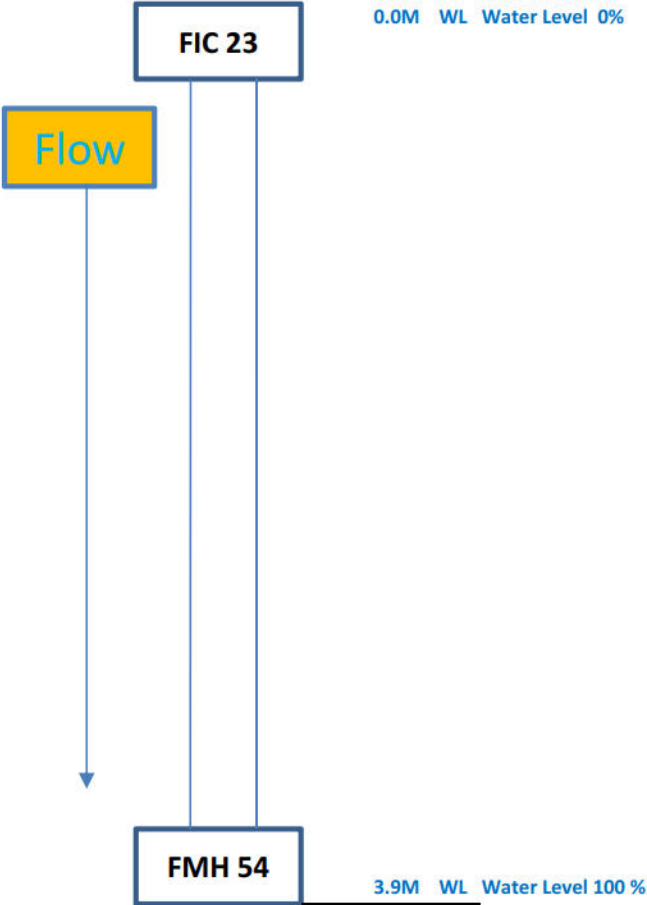
REM; THERE ARE NO MAJOR DEFECTS WITH THIS SECTION OF PIPE BUT THE MAINLINE IS RUNNING HIGH SO THERE IS WATER LAYING IN THE PIPE

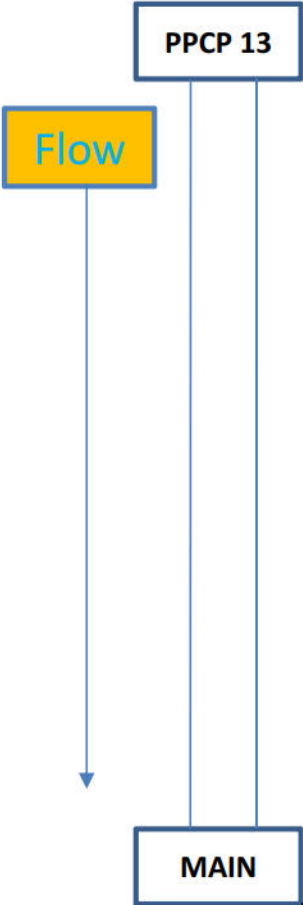
1.6M PC Pipe Changes To Clay  
1.8M MC Multiple Cracks In Pipe

REM; THERE ARE MULTIPLE CRACKS IN THE PIPE AT 1.8 METRES WHICH CAN BE PATCH REPAIRED

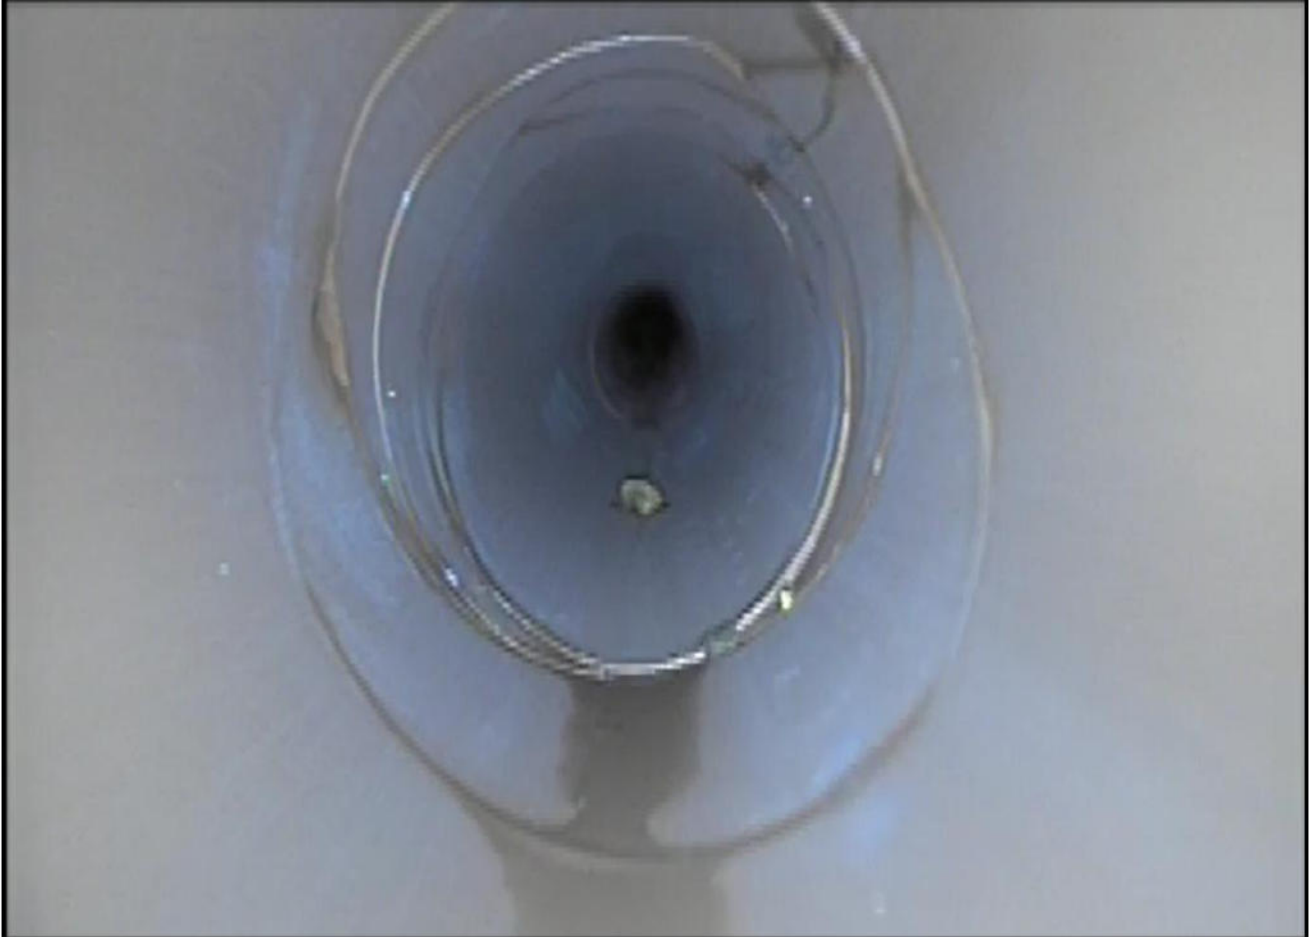
PPCP 13 DS TO MAIN

MULTIPLE CRACKS IN PIPE
