**12 River Road**  
**Littlehampton**  
**West Sussex**

**Existing Floor Plans**

| <b>19072</b> | <b>01</b> | <b>-</b> |

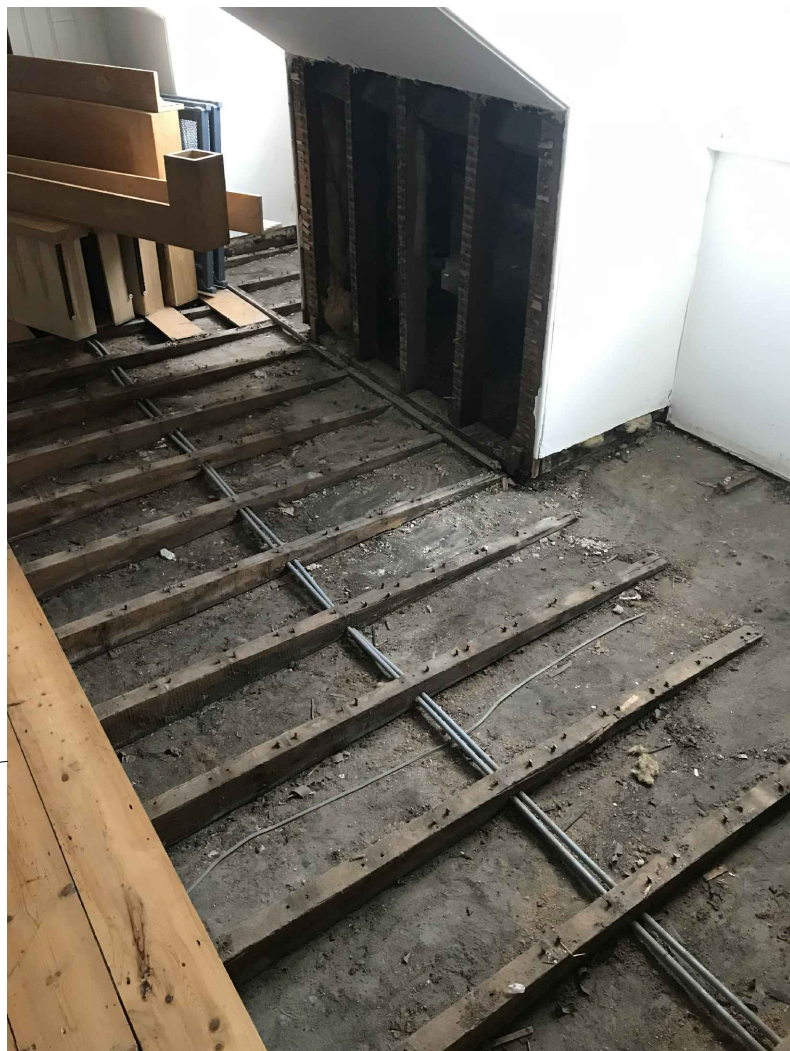
**Photograph 1**  
(Showing possible firings over original joists)

It appeared that the original roof of the property may have fallen towards the rear. The joists visible in the loft space appeared to be firings to provide a level attic floor at a later date **THIS HAS NOT BEEN CONFIRMED!**

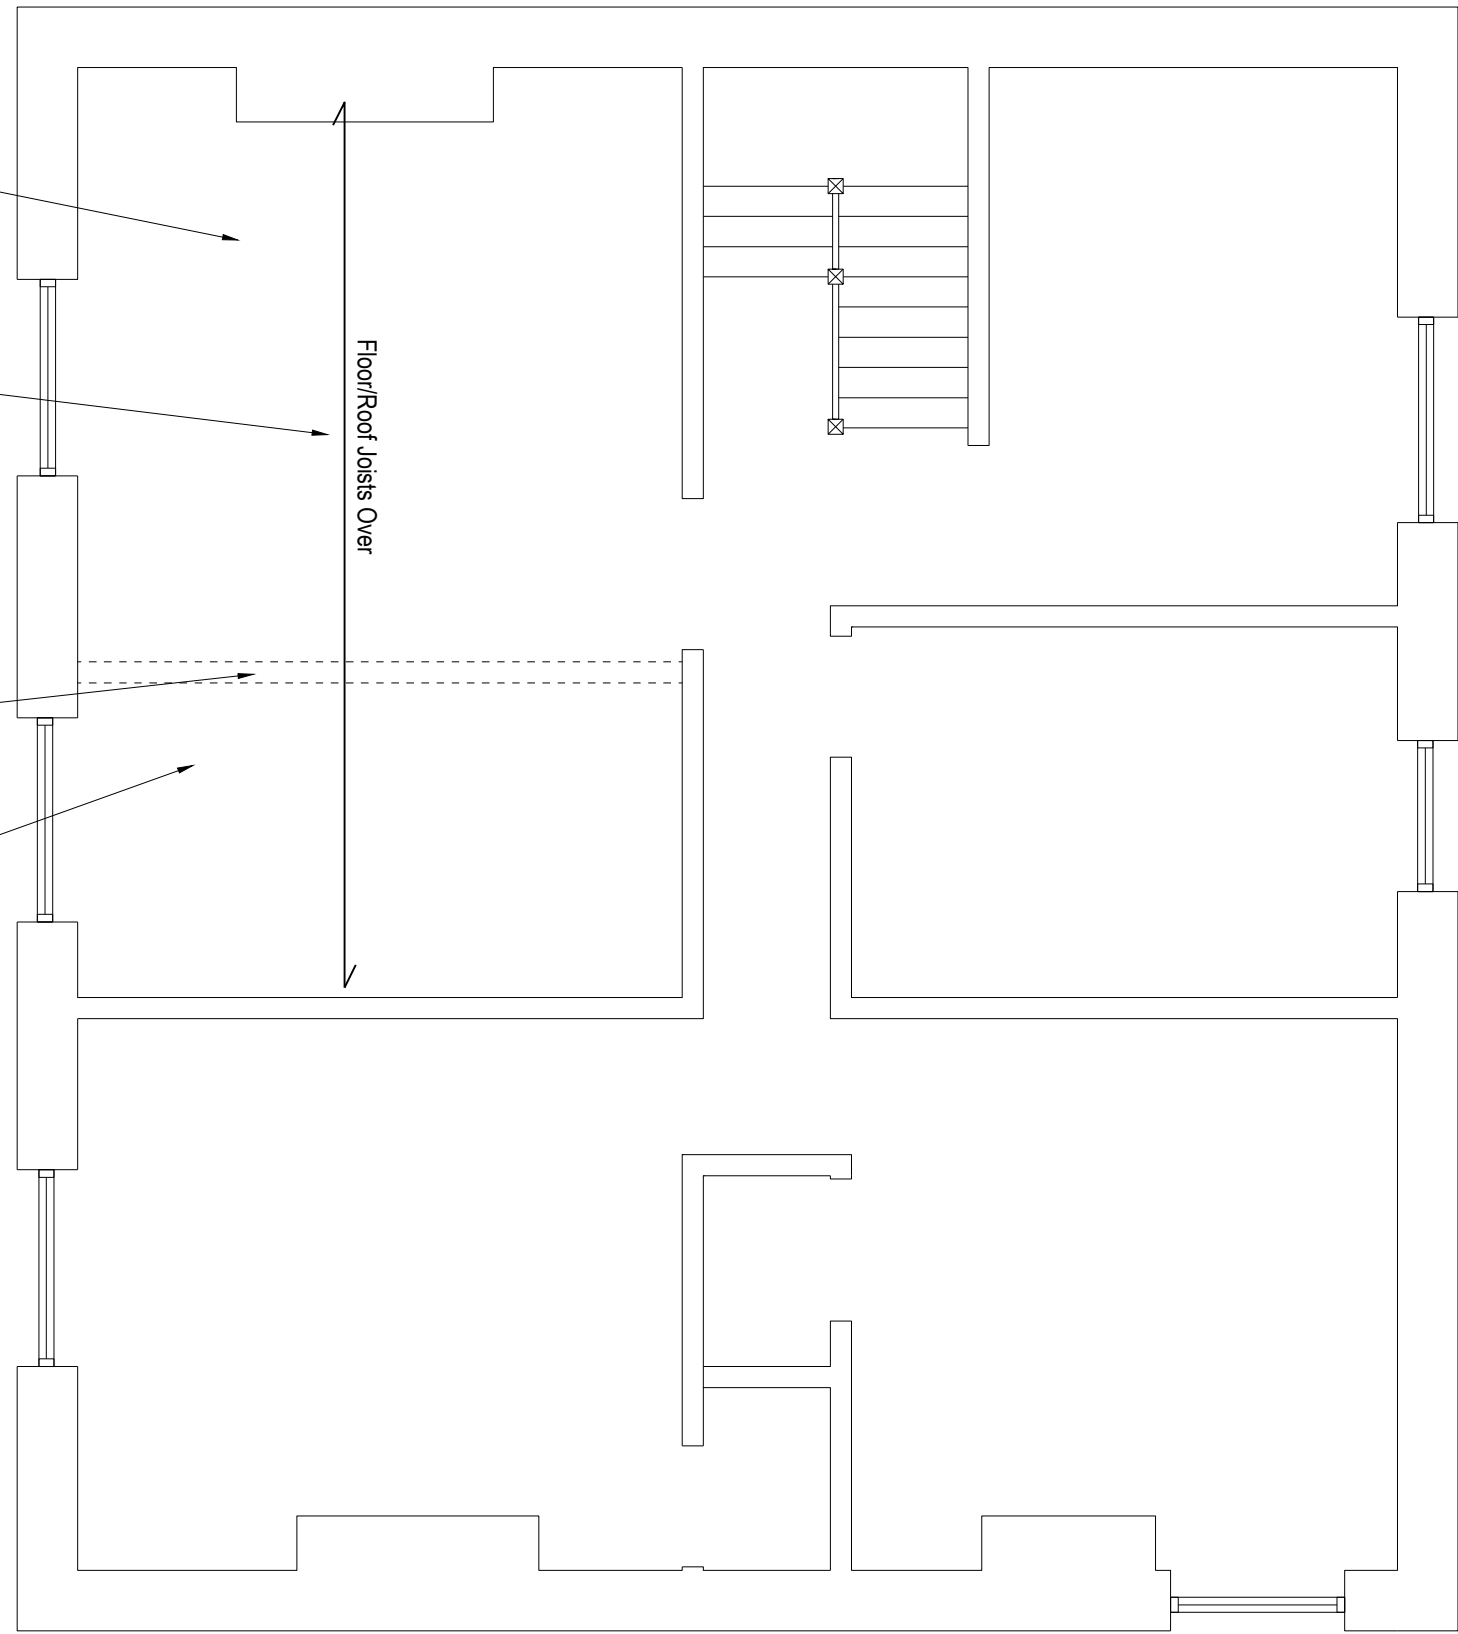
**Existing First Floor Plan.**  
(Showing current layout - from planning records)  
(1:50)

The Contractor has advised that the joists over Sitting Room spanned in the direction shown. The Contractor advised that the joists were in a single length across top of wall. **Joists were hidden and not visible at time of inspection. It has not been confirmed that this is correct!**

Dotted line indicates approximate position of studwork wall removed by others in 2017/2018. Wall was considered to be non-load bearing by others.

The Contractor has advised that cracking appeared in the attic upon removal of the wall and that gaps appeared between the skirting boards to the dormers and the knee walls and the floor boards, suggesting that the structure had dropped. This has not been independently verified. The purpose of the works is to resupport the attic floor joists and original roof elements along the line of the wall to prevent further movement occurring.
