Inspection Report

| Site ; 468<br>Place ; LITTLEHAMPTON | | Division:<br>District:<br>Tape No: 1 | | Start MH: PPCP 30<br>End MH: LAT 1<br>Total Length: | |

## 468 Littlehampton - Defects

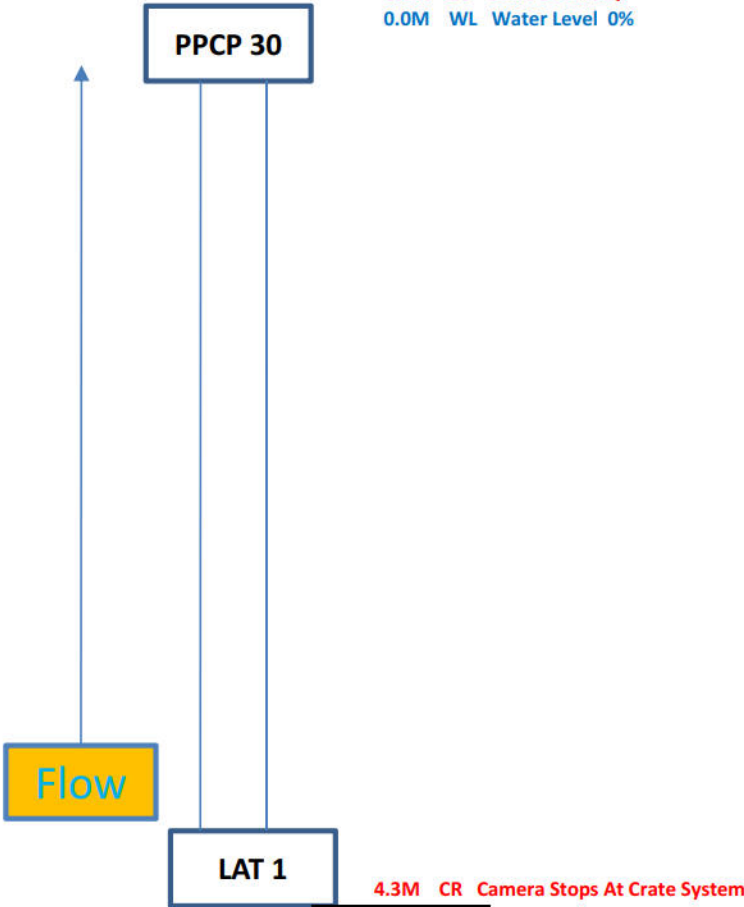
REM; THERE ARE NO MAJOR DEFECTS WITH THIS SECTION OF PIPE

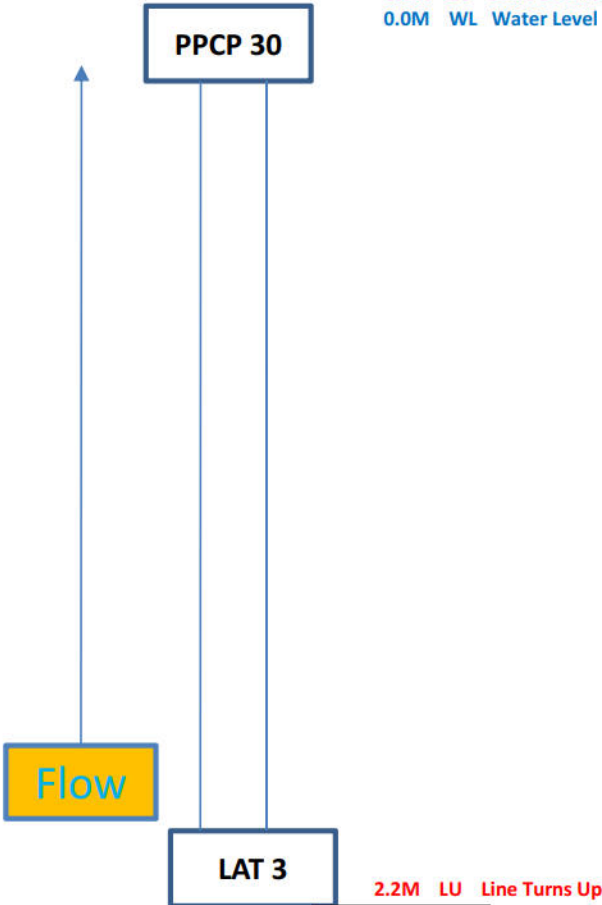
REM; THERE ARE NO MAJOR DEFECTS WITH THIS SECTION OF PIPE

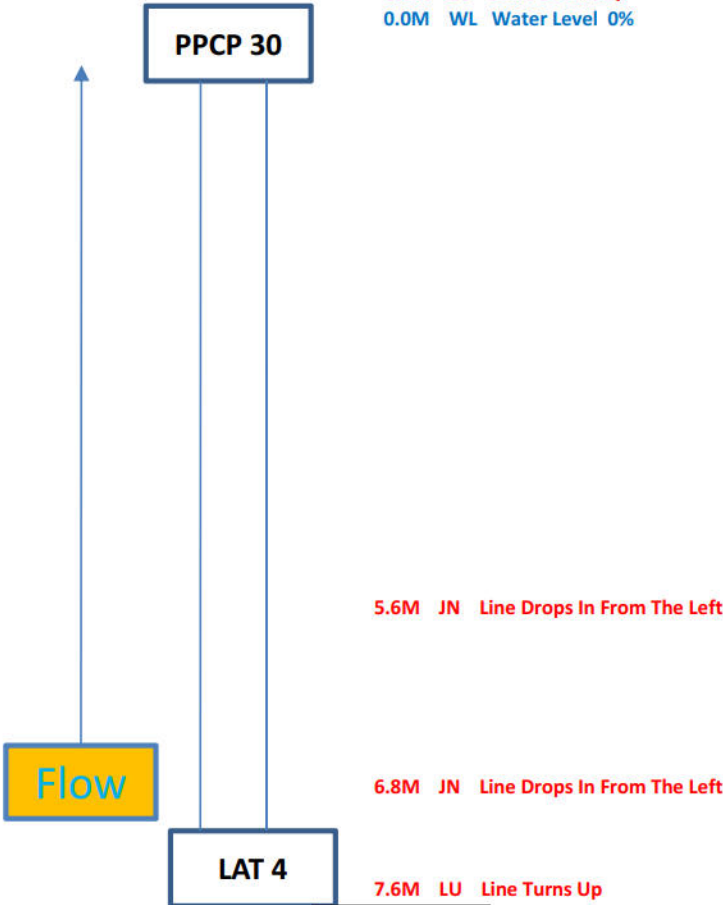
REM; THERE ARE NO MAJOR DEFECTS WITH THIS SECTION OF PIPE

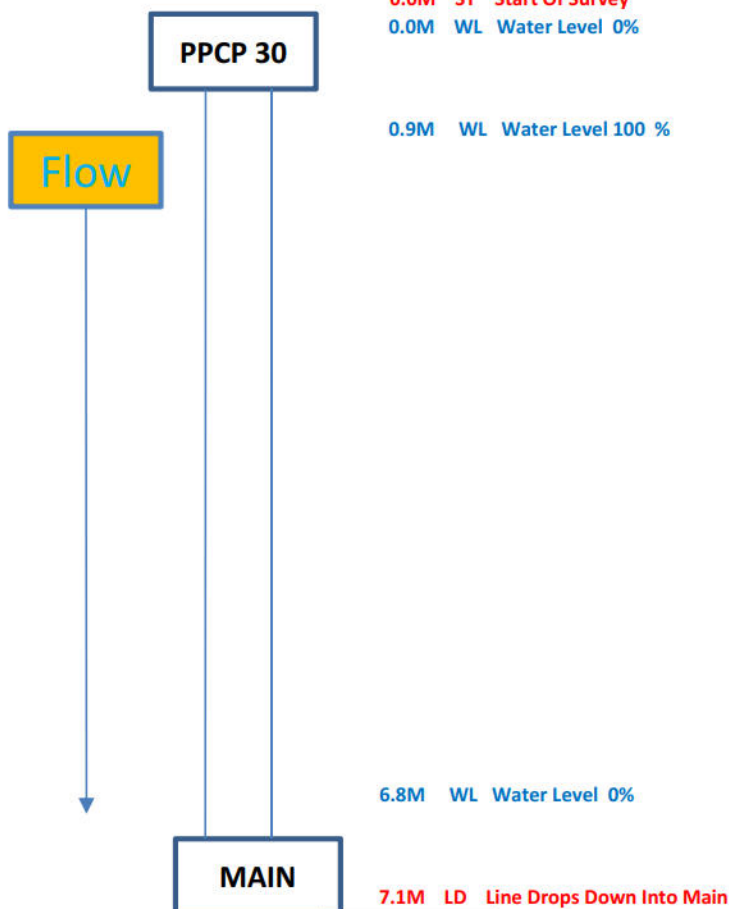
REM; THERE IS AN UNDERROLL IN THIS SECTION OF PIPE

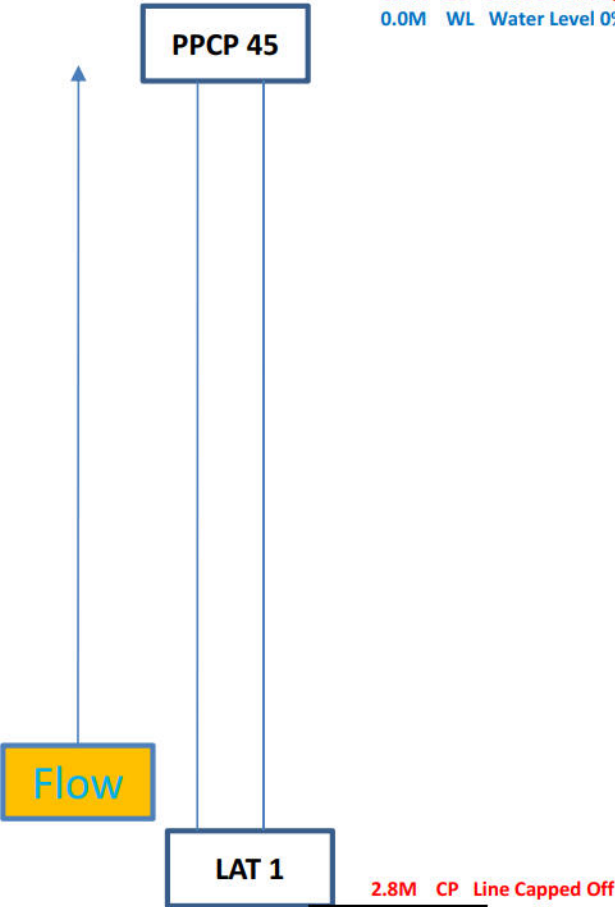
REM; THIS SECTION IS CAPPED OFF AND NOT CONNECTED TO CRATE SYSTEM

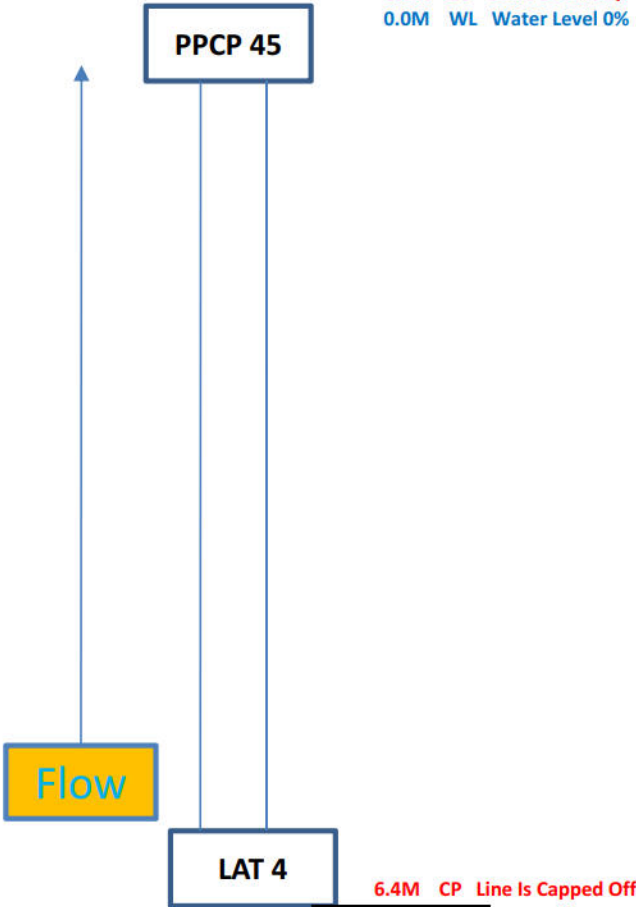
REM; THIS SECTION HAS NOT BEEN CONNECTED TO THE CRATE SYSTEM
