## Post Installation Report

Proludic Ltd

Hampton Park - Littlehampton

Inspection Ref: 1339409

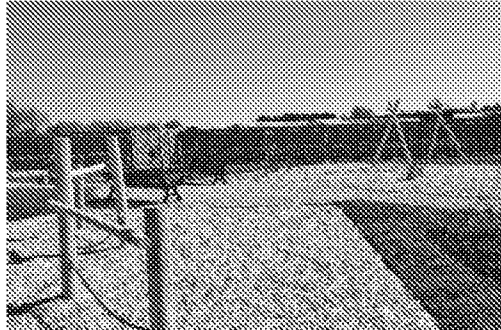
| 8 - Low Risk | |
|---|---|
| <b>Item:</b> | Site General |

| Finding 1 | Finding 2 |
|---|---|
| The pathway was unfinished at the time of inspection and there are a number of holes in the surface creating trip hazards - Complete installation of pathway | NOTE - this report has been updated on the 7th July 2021 based on an image and written confirmation of works provided by the contractor after the inspection took place - |

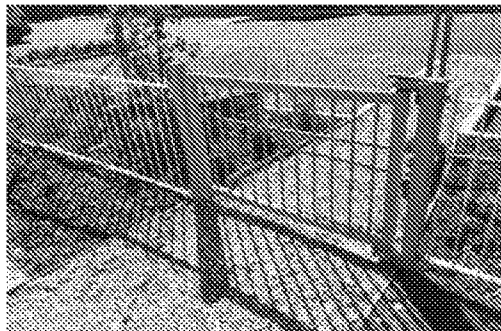
| 4 - Very Low Risk | |
|---|---|
| <b>Item:</b> | Gate - Self Closing |

| Finding 1 |
|---|
| This item is satisfactory - no work required - |

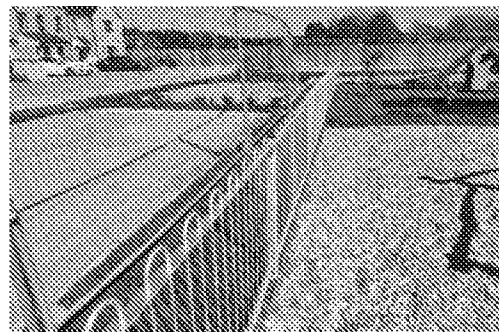
This item is satisfactory - no work required -

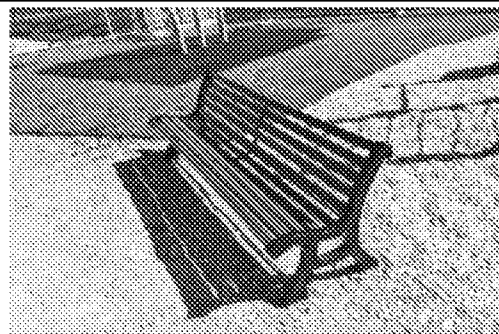
This item is satisfactory - no work required -

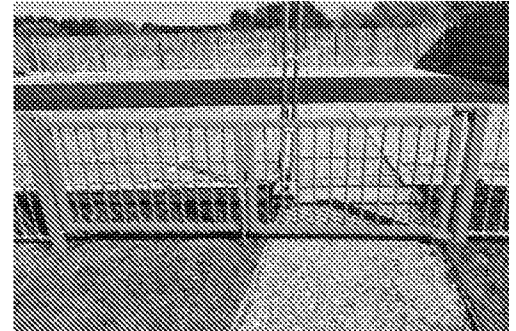
**Item:** Gate - Combination  
**Manufacturer:** Mono Gate Ltd  
**Surface Type:** Crushed Stone  
**Item Quantity:** 1  
**Equipment Compliance:** N/A  
**Surface Area Compliance:** N/A

There is no padlock on the maintenance gate - Provide a padlock to secure the gate

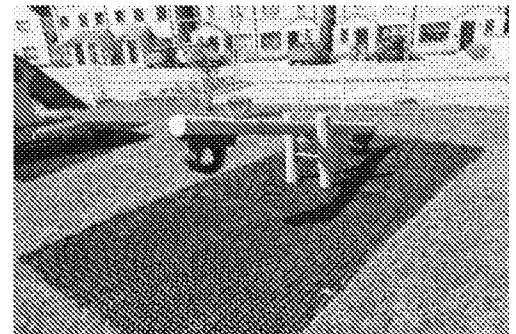
This item is satisfactory - no work required -

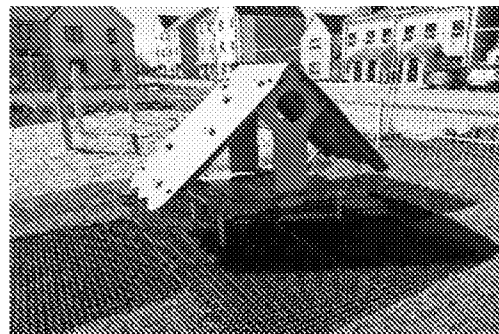
**Item:** Playhouse  
**Manufacturer:** Proludic  
**Surface Type:** Grass Matrix Tiles  
**Item Quantity:** 1  
**Equipment Compliance:** No  
**Surface Area Compliance:** Yes

The adjacent foliage forms a hard sharp object within the falling space of the equipment in contravention of the requirements of BS EN 1176 Part 1 - Refer to the contractor / designer

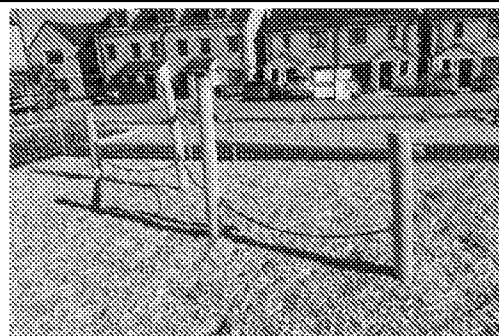
This item is satisfactory - no work required -

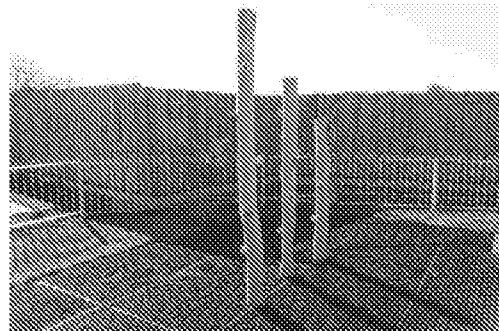
This item is satisfactory - no work required -

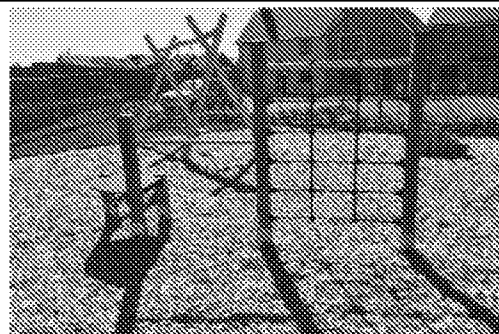
This item is satisfactory - no work required -

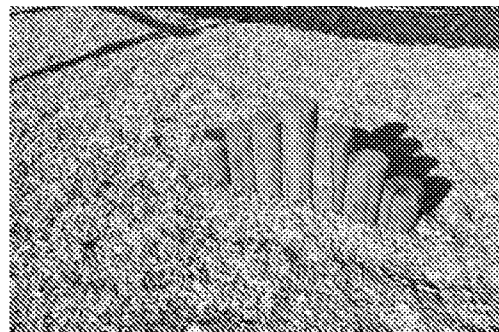
This item is satisfactory - no work required -

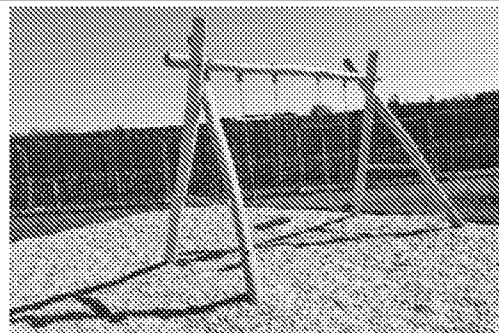
This item is satisfactory - no work required -

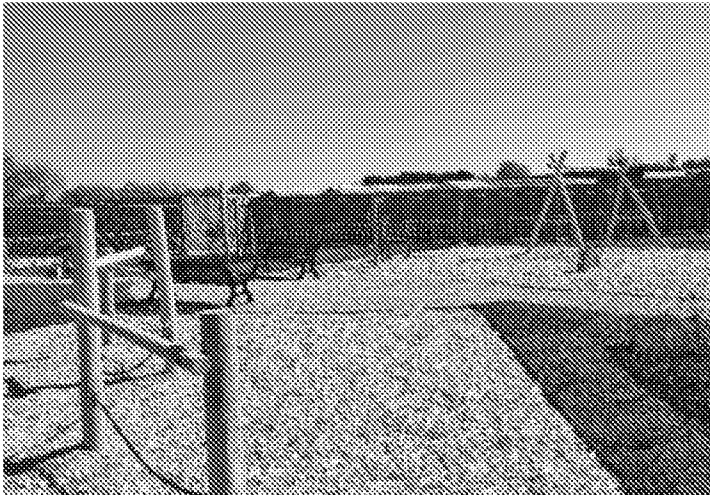
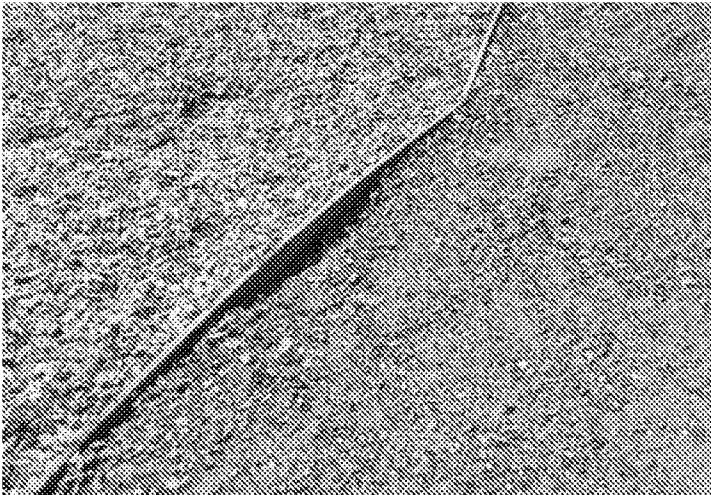
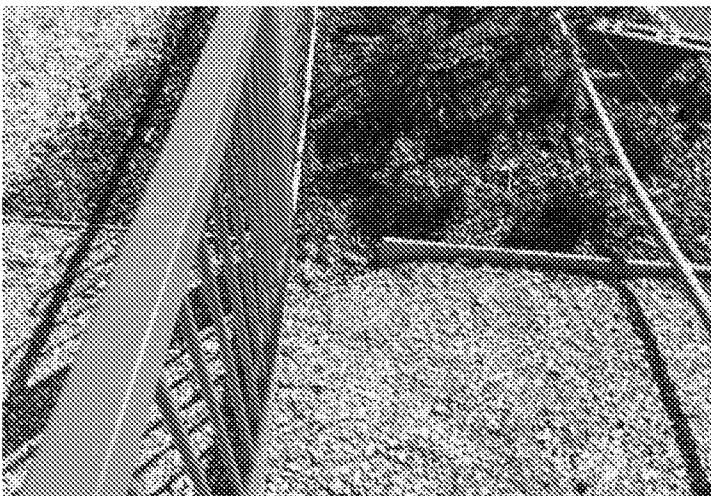
| 3 - Low Risk (Finding 1) | | | |
|---|---|---|---|
| <b>Item:</b> | Ancillary Items - Site General | <b>Risk Level:</b> | L - Low Risk |

| 3 - Low Risk (Finding 1) | | | |
|---|---|---|---|
| <b>Finding:</b> The pathway was unfinished at the time of inspection and there are a number of holes in the surface creating trip hazards | | <b>Action:</b> Complete installation of pathway | |

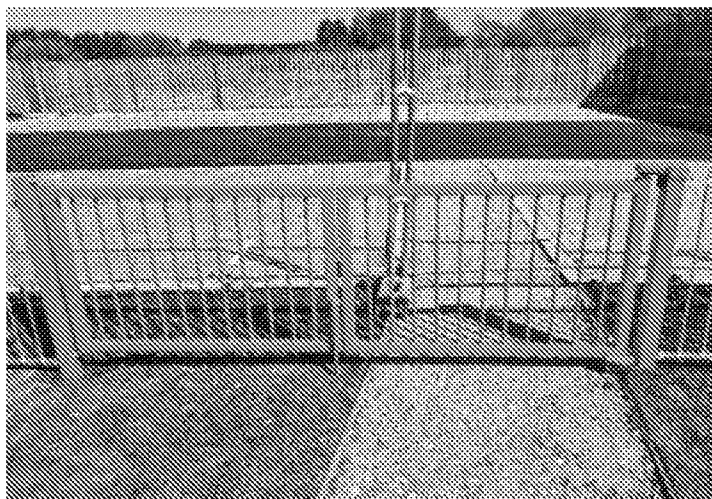
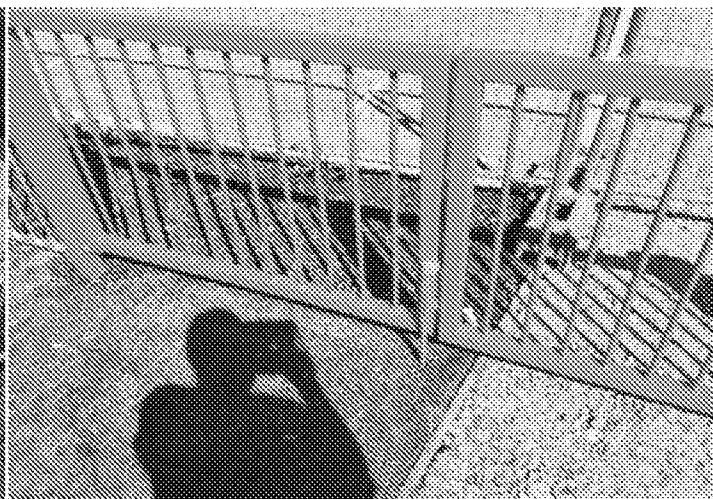
**Item:** Gates - Gate - Combination  
**Manufacturer:** Mono Gate Ltd

**Finding:** There is no padlock on the maintenance gate

**Action:** Provide a padlock to secure the gate
