**ENVIRONMENTAL IMPROVEMENT (REMEDIATION) WORKS AT THE FORMER GASHOLDER STATION, HARWOOD ROAD, LITTLEHAMPTON BN17 7AU**

Following the receipt of comments from Environmental Health and the Environment Agency relating to *Condition 3 – Verification Report*, please find below Worley Consulting responses.

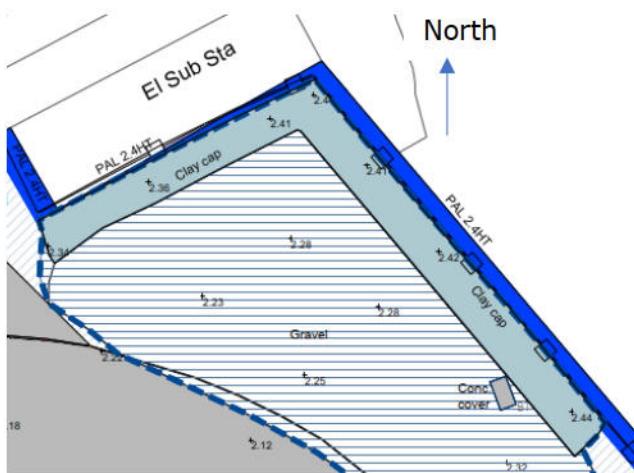
*Clarification is required regarding the clay cut off wall. The approved remediation strategy specifies installation along the north and west boundaries of Area C, whereas the Verification Report records installation along the north and east boundaries. This may be clerical error, but confirmation is required as to which is correct.*

The clay cut-off wall was installed along the northern extent of Area C, extending along both the northwestern and northeastern boundaries, as shown in the verification drawing below. The wall was installed in accordance with the approved design and remediation strategy. The apparent discrepancy arises from differences in the description of the wall alignment rather than any variation from the approved design. The verification report correctly reflects the as-built installation, and no deviation from the approved remediation measures occurred.

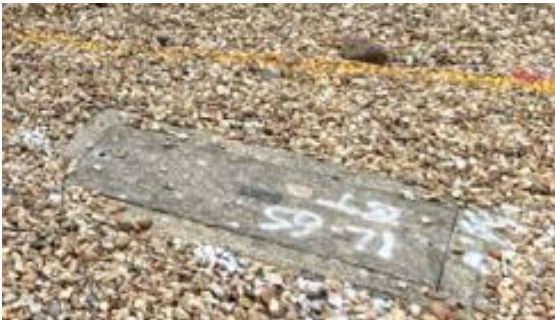
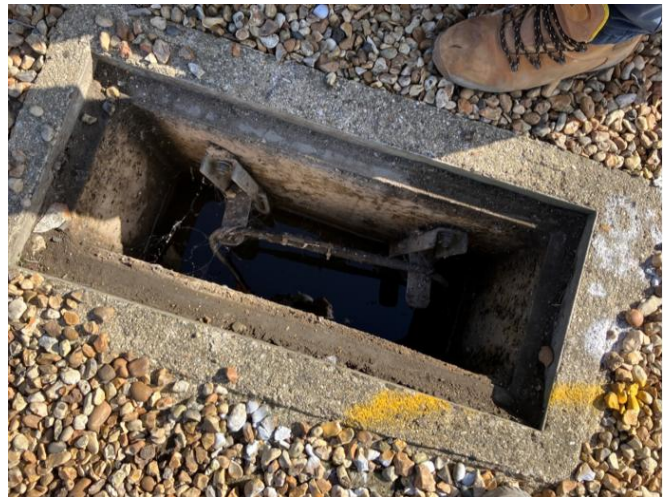
*The Verification Report records that material beneath the concrete cable housing box was retained insitu because of the presence of services. An assessment of the residual contamination risks associated with this material is required, together with confirmation that's its retention does not compromise the remediation objectives.*

The telecommunications cable box contains live services within the chamber concrete cover. The material beneath the chamber was therefore left in situ to avoid undermining or disturbing the cable box and associated services. The cable box occupies approximately 0.35% of the total Area C remediated. Consequently, the very small volume of material potentially remaining in situ does not compromise the overall remediation objectives or the effectiveness of the remedial works.

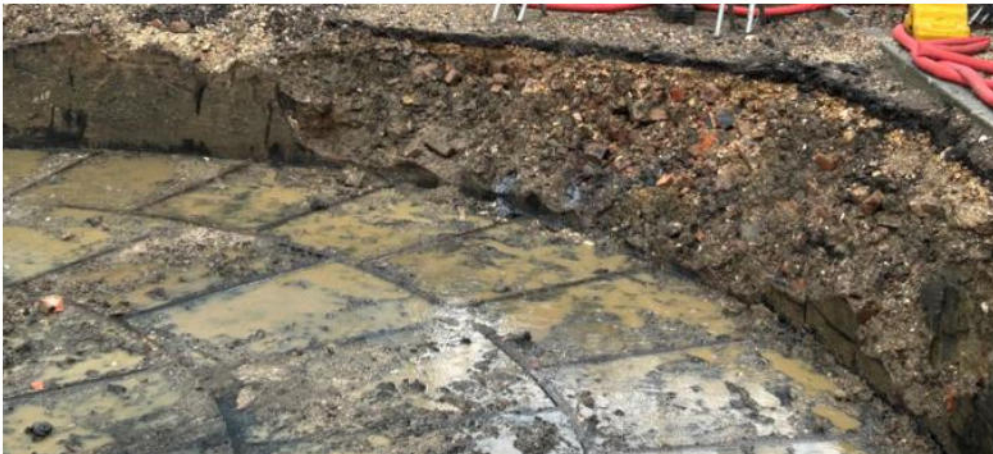
*The approved remediation strategy required all fill material within the gasholder tank to be excavated down to the base of the concrete slab, with all steel lifts removed. However, the verification report states that the steel base and tank walls were retained insitu. This discrepancy is particularly significant because pockets of tar were observed leaching through the made ground adjacent to a locally degraded section of the cast iron tank wall.*

*As above, plus.....This observation is of particular concern, as it indicates the potential presence of gross contamination associated with, or beyond, the retained gasholder structure. By retaining the former gasholder structure in situ, it has not been possible to verify the condition of material immediately outside the tank walls, nor to demonstrate whether gross contamination remains present in these areas or the extent of any such areas. Consequently, we consider this to be a significant departure from the approved remediation strategy. The available information does not provide sufficient evidence to demonstrate that contamination associated with this principal source area has been adequately characterised, removed, or rendered acceptable from a controlled waters perspective. We therefore require the applicant to provide a strategy to address this issue, and provide verification that no significant contamination remains beyond the tank walls.*

The small, limited area of tar-impacted material shown below was isolated by the placement of a clay capping layer. This clay barrier prevents any potential migration of contaminants into the tank void and eliminates direct contact between the impacted material and the imported fill.

Retaining the steel base and associated support structures, where present, is a recognised and widely accepted approach when remediating former underground tanks. It is common practice for these steel elements to remain in situ following remediation, as their presence does not adversely affect the effectiveness of the remedial works or the achievement of the remediation objectives. The insitu steel base and side walls (where present, reference the below photo showing the wall had previously been removed/damaged in parts) also provides stability to the excavation.

The voluntary remedial works were designed to address the identified contaminant linkages associated with the below-ground tank and the localised area of impact in the northern corner of the site. The remediation strategy was focused on the known contaminant sources and pathways accessible at the time.
