Gas Protection Measures Inspection Report

| Project Name | Cornfield Close |
| Project No. | GE18103 |
| Plot No. | Block A and B |

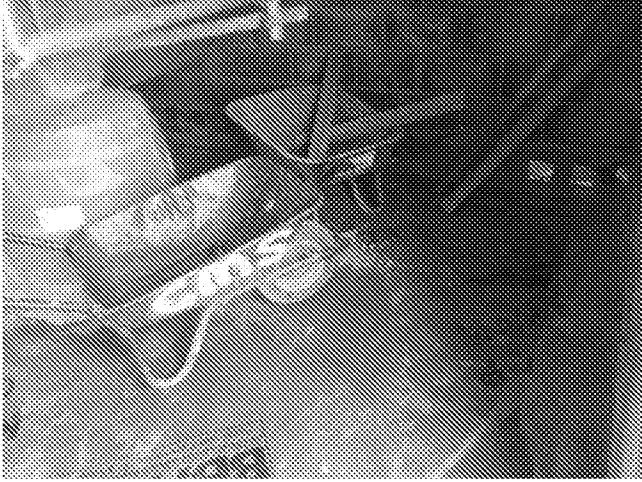
| | Block B materials stored |

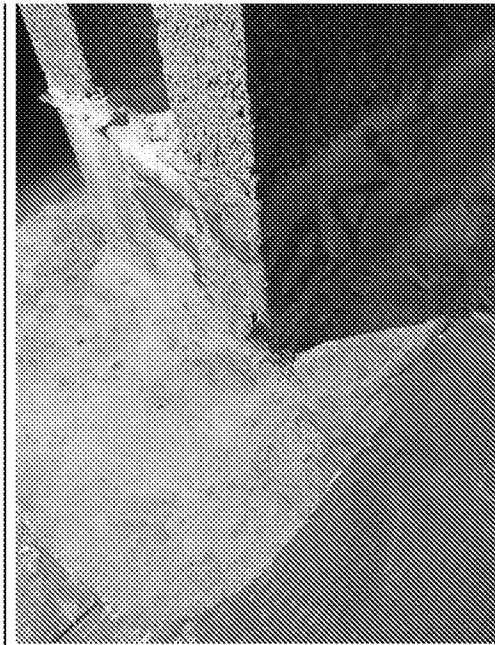
Block B damage

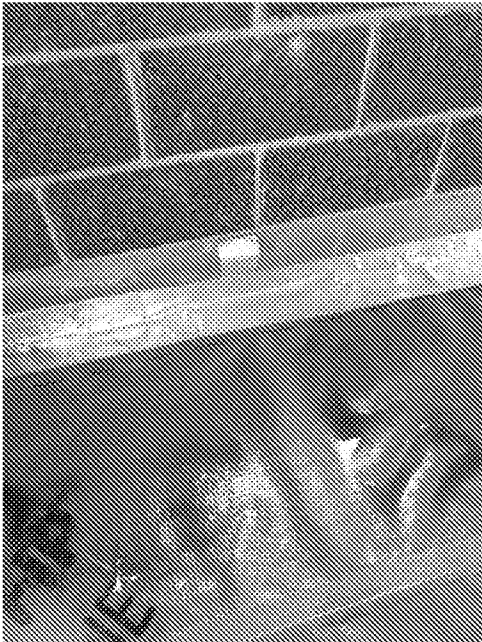
| 1.6 Laps, welds and joints seals | All heat sealed joins and well sealed. Patch repairs over areas of membrane that had been installed as part of the timber frame construction and therefore exposed for sometime |

Block B patch repairs
