**VERIFICATION REPORT**  
**for BLOCK A (SOIL COVER SYSTEMS) &**  
**ALL PLOTS (GROUND GAS) AT**  
**CORNFIELD CLOSE, LITTLEHAMPTON,**  
**WEST SUSSEX, BN17 6LD**  
**on behalf of**  
**THAKEHAM CLIENT LTD**

| <b>Date:</b> | <b>03/08/2021</b> |
| <b>Reference:</b> | <b>GE18103/VR/BLOCK A (Soil) &amp; All Plots (Gas)/AUG21</b> |

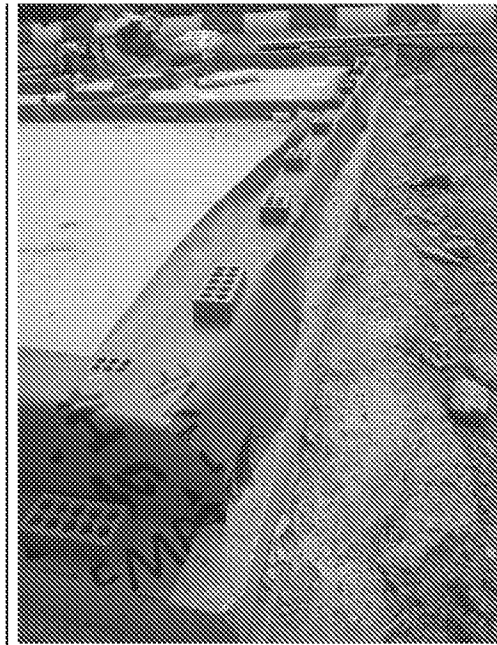
Outer North West - still unfinished

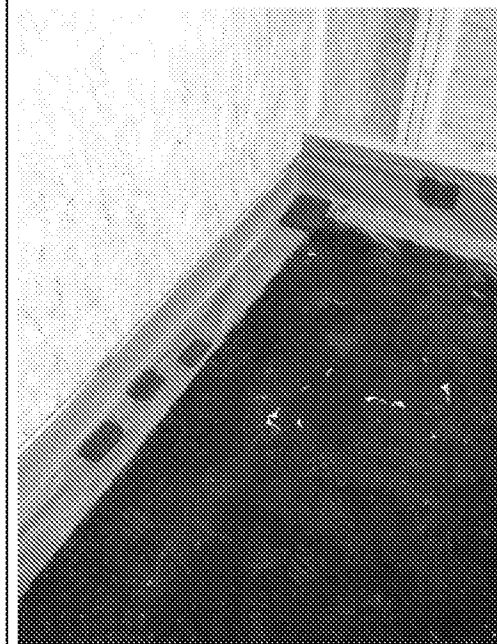
Plot 5 - Patching of holes already complete

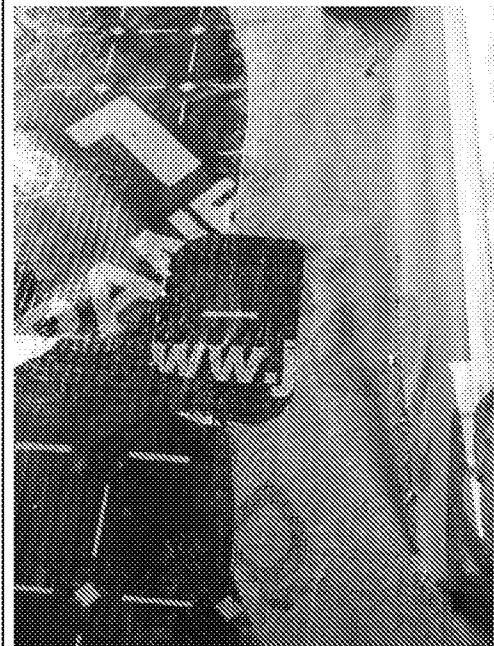
Plot 9 patch repair

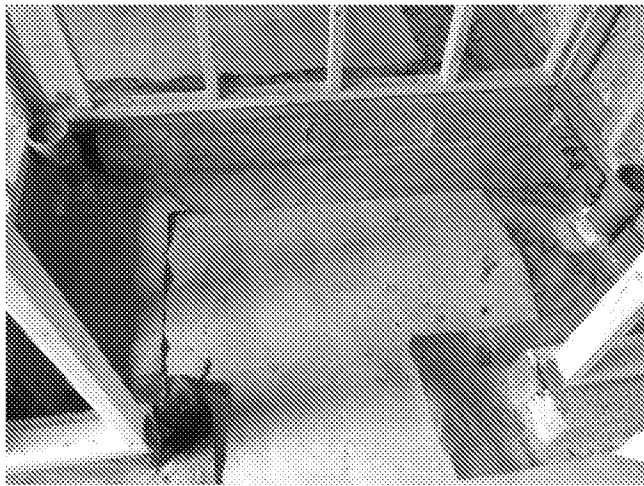
Plot 15 - Services sealed

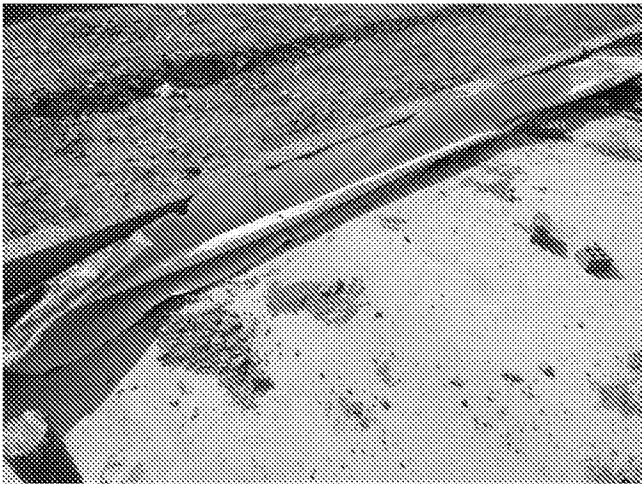
| | <p>Plot 20-21(Phase 4) - Wind damage</p> |

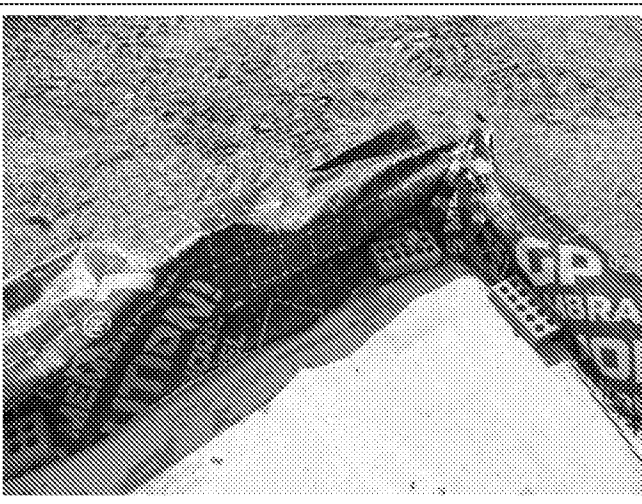
| | <p>Plot 20-21(Phase 4) - Damaged membrane will be replaced before bitumen tape placement</p> |

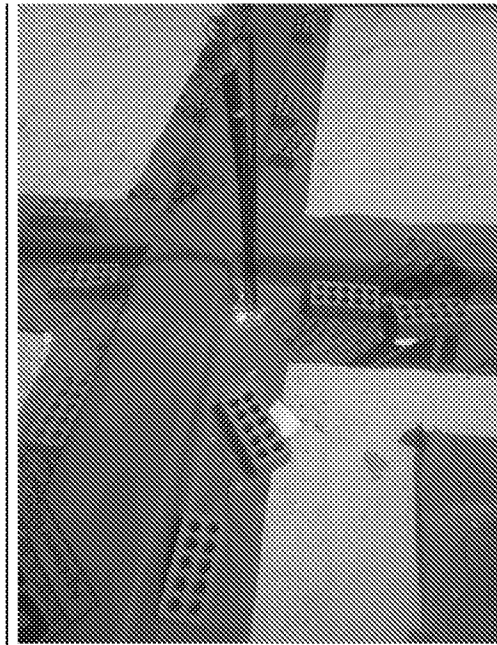
Plots 24-27. Service seal. Road pin will be cut out.
