**County Building**

**Littlehampton**

**Existing building visual inspection notes**

754990\_XXXX\_MAC\_CB\_XX\_RP\_Z\_00001

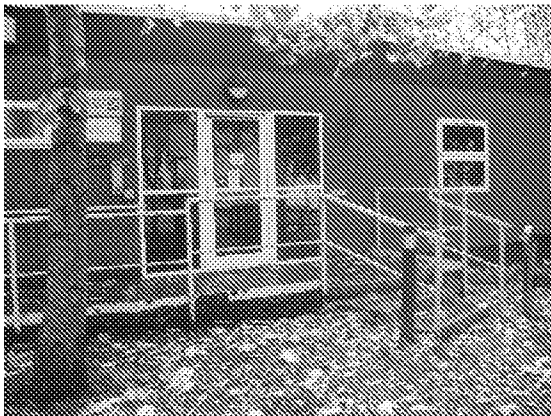
Main entrance

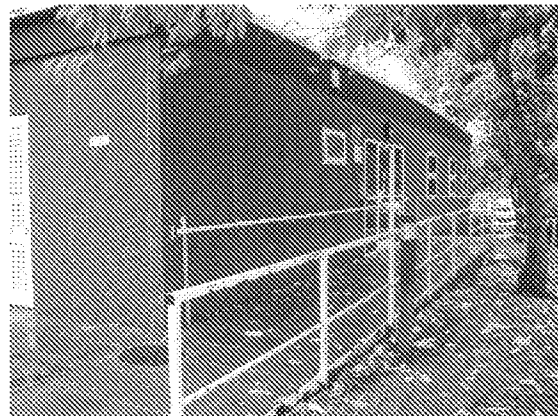
Front elevation

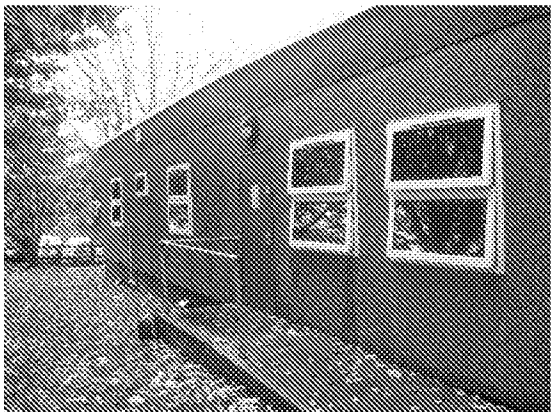
Rear fire exit

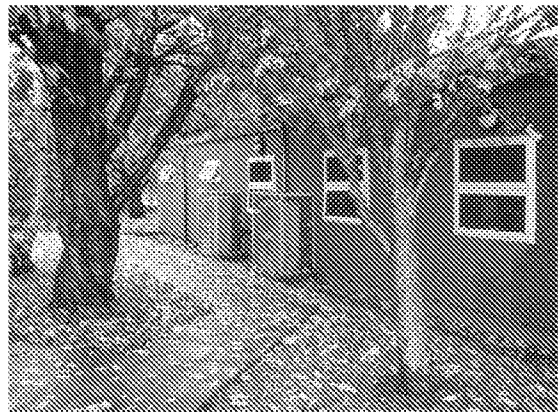
Side elevation

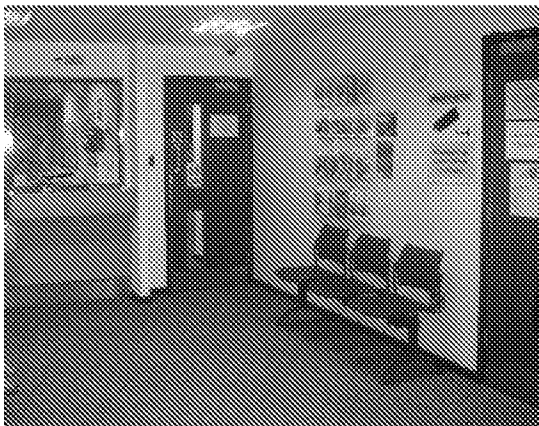
Waiting area

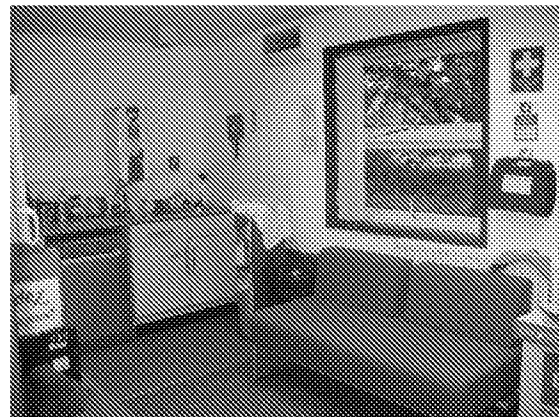
Tea point

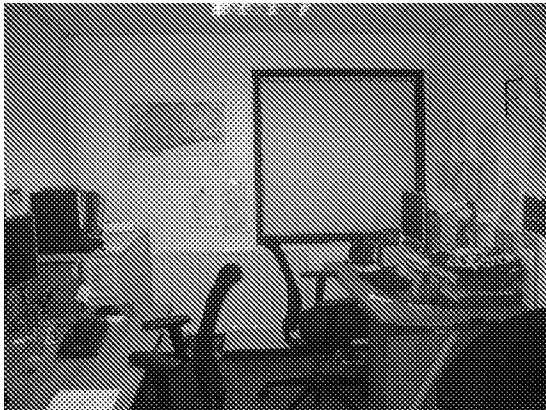
Part of the open plan office

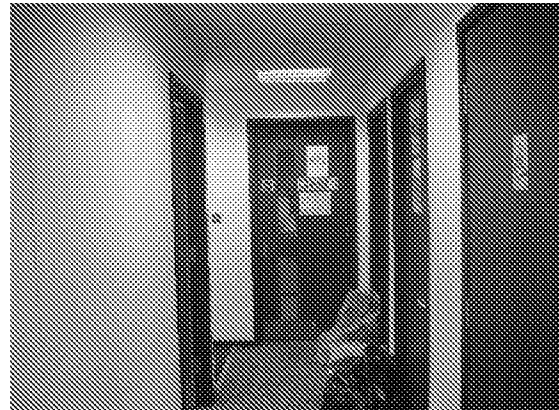
Corridor to staff facilities
