Gas Protection Measures Inspection Report

| Project Name | Cornfield Close |
| Project No. | GE18103 |
| Client | Thakeham |

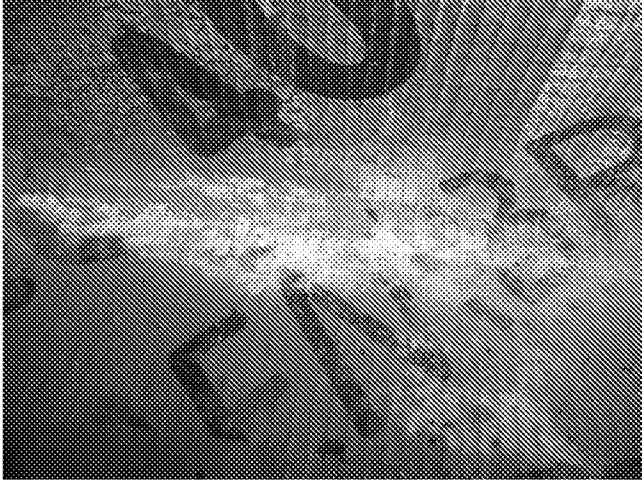
| | Block B damage |

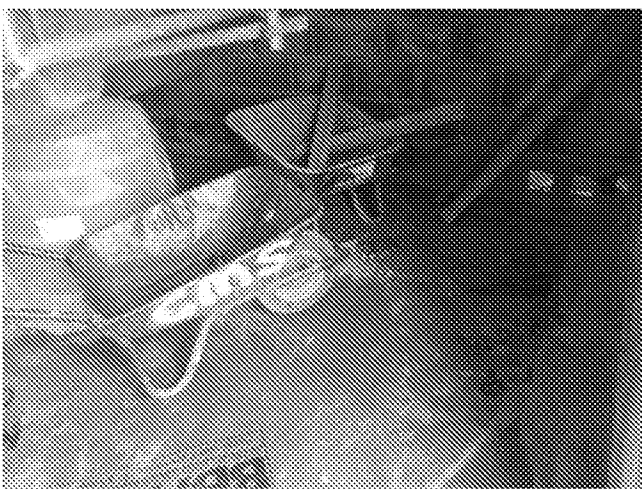
| | Block B materials stored |

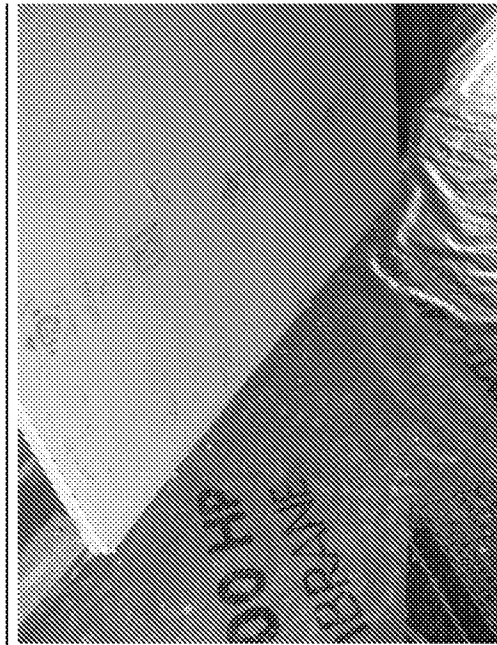
Block B materials

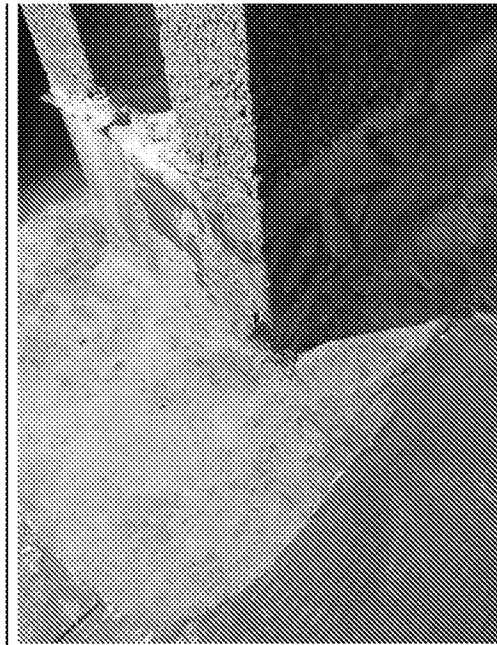
Block B damage

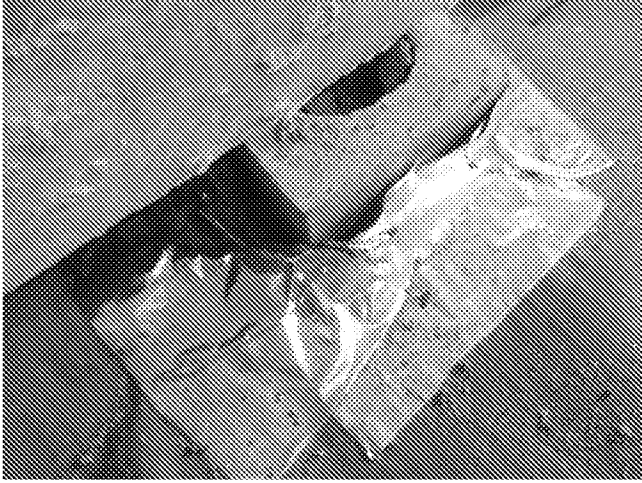
| | <p>Block A not sealed</p> |

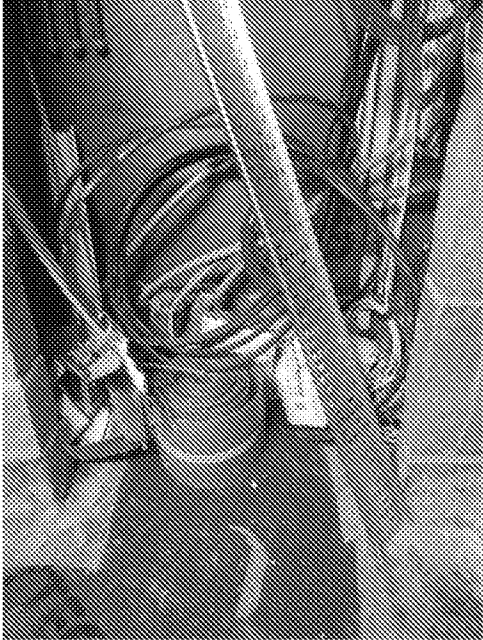
| | <p>Block A materials</p> |

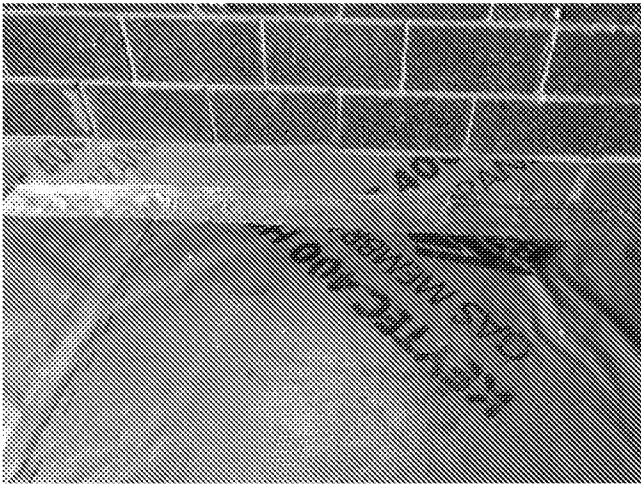
| 1.6 Laps, welds and joints seals | All heat sealed joins and well sealed. Patch repairs over areas of membrane that had been installed as part of the timber frame construction and therefore exposed for sometime |

Block B repairs

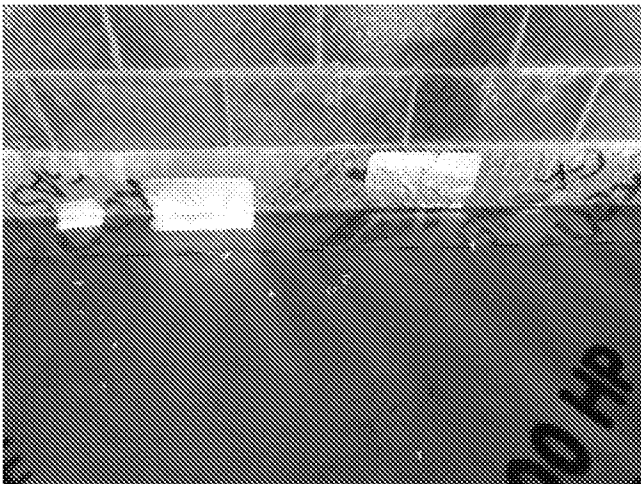
Block B repairs

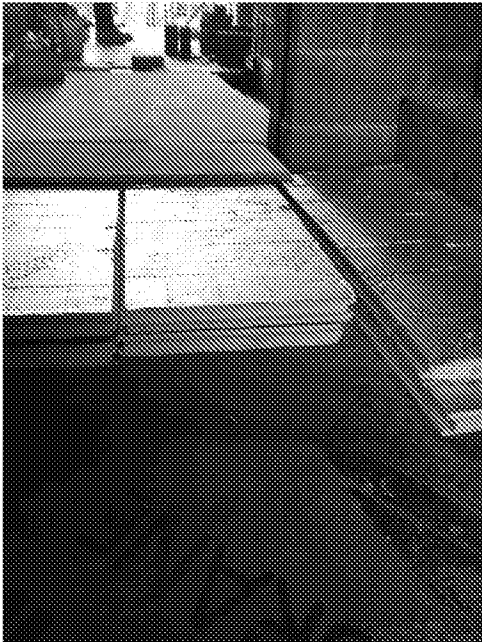
Block B walkway

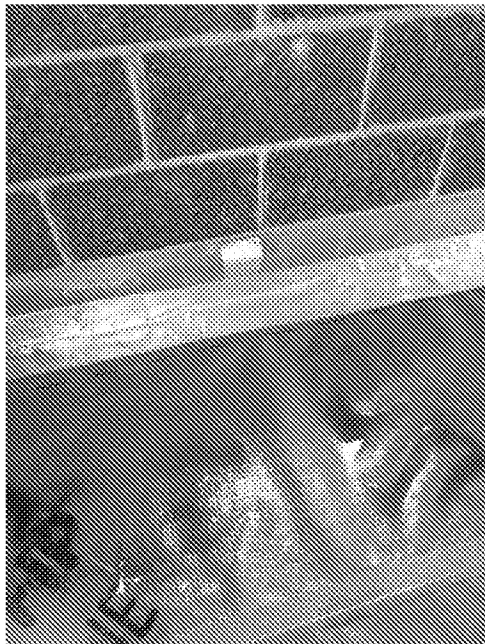
Block B patch repairs
