| Project Name | Cornfield Close |
| Project No. | GE18103 |
| Client | Thakeham Homes |

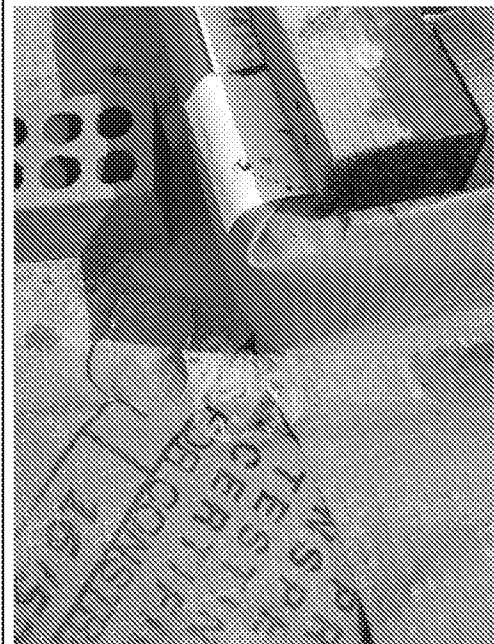
Plot 27 damage

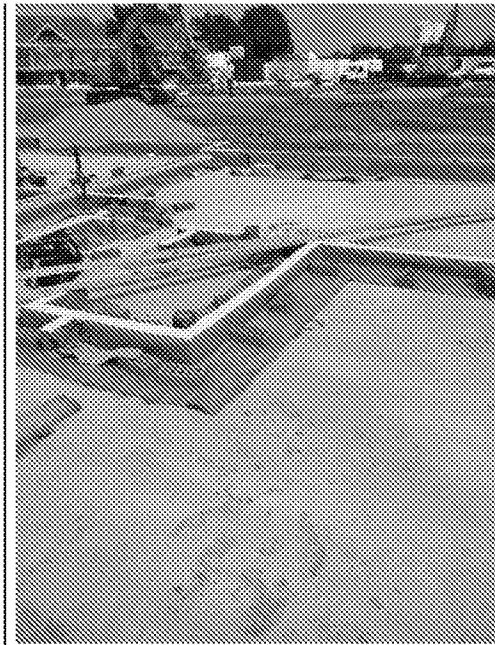
Plot 27 corner damage

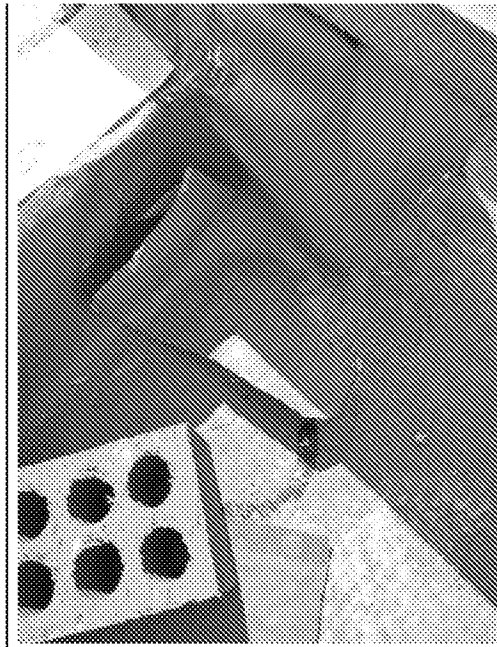
Plot 28 corner needs sealing

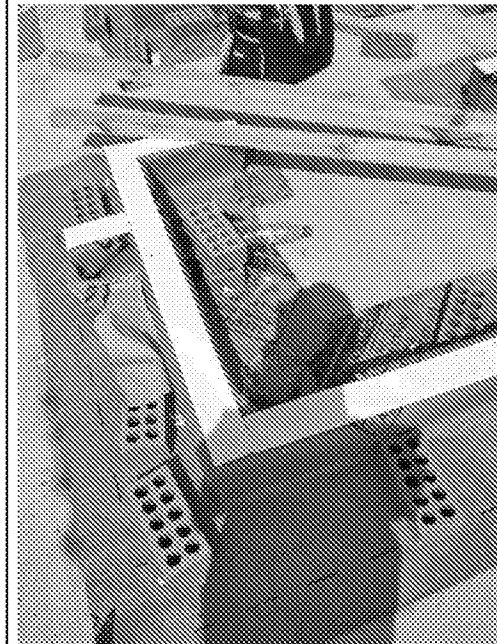
Plot 28 lapping needs sealing

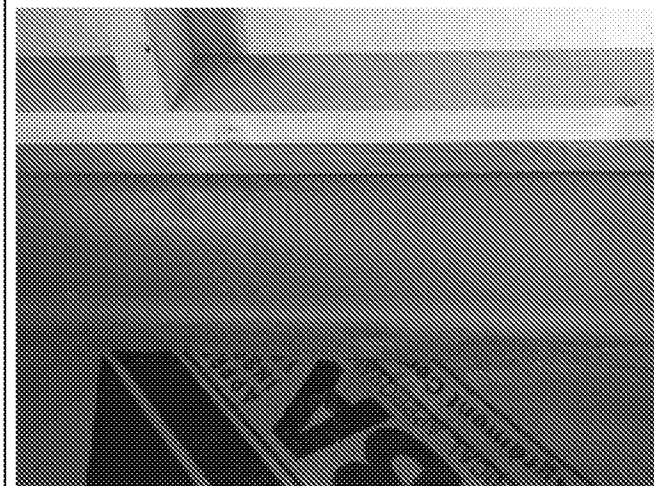
Plot 36 Patch repairs

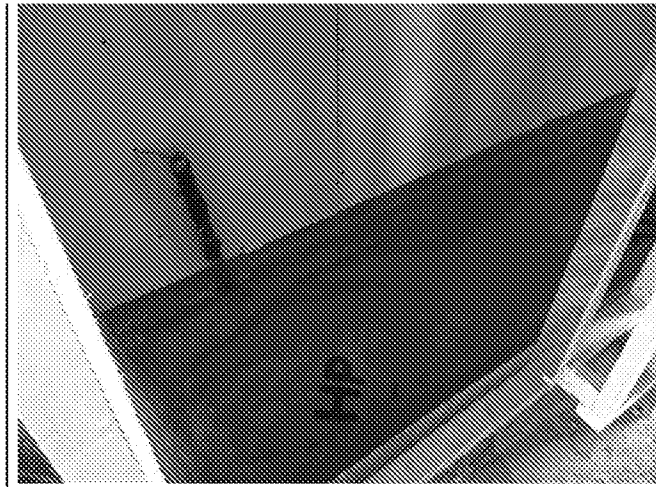
Plot 37 Joins and a patch repair

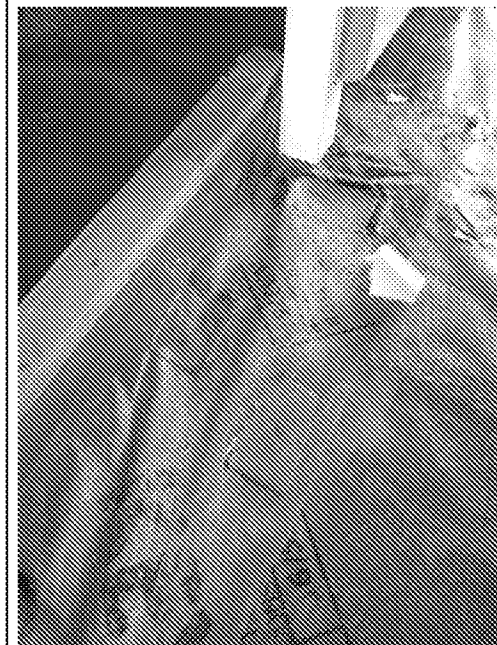
Plot 41 - Holes patched during inspection

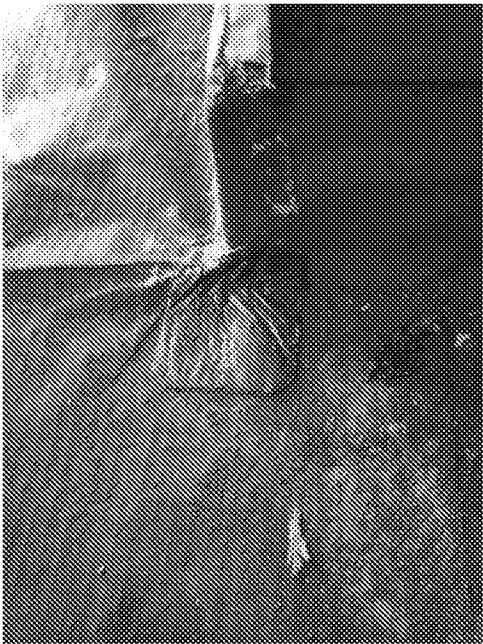
| | Plot 33 patch repair |

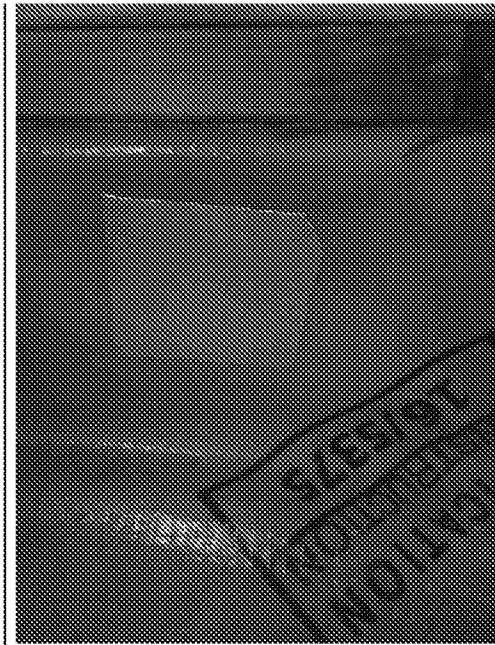
Plot 33 repair

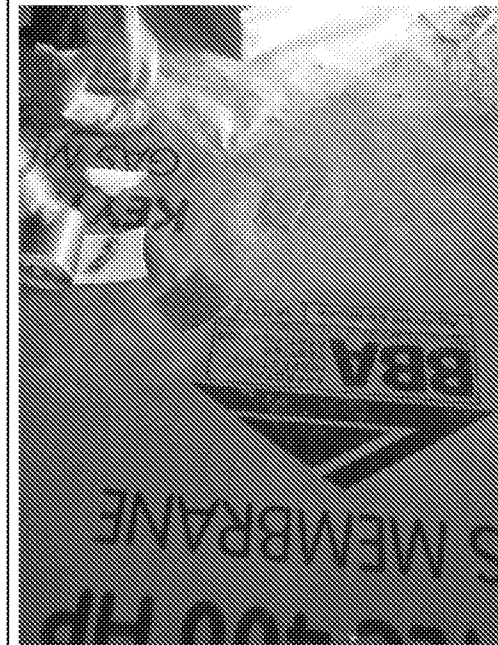
Plot 30 - Patching after removal of debris under membrane

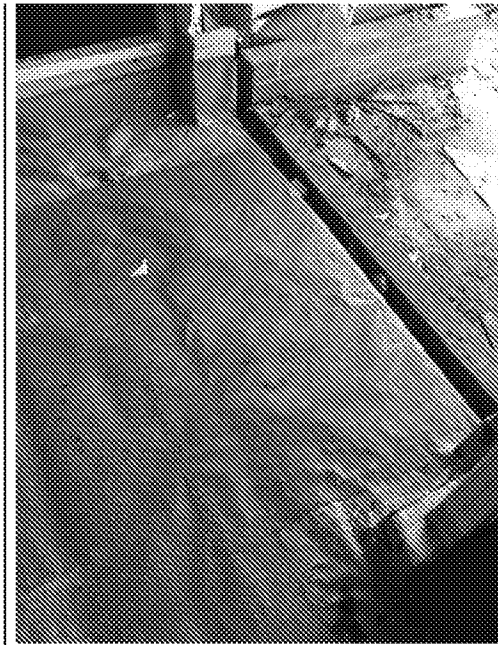
Plot 28 - Debris visible under membrane in doorway

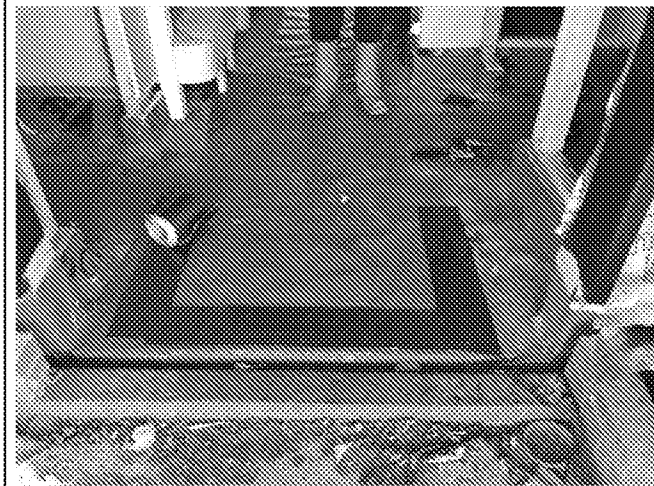
Plot 28 - Doorway area with patching after removal of debris from under membrane

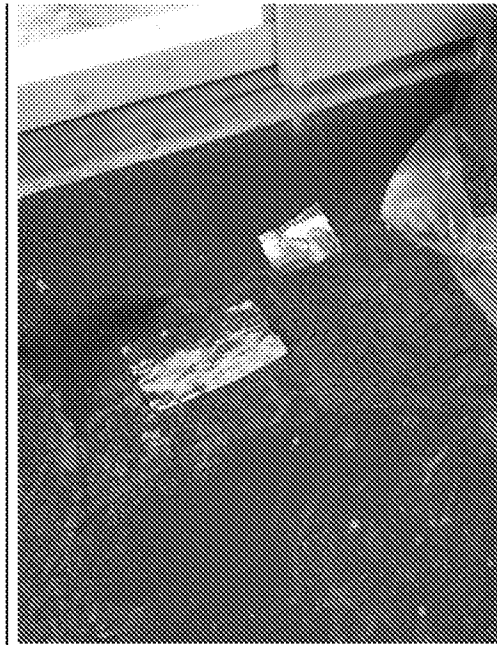
Plot 26 repair

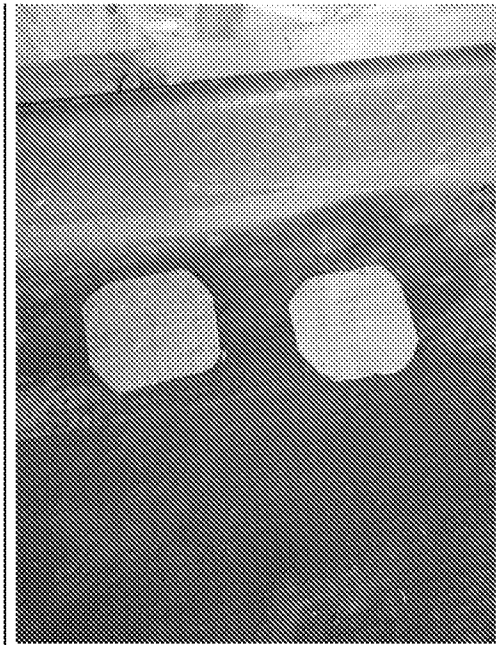
Plot 25 repairs

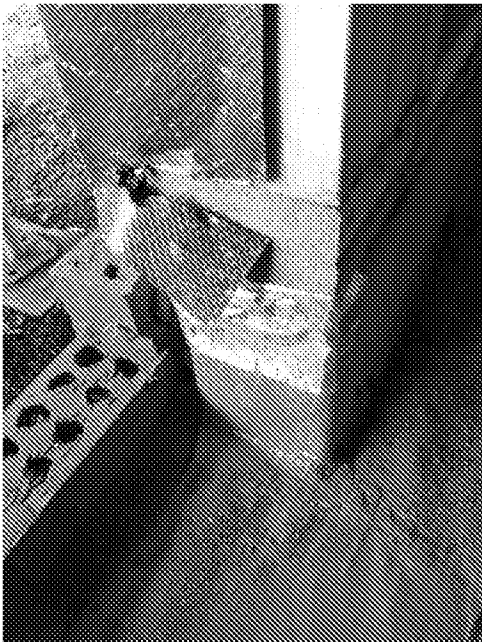
Plot 22 patch repair

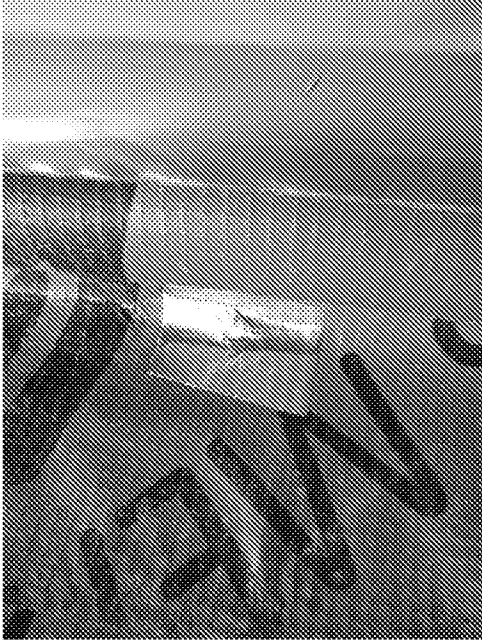
Plot 23 patch repair

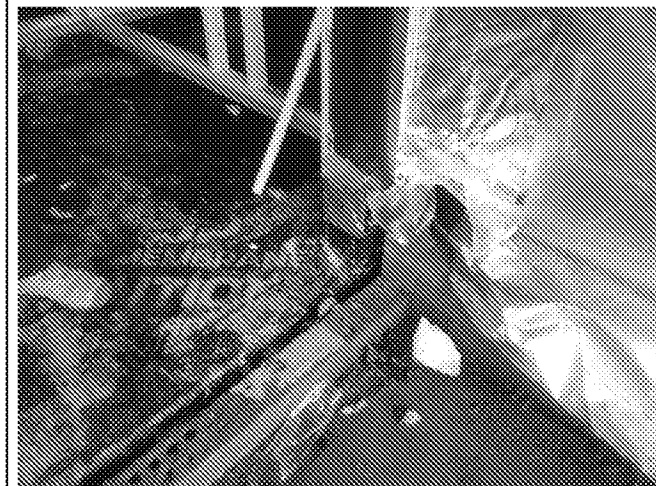
Plot 47 patching.

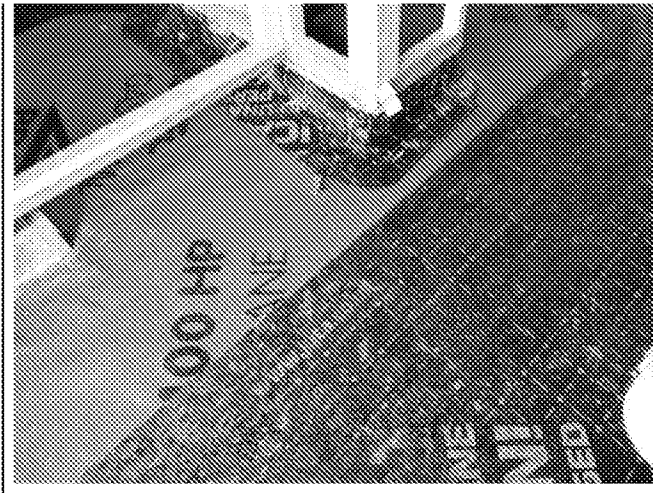
Nail under walkway. Plot 46 fail.

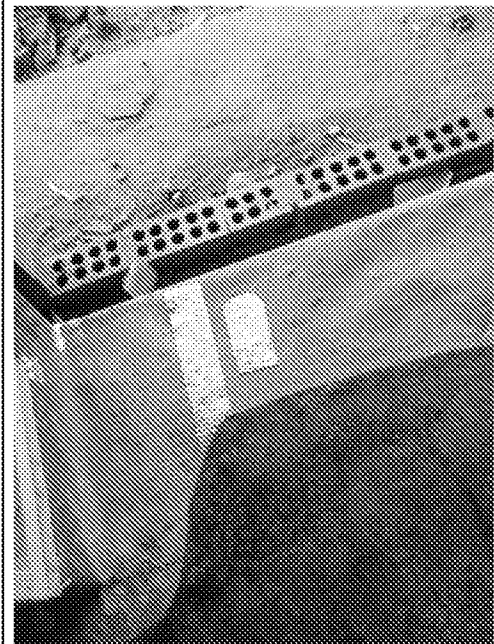
Plot 51 repairs

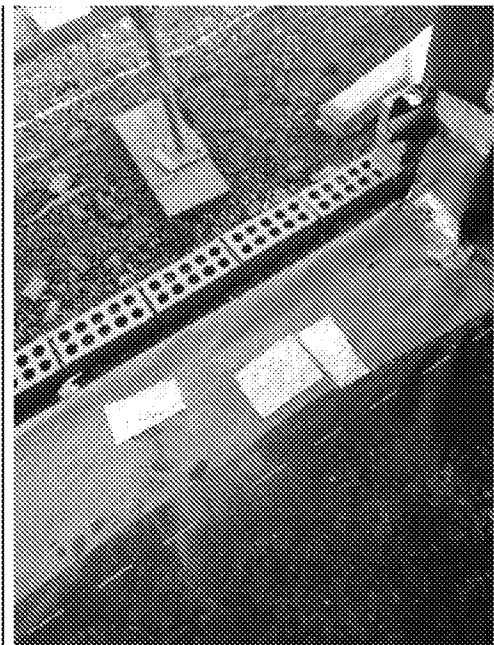
Plot 52 patch repair

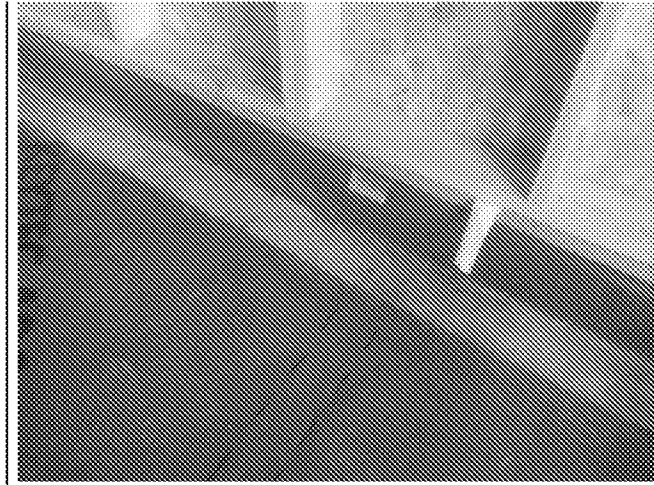
Plot 55 patch repair

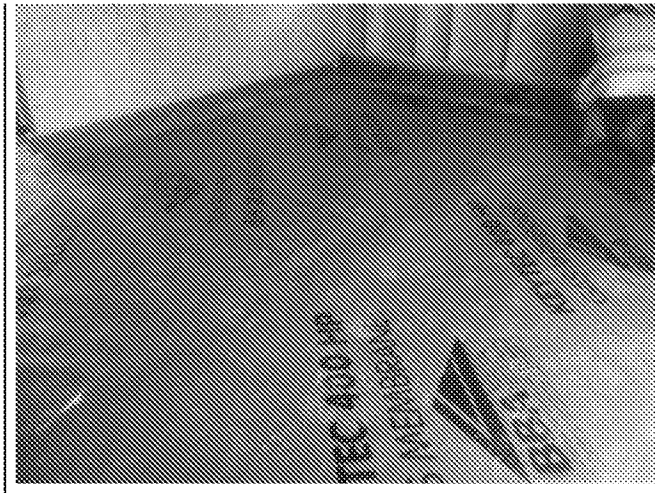
Plot 57 floor and patching underway

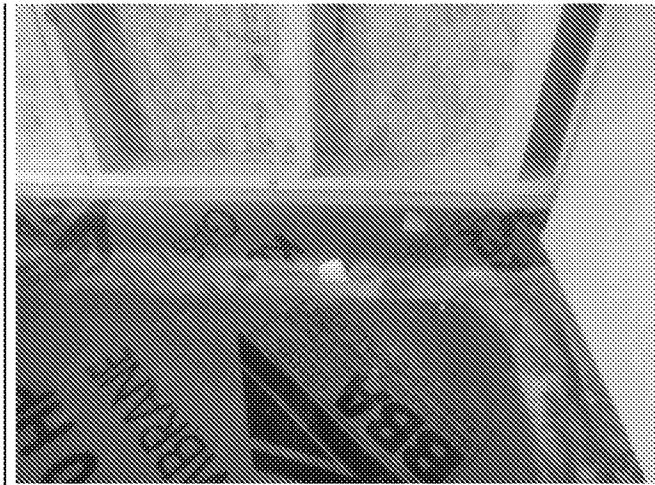
Plot 58 patch repair

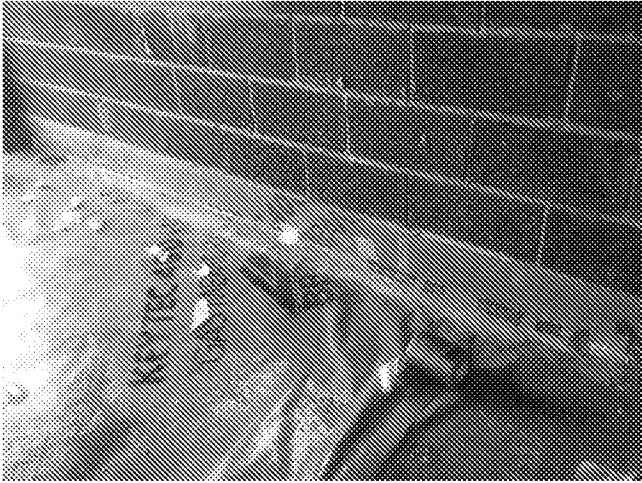
| 1.6 Laps, welds and joints seals | <p>All heat sealed joints.</p> <p>Block B - A large number of patch repairs are required</p> <p>Block A - seal around stairs is not sufficient</p> |

| Photograph | Photograph Title |
|---|---|
| | Block B patch repairs |
