**VERIFICATION REPORT**  
**for PLOTS 50-59 (SOIL COVER SYSTEMS) &**  
**ALL PLOTS (GROUND GAS) AT**  
**CORNFIELD CLOSE, LITTLEHAMPTON,**  
**WEST SUSSEX, BN17 6LD**  
**on behalf of**  
**THAKEHAM CLIENT LTD**

| <b>Date:</b> | <b>27/08/2021</b> |
| <b>Reference:</b> | <b>GE18103/VR/PLOTS 50-59 (Soil) &amp; All Plots (Gas)/AUG21</b> |

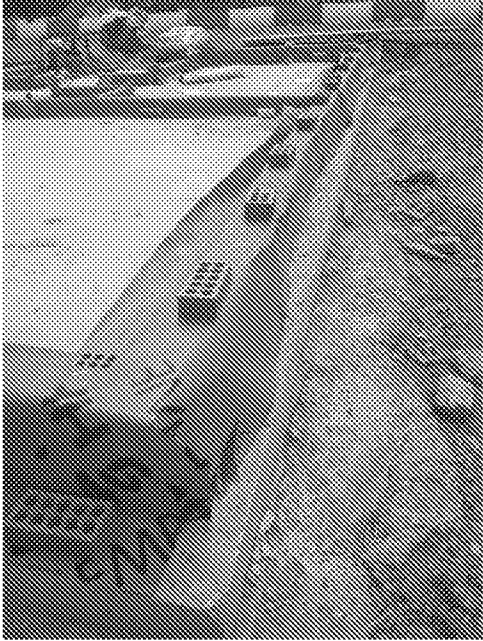
| | Outer North West - still unfinished |

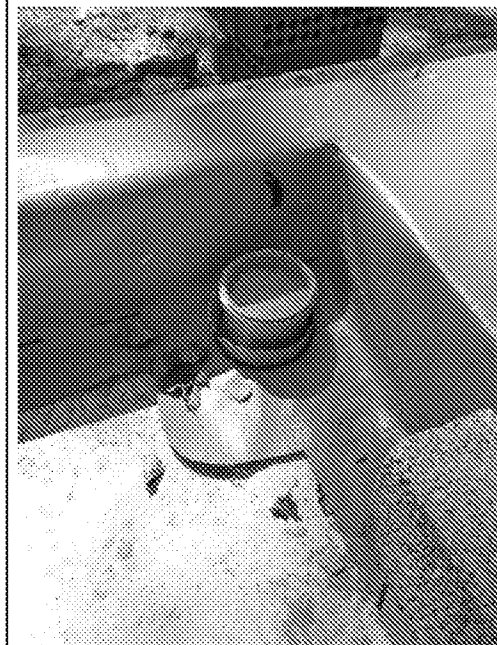
Block B - services not yet sealed

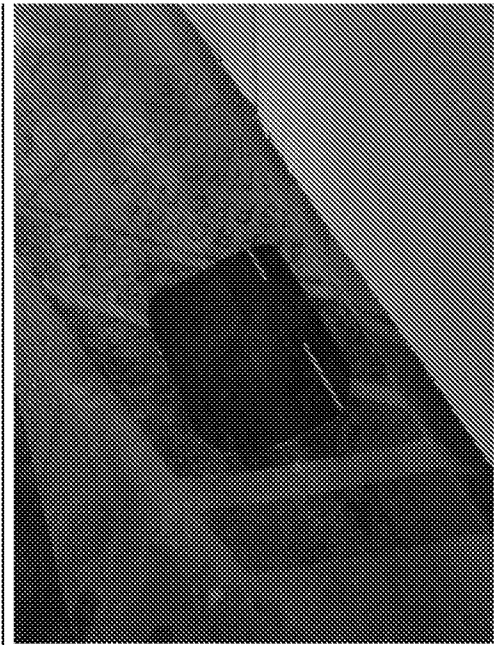
Plot 6 repair

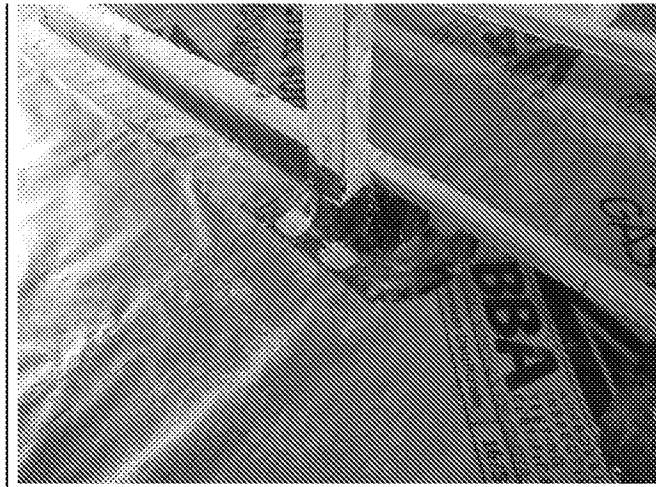
Plot 13 - Patching
