Our Ref: PJW/SD/29079

**Kingley Site, Littlehampton  
Report on Structural Inspection of Dovecot**

**Kingley Sile, Littlehampton**  
**Report on Structural Inspection of Dovecot**

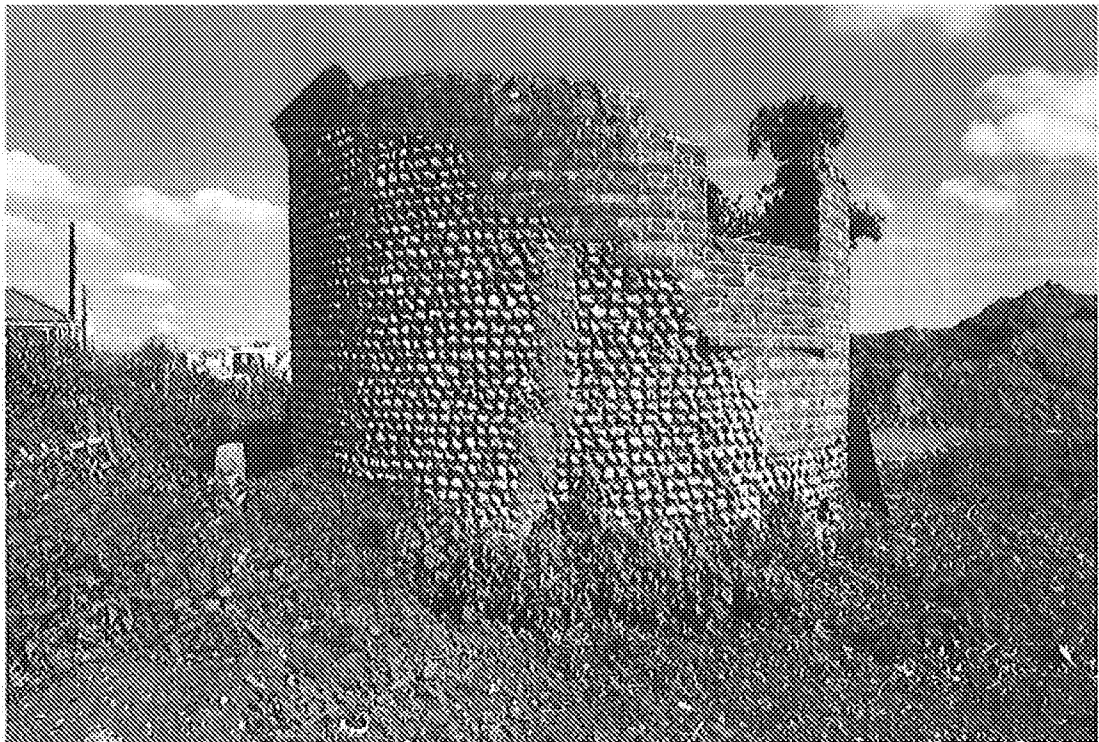
The nature of construction of the dovecot is well depicted by the attached photographs taken by us on the day of inspection. The structure which we believe would be in excess of 150 years age is of cylindrical form about 5 meters diameter and constructed in brick and flint materials. In its original form we believe it would have had a conical roof long since removed. In addition the nesting boxes which show in photograph 2 would we believe have extended the full circumference of the dovecot interior. The nesting boxes that remain are constructed in brickwork set into the body of the flint circumference and separated by horizontal brick string coursing none of which would have showed externally. The structure has been subject of reconfiguration with the southern half largely rebuilt in either solid flint or brick this showing in photograph 1. The roof was replaced at a lower level as a monopitch structure having close boarded timber joists. This is in a state of near collapse as seen in Photograph 2. The later flint constructions have been subject of repair noting the vertical mortar filling visible at intervals as photographs 1 and 5.

Photograph 1 – General view looking to north west

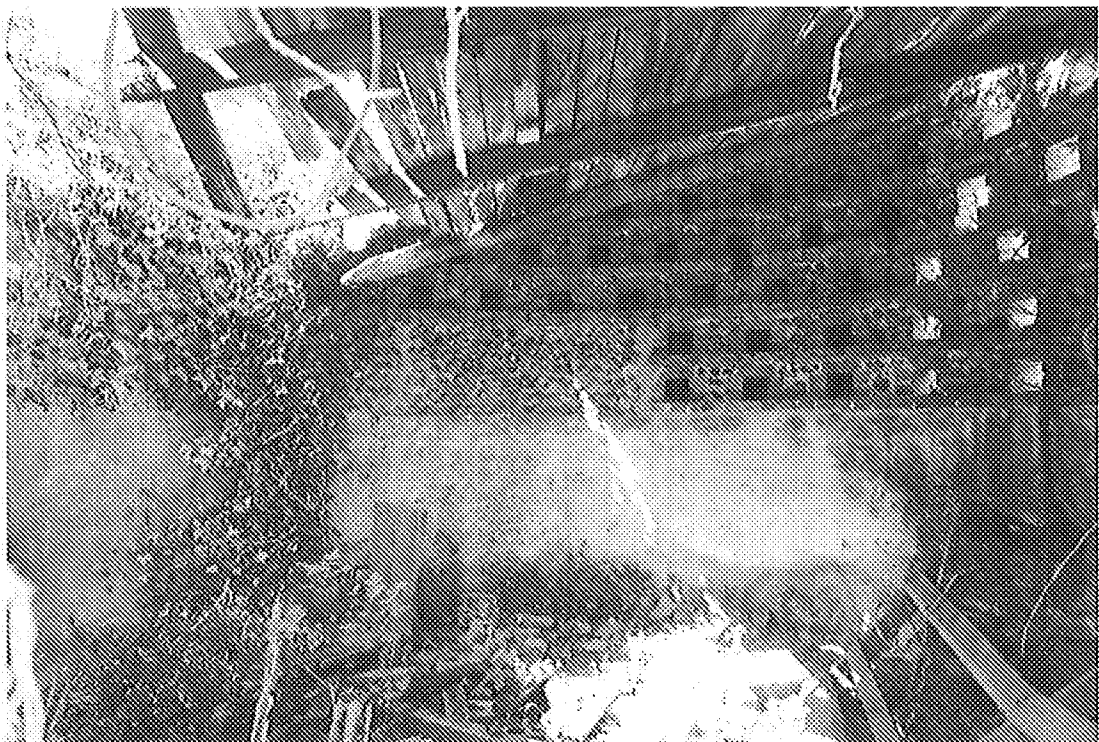
Photograph 2 – Interior showing collapsed roof

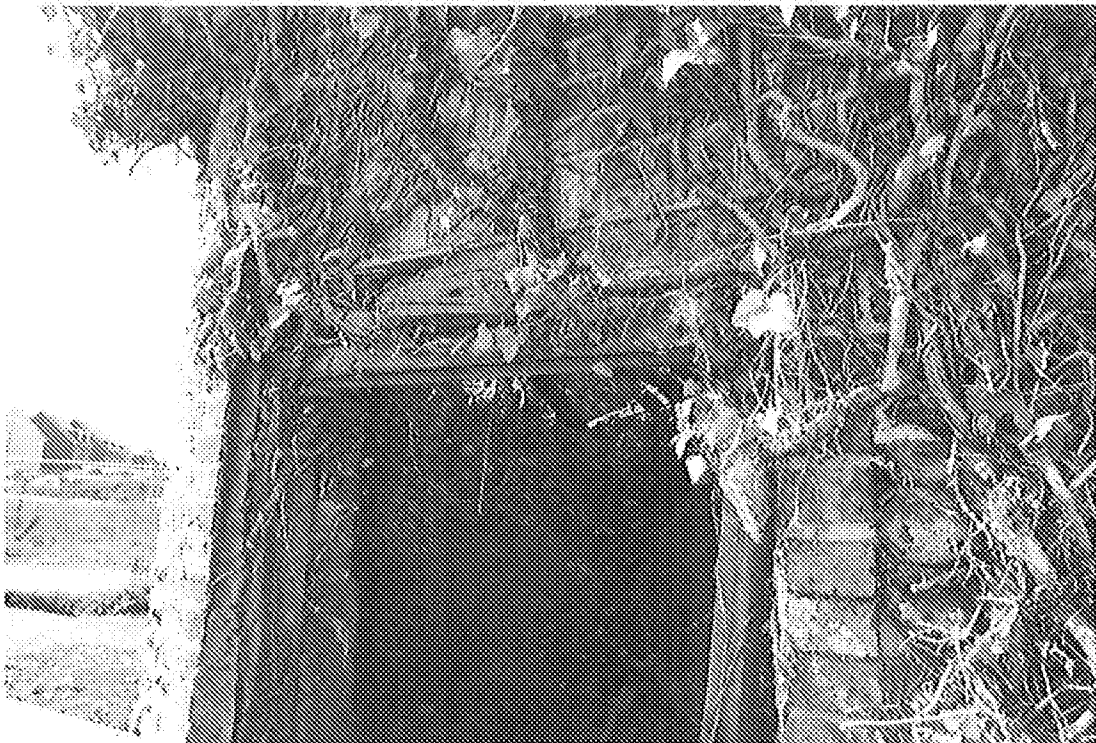
Photograph 3 – Ivy growth at entrance – timber lintel decayed

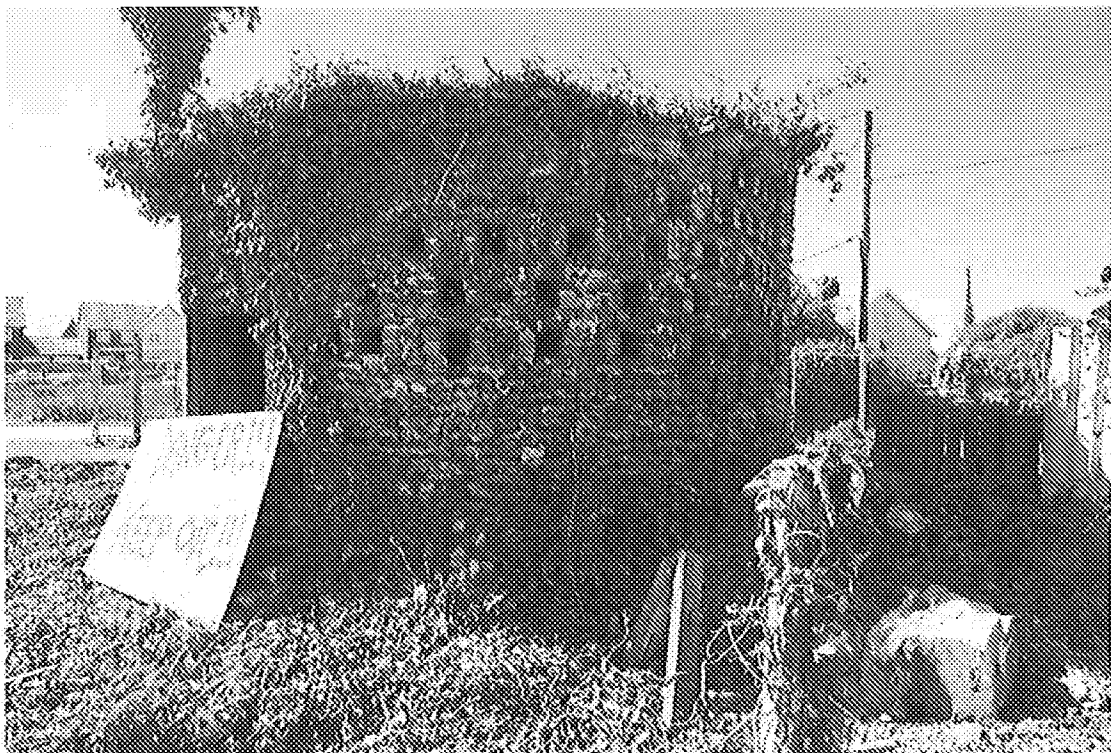
Photograph 4 – General view looking south

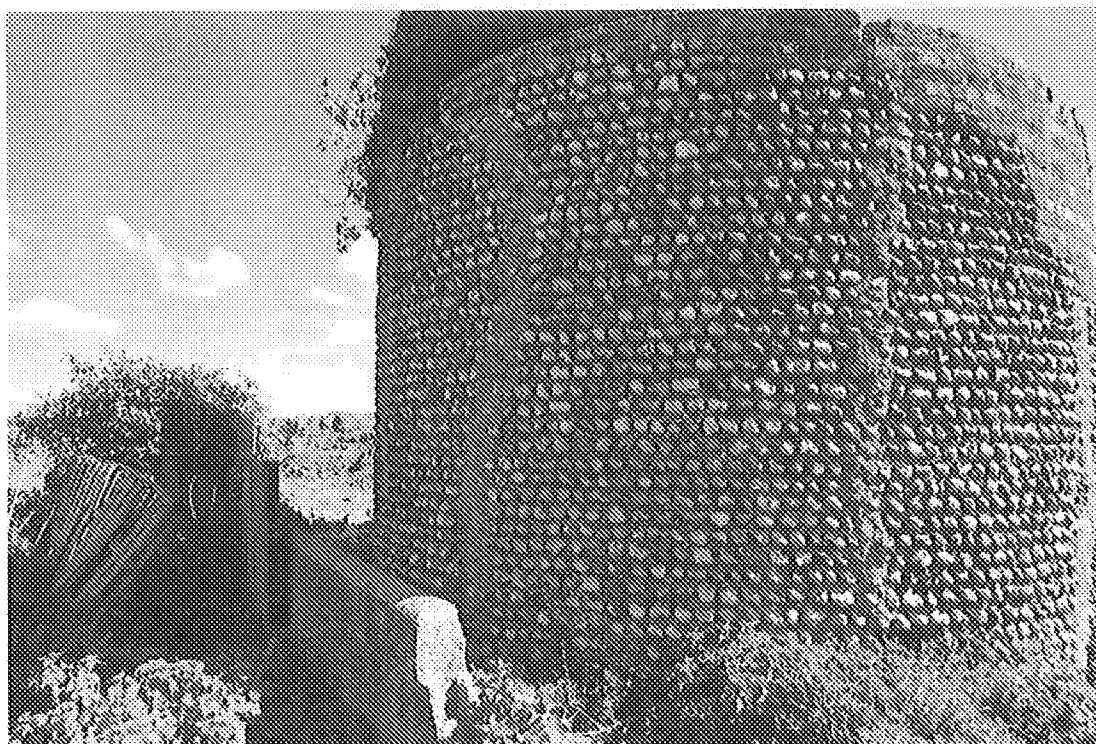
Photograph 5 – General view looking north

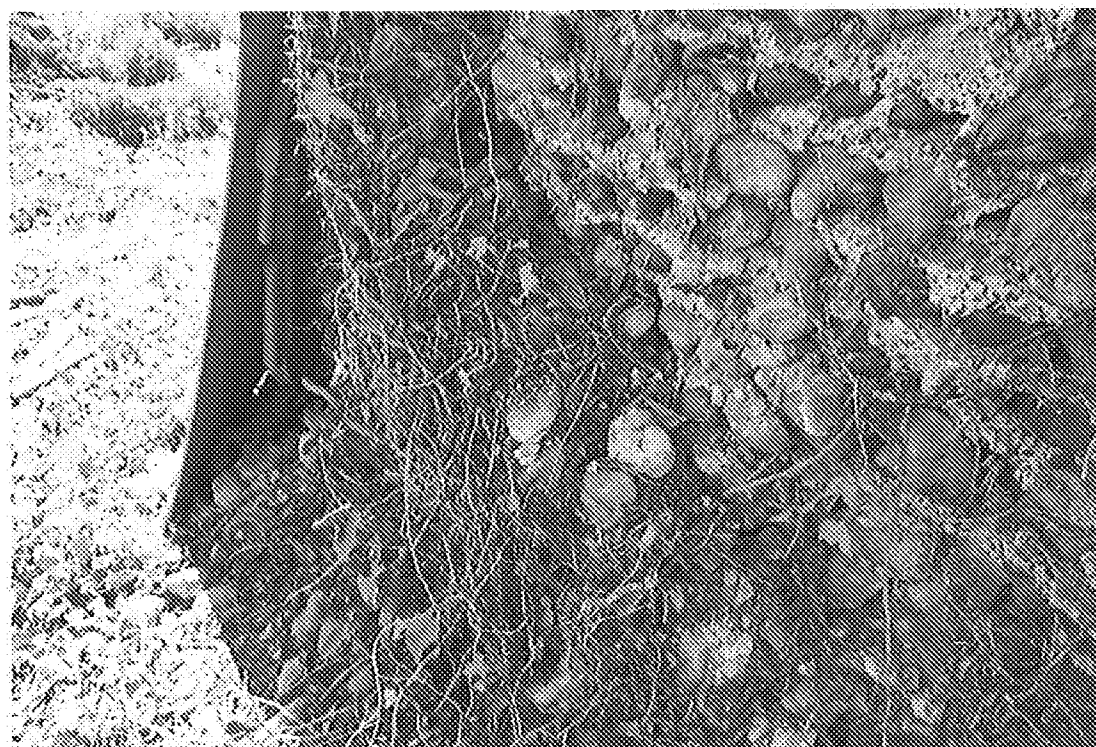
Photograph 6 – Loose flintwork adjacent door

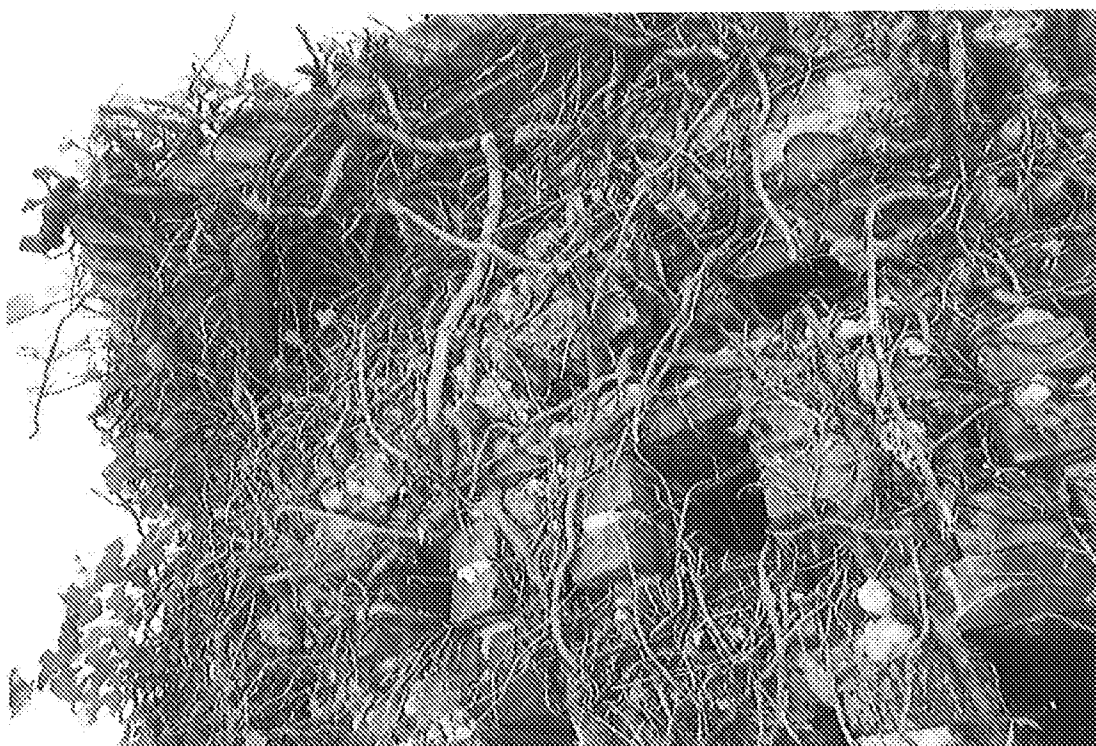
The majority of our photographs record the extensive ivy incursions which have prised away the exterior "skin" of flints which has collapsed and is present as rubble at the base of the dovecot. Whilst much of the ivy has necessarily been cut away to permit an evaluation of structural damage much remains and is penetrating to the building interior also causing masonry damage. The whole of this area which takes in the remaining nesting boxes is beyond repair.

Photograph 7 – Extensive ivy incursions and flint skin collapsed

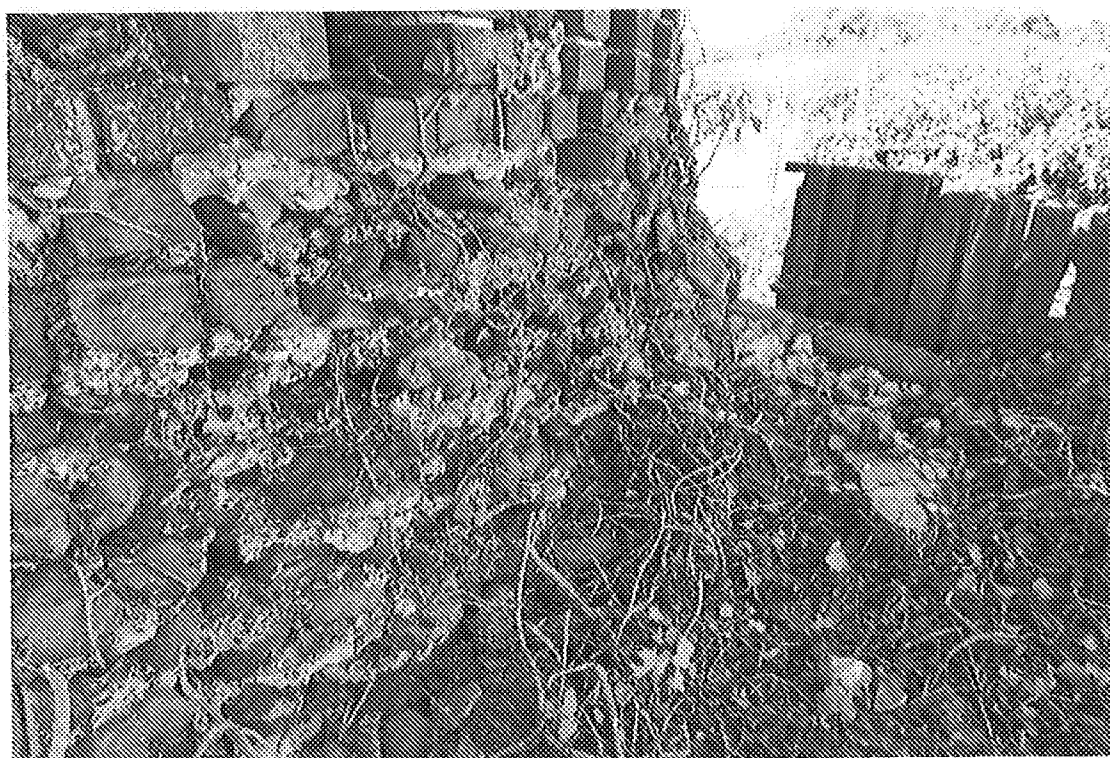
Photograph 8 – Collapse of flint skin

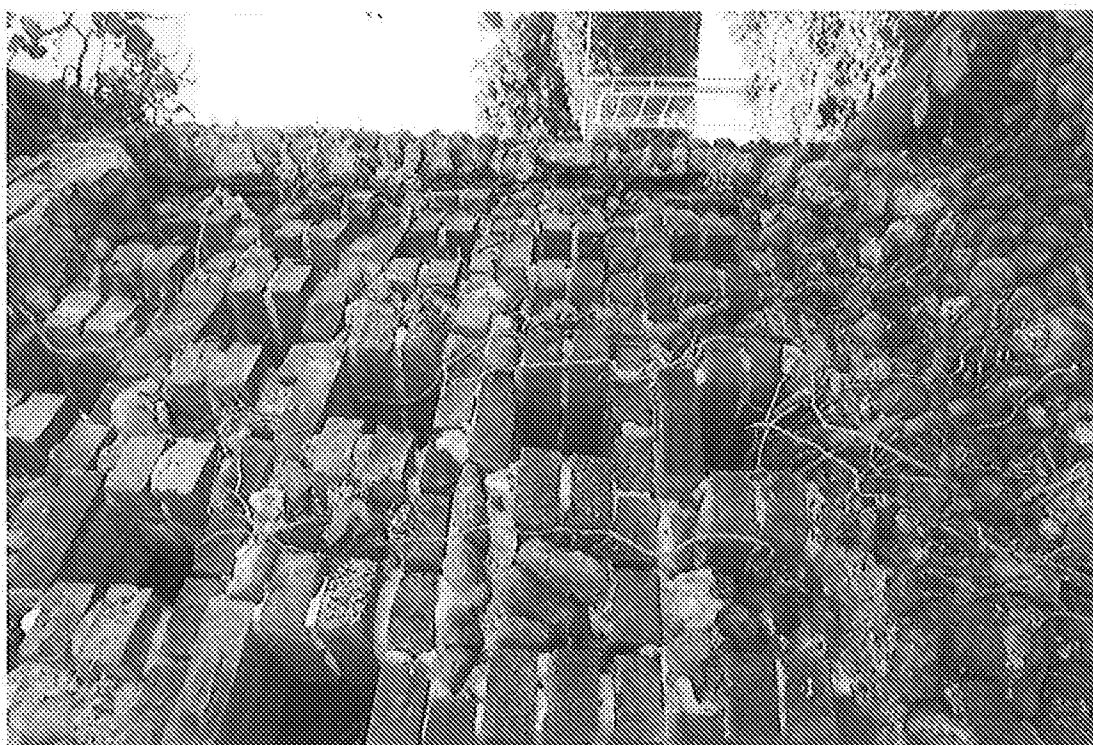
Photograph 9 – Collapse of flint skin

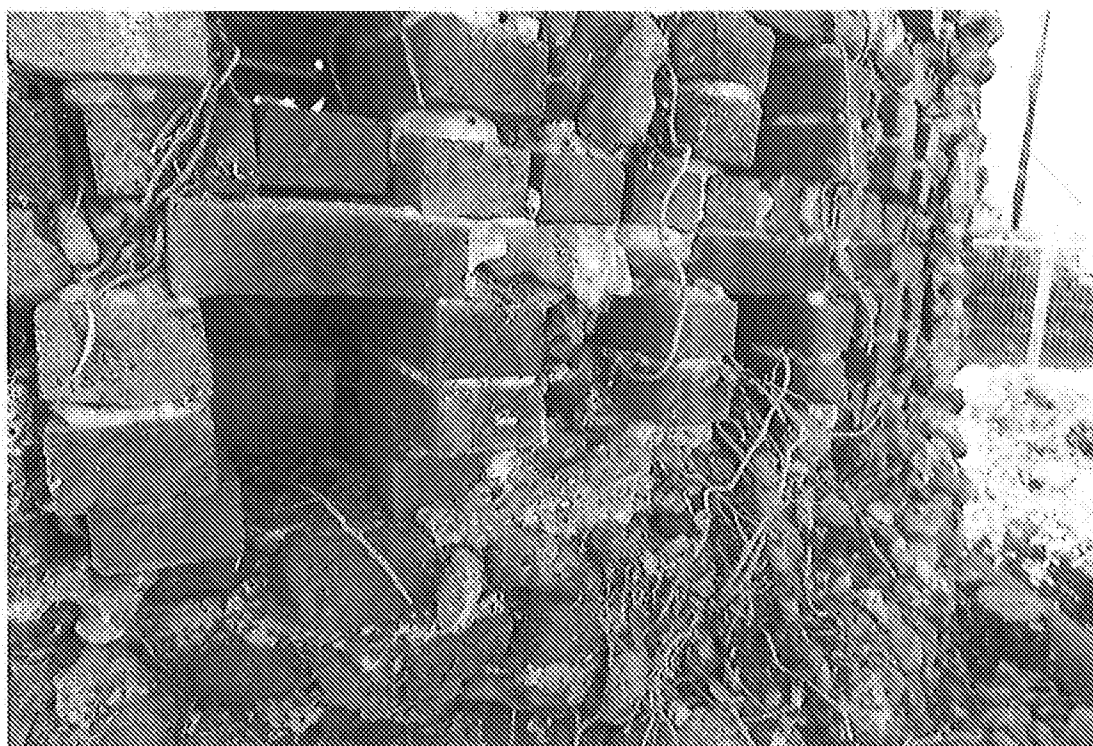
Photograph 10 – As above
