Gas Protection Measures Inspection Report

| Project Name | Cornfield Close |
| Project No. | GE18103 |
| Client | Thakeham |

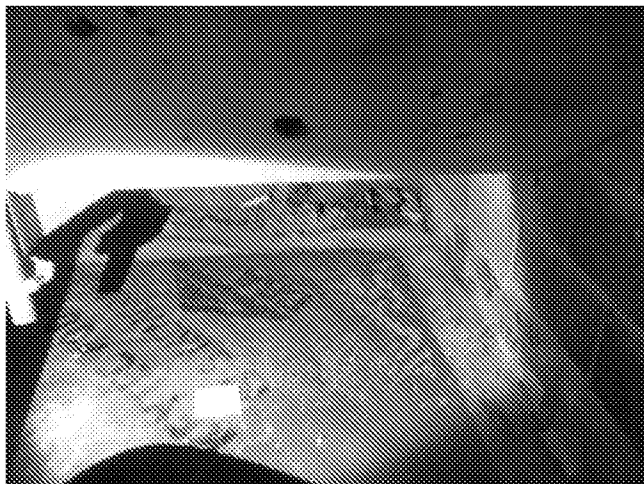
Block B understairs

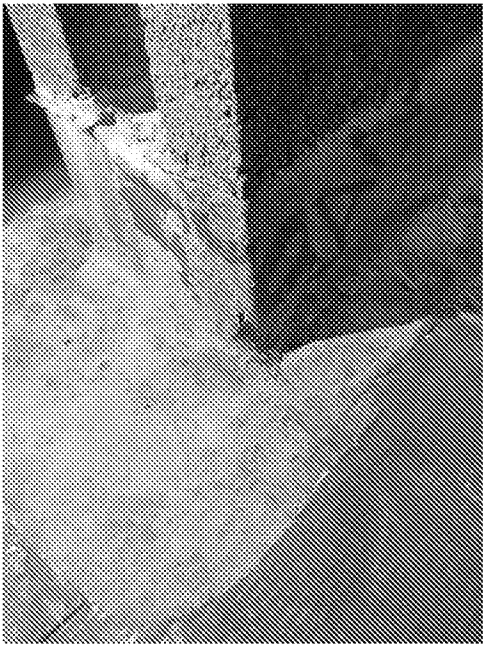
| | Block B damage |

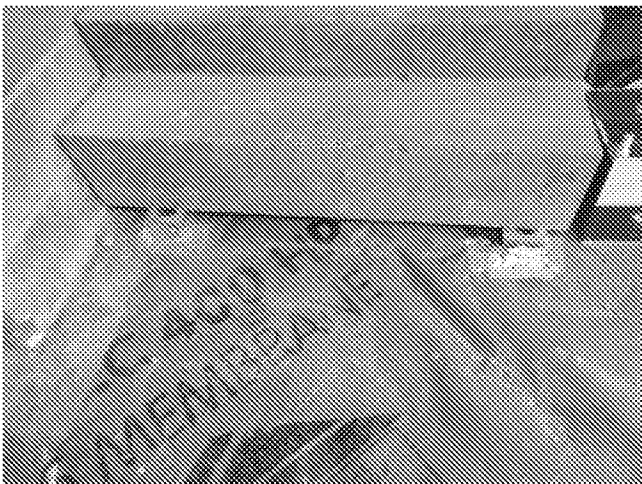
| | Block A stairs |

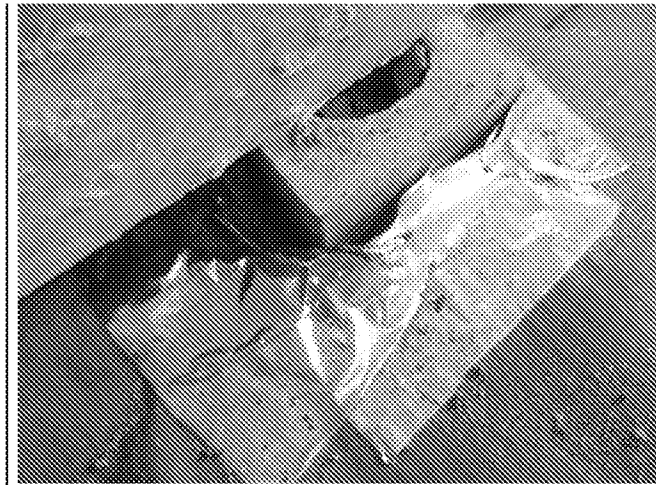
Block A not sealed

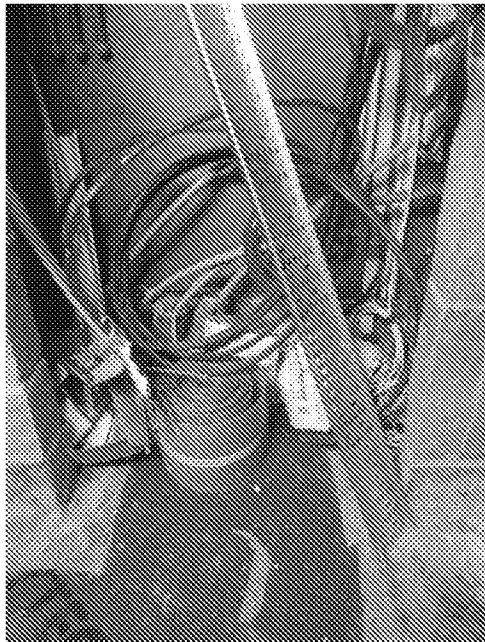
Block A materials

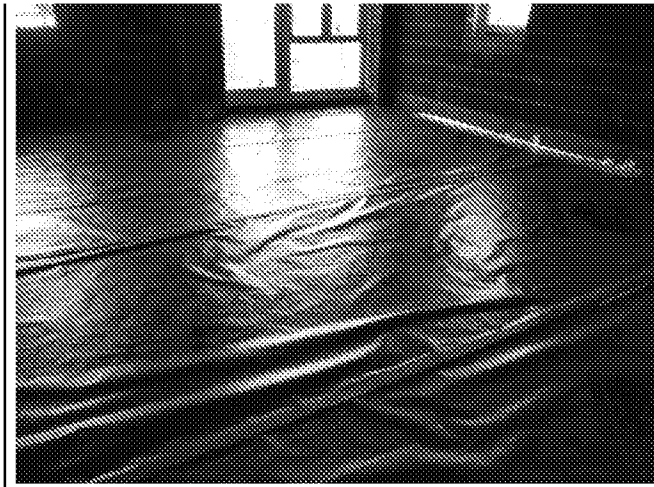
Block B overview

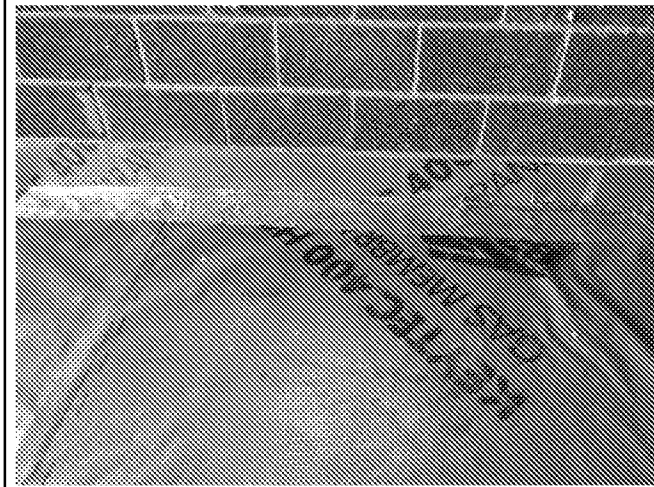
| 1.6 Laps, welds and joints seals | All heat sealed joins and well sealed. Patch repairs over areas of membrane that had been installed as part of the timber frame construction and therefore exposed for sometime |

Block B repairs

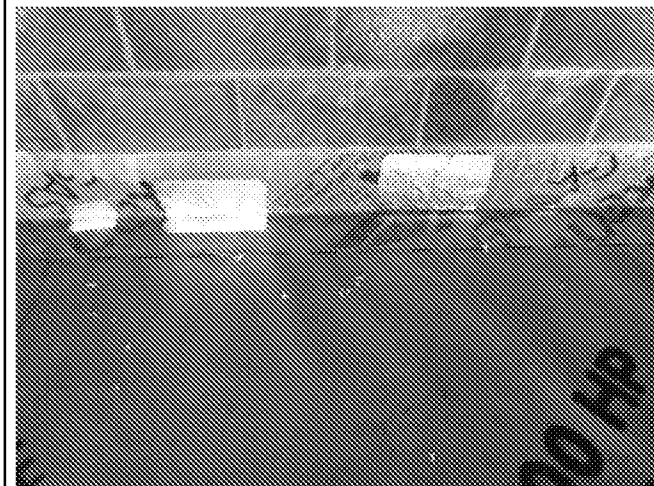
Block B repairs

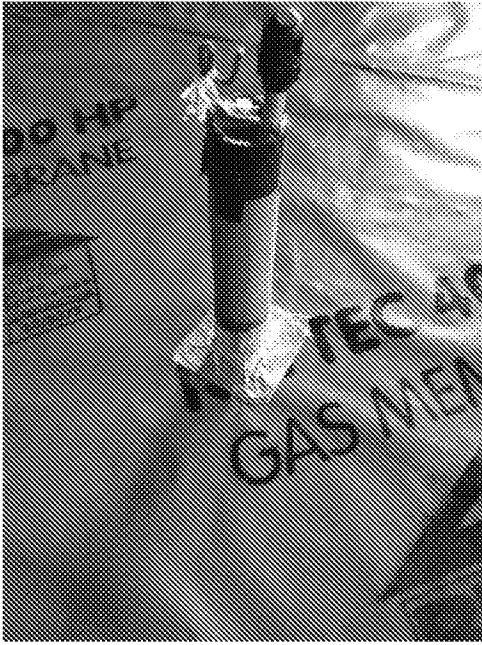
| 1.7 Service seals | Site made seals, well sealed |

Block B services

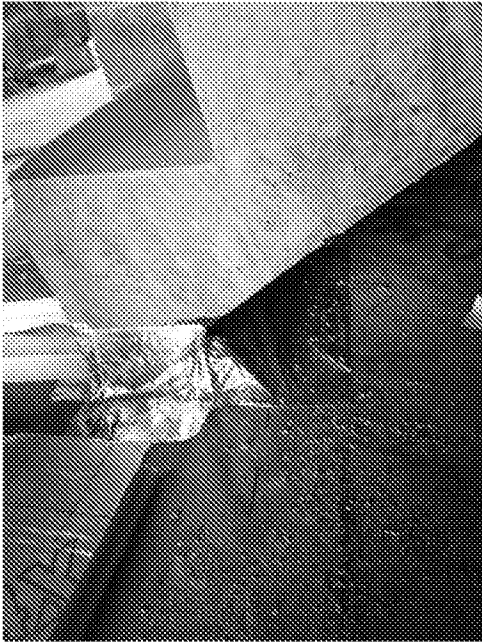
| Jointing tape product | Double sided heat sealed butyle tape and liquid membrane on concrete stairs |

Block B stairs

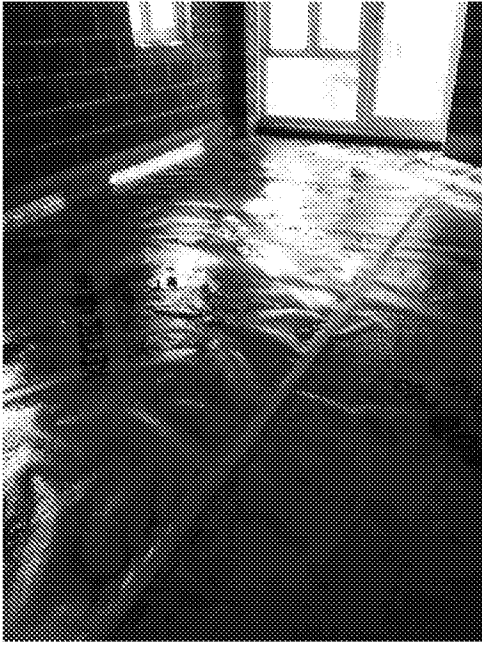
Block B overview

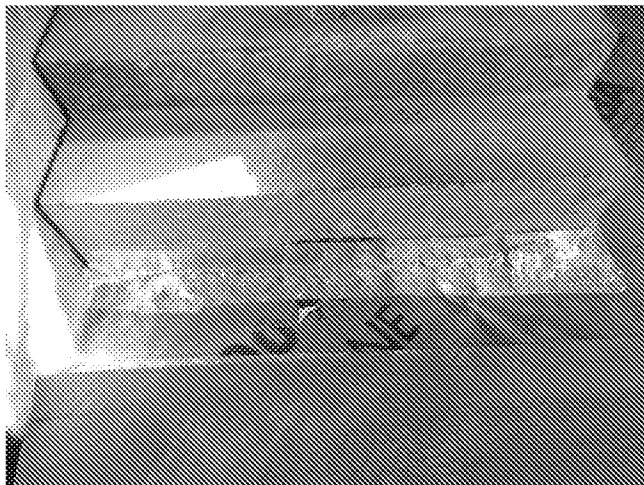
Block A stairs

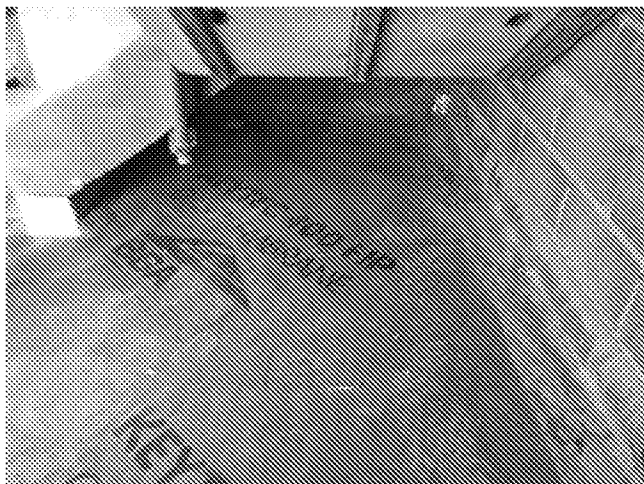
Block A under stairs

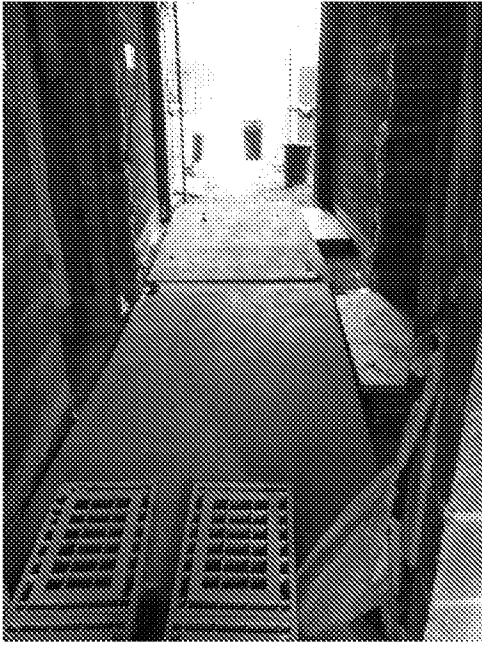
Block A walkway
