## The Old House, Franciscan Way, Littlehampton

PART OF SURVEY 4 REPORT BY

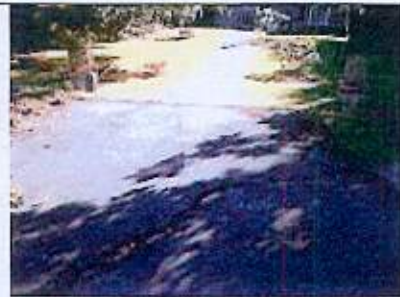
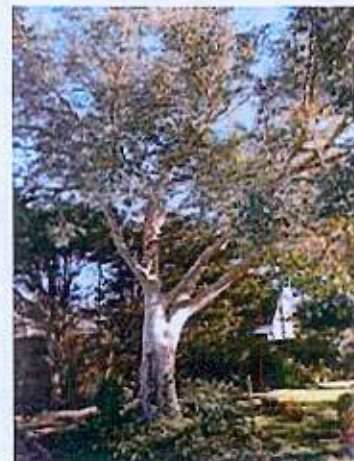
| LOCATION | CONSTRUCTION | CONDITION | REMEDY and TIMEFRAME | PHOTOGRAPHS |
|---|---|---|---|---|
| Rear Driveway | | Cracking and deteriorating due to pressure of roots from large Eucalyptus/ gum tree. | Subject to liaising with the Local Authority and obtaining permission to remove the tree because the property is Listed, it is recommended that the tree is removed and a new tree with weak root activity provided. Allow for hacking up the drive and re-laying with new tarmac. We recommend that this work is carried out within 2 years as a tripping hazard is now introduced to path and driveway and deterioration will only get worse as the gum tree grows larger. | |
