## Pre Demolition Survey

Site: 46A-47 Pier Road, Littlehampton, West Sussex, BN17 5LW  
Client: TL Homes  
Report No: J017095  
Survey Date: 12th October 2020  
Report Date: 12th October 2020  
Surveyors: Michael Hayward  
Report Produced By: Report Authorised By:

### **Type of Survey: Demolition**

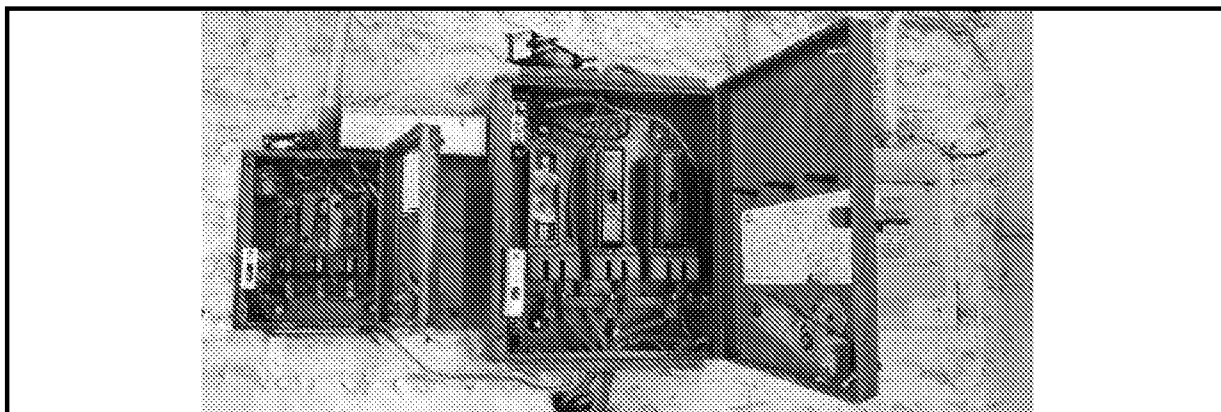
| Sample No: | DA002011 |

| Recommended Action: | Low risk ACM (bound in matrix) remove, repair or encapsulate under controlled conditions. Work on this material does not require a license. Work on this material may be notifiable to the appropriate enforcing authority. Disposal of asbestos waste by a licensed contractor only. All work must conform to the 'Control of Asbestos Regulations 2012'. |
