# **A1 – A5 Viability Report**

**2 - 13 Duke Street**

**Littlehampton**

## **The condition report**

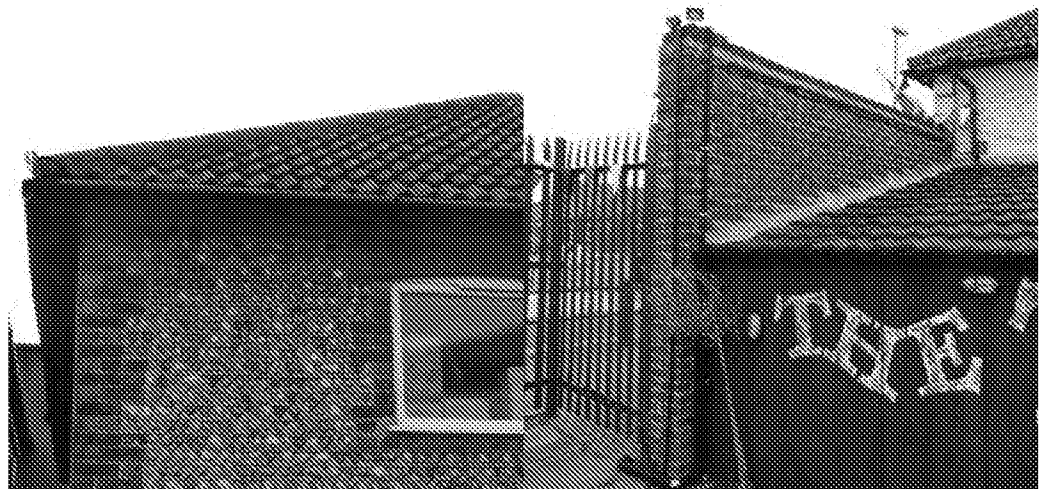
There is a pitched roof of interlocking concrete tiles that runs from North to South. The roof coverings are in good condition generally.

The roof has concrete ridge and hip fittings that are also in good condition generally, although the mortar bedding and joints are starting to deteriorate and should be maintained and repaired as necessary.

There is a metal snow guard fitted to the edge of part of the roof slope on the West side, which is in deteriorating condition.

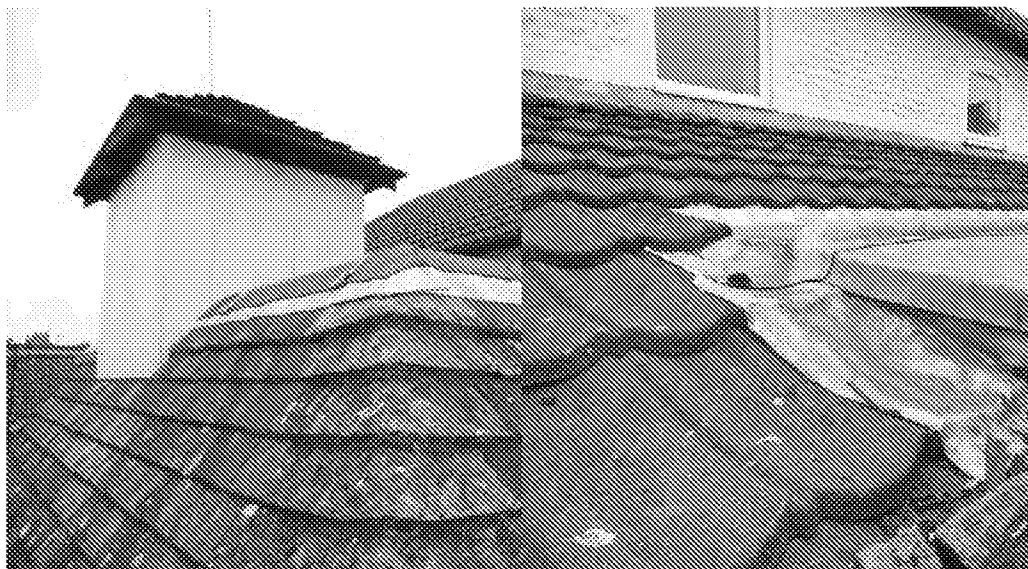
There are PVCu half round gutters to the elevations, which are secured with a mixture of metal and PCVu gutter brackets. The guttering appears to be adequately secured generally, however some of the metal gutter brackets are beginning to deteriorate.

The gutters are in deteriorating condition generally, with evidence of leakage observed to the gutter joints throughout. Evidence of long-standing leakage from the gutter on the West elevation was observed.

A length of bowed gutter was observed at the southern end of the West elevation and it is advised that this should be repaired.

Moss and debris collection was observed within the low level gutters that prevents adequate drainage provision and clearing of this is also advised. The condition within the gutters to the main roof could not be observed, however it is recommended that the gutters should be checked and cleaned out at the same time.

Repairs to the guttering throughout is advised as a matter of urgency. It is likely to be more economical in the long term to replace the guttering to the main roof.

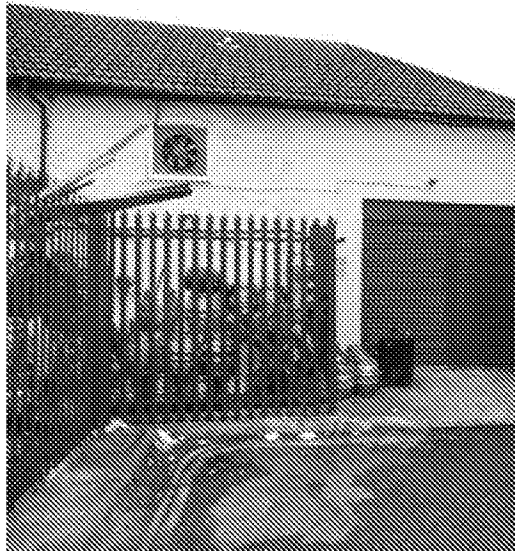
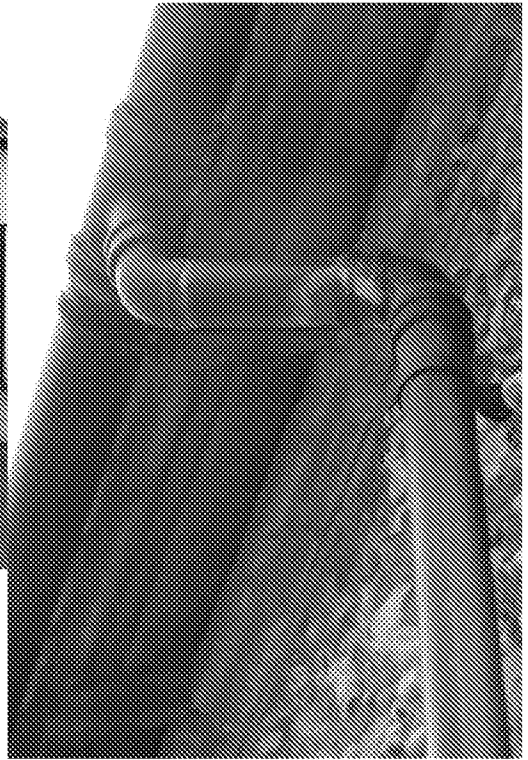
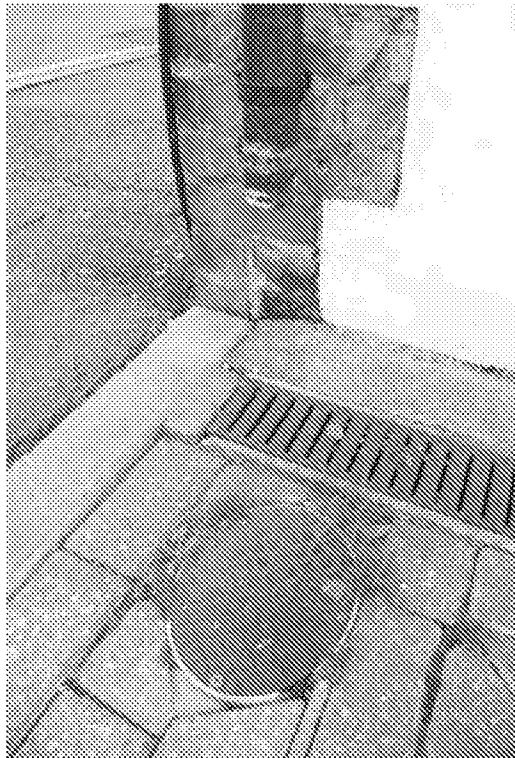
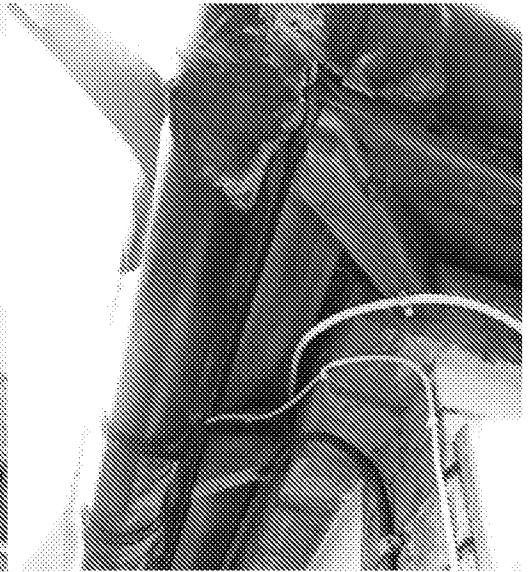
The pipes are in deteriorating condition generally, with evidence of leakage observed to the joints throughout.

The bottom section of the pipe at the North East corner of the main building is missing and it is recommended that this pipe should be extended to discharge directly over the drainage gully below the pipe.

It was also observed that a screw has been inserted to support a pipe joint, puncturing the pipe. It is recommended that additional pipe brackets should be installed to adequately support the pipe joint.

There is a rainwater pipe at the North West corner of the extension that is routed flat at ground level around the corner of the building, to discharge into a drainage gully. The inadequate fall to the pipe is likely to cause blockage within the pipe and it is recommended that the pipe should be modified to ensure adequate drainage.

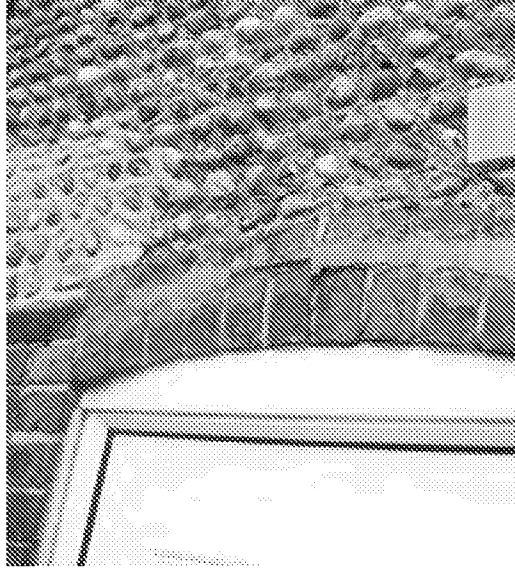
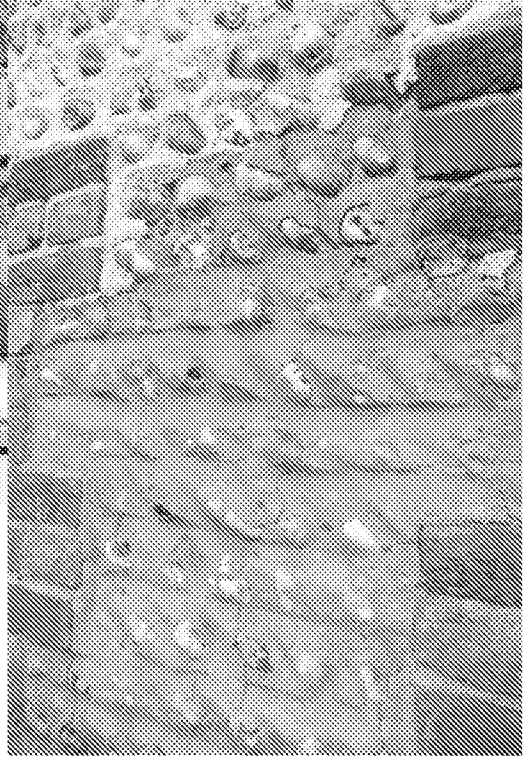
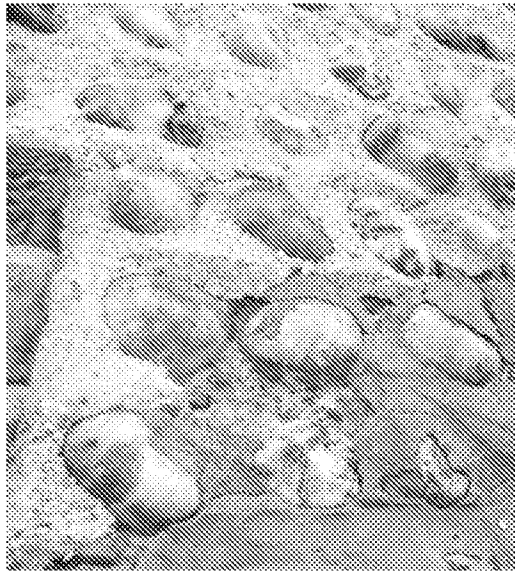
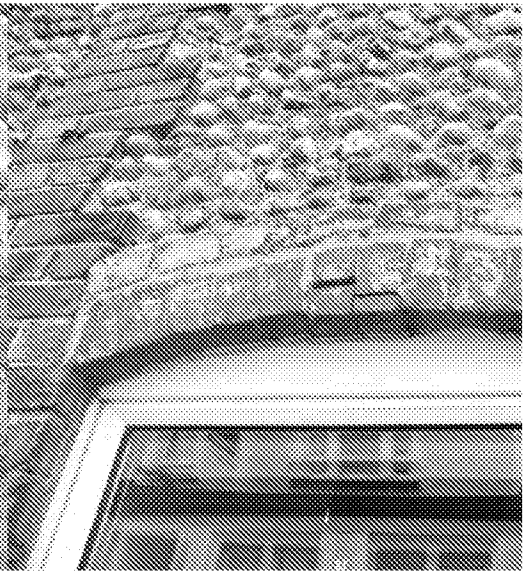
The wall is of coursed flint pebbles with facing brick arch lintels to the window openings and door openings and with facing brick dressings to the windows, doors and at the corners. The flint wall is without a plinth at base level. A damp proof course (dpc) was not observed to the walls.

The wall is in sound condition generally, however the mortar bedding to the flints is in

deteriorating condition generally, with various areas of mortar decay and previous patch repairs observed. It is advised that the mortar bedding to the flints should be repaired as necessary. This is likely to involve extensive mortar repair.

The brick lintels and dressings to the wall are in sound condition generally, however localised brick decay and deterioration of the mortar joints were observed in places. Fractured and dropped key bricks were observed to the brick arch lintel above the infill door panel that is located centrally to the elevation. It is advised that the brick lintels and facing brickwork should be repaired as necessary.

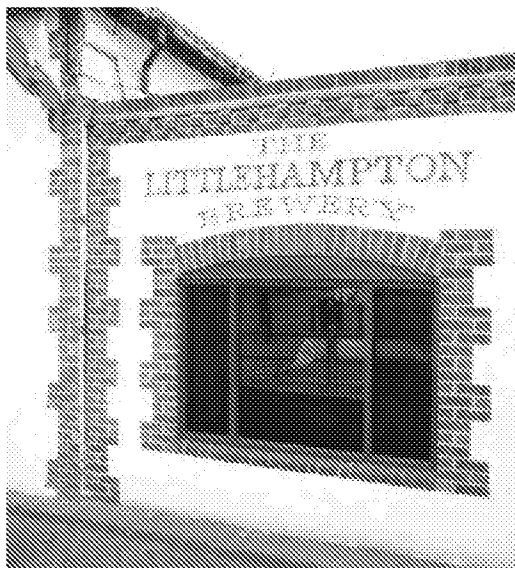
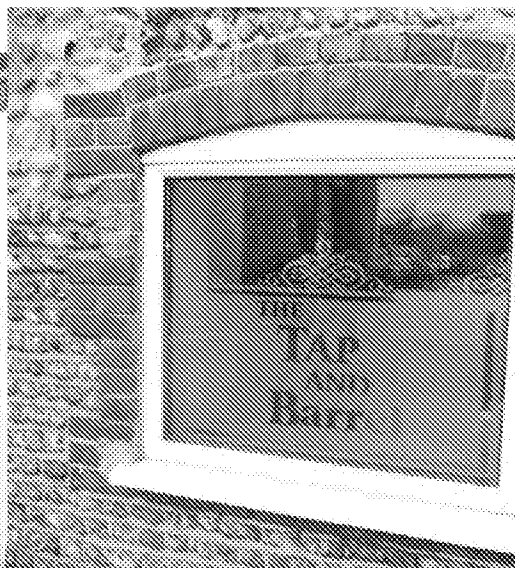
The windows are a mixture of double-glazed PVCu and decorated aluminium fixed casements, with head panels to the arched openings. It should be noted that there are no opening casements. The upper windows are fitted with trickle ventilators. There is pub-branded glazing to some windows. The windows are in fair condition generally, although the frame sealant to the gaps between the frames and walls is in deteriorating condition generally. It is recommended that the windows should be replaced throughout to provide opening

casements for ventilation.

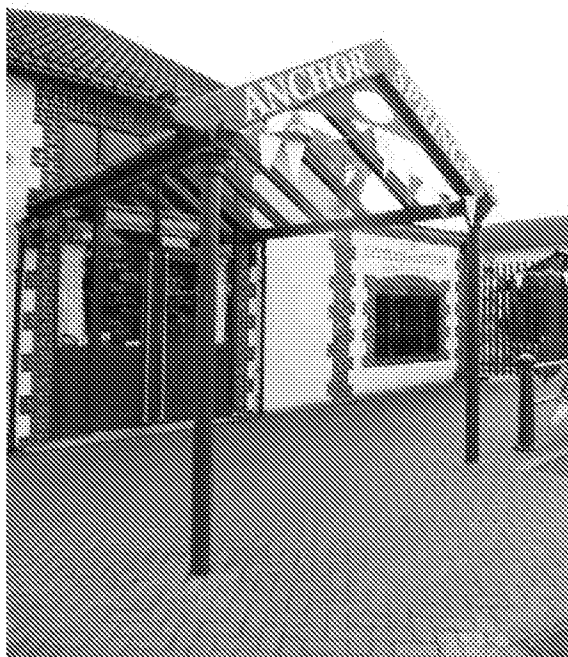
Photo 64

construction concealed beneath the pitched roof, wall cladding and internal wall linings. Further investigation is advised to ascertain the structure and construction of the extension and the concealed conservatory.

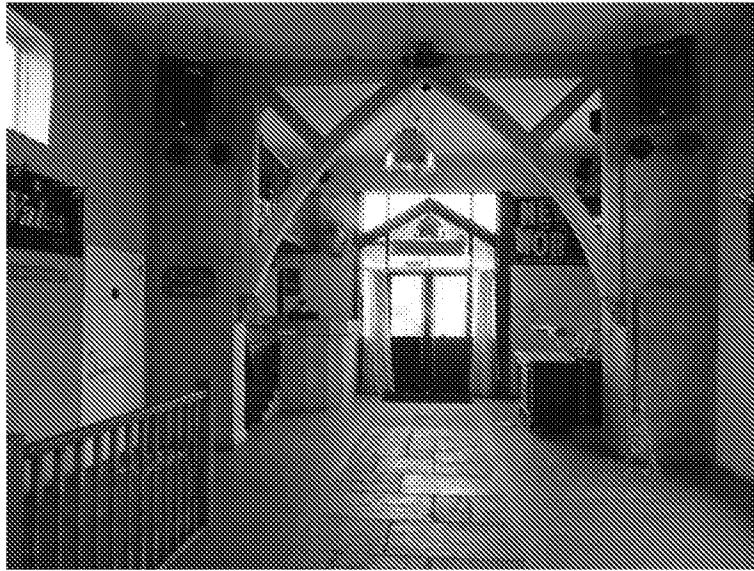
Photo 130

Moisture readings were taken at high and low level using a moisture meter to the walls, floors and ceilings and high levels of moisture were observed to the lengths of the North and East external walls in the Main Bar and Brewery area, up to a height approximately 1000mm above floor level.

A specialist damp survey is advised to fully understand the cause and scope of the damp and will provide suggested appropriate remedial work and costing.
