# Addendum to Heritage Statement

**14 South Terrace**  
Littlehampton  
West Sussex  
BN17 5NZ

Ref: LG/MG/R10  
Date: February 2018

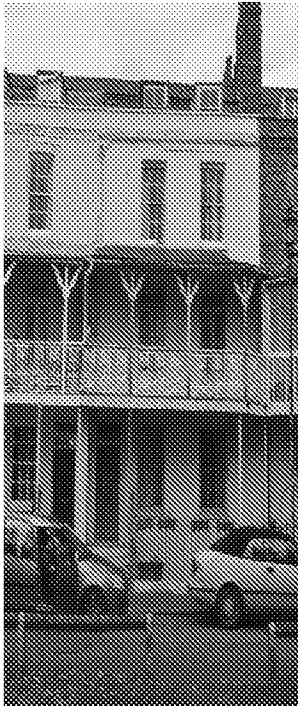
01

Photograph 1 – Front Elevation

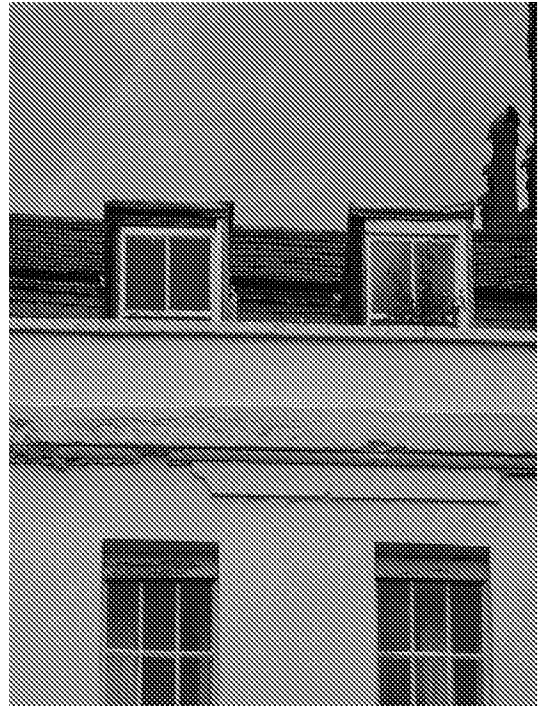
02

Photograph 2 – Damage to high level cornice and missing lead to dormers

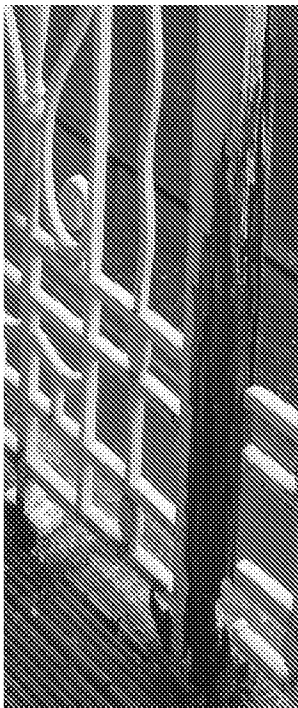
03

Photograph 3 – Decayed posts to balcony

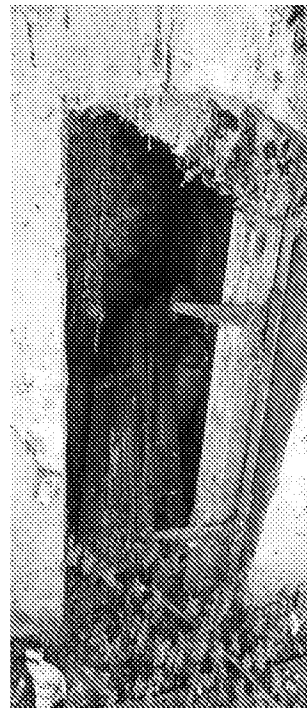
04

Photograph 4 - Decayed and missing doors to pavement vaults

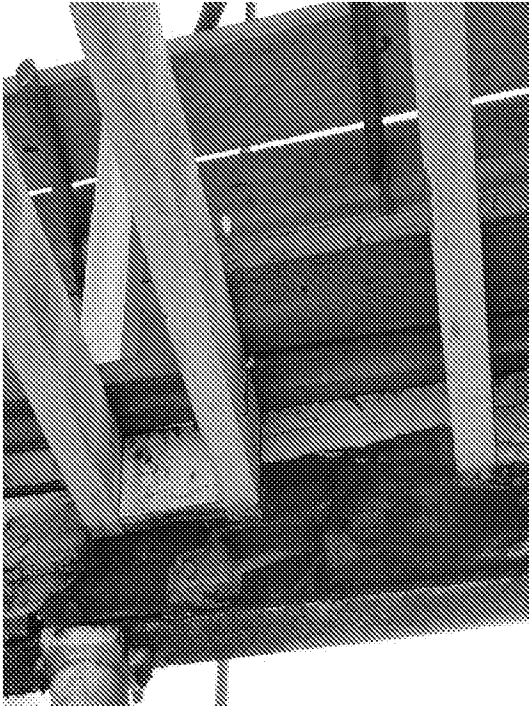
05

Photograph 5 – Decayed timber supports to balcony floor

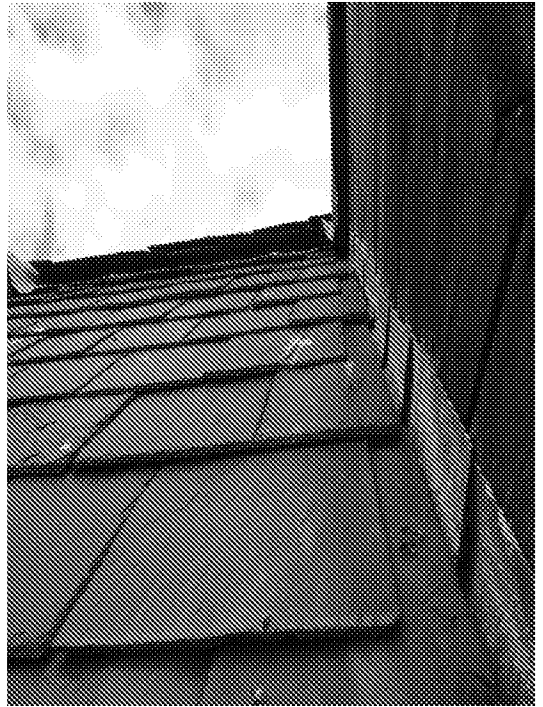
06

Defects to the main roof coverings resulted in damp ingress to ceiling and wall plaster for a prolonged period. This resulted in wet rot to the timbers forming the roof structure and the parapet gutter. These have been exposed and allowed to dry out for a period of time.

Photograph 6 – Missing leadwork to dormer cheeks and slating cut incorrectly

It is proposed that the previously hard boarded and battened ceiling and sloping soffits to the third floor be replaced with 30mm “Thinsulate” and counter battened and clad with 12.5mm of plasterboard and setting coat of plaster to restore the ceiling and improve thermal insulation.

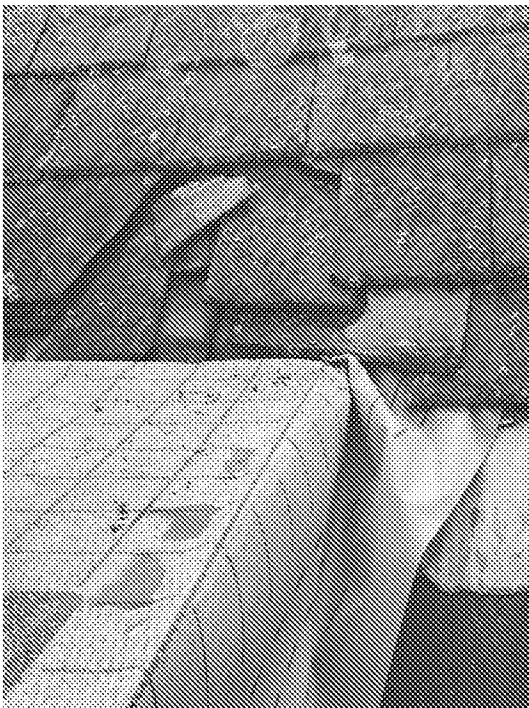
07

Photograph 7 – Damage slating to roof

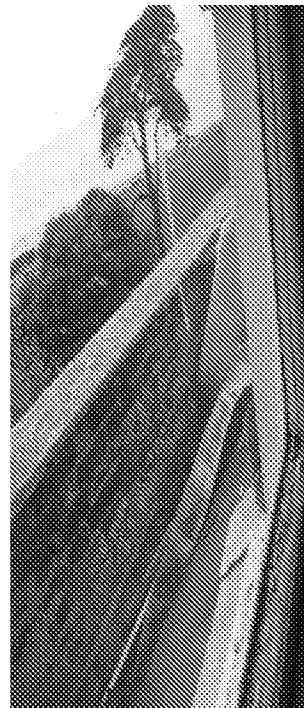
08

Photograph 8 – Damaged and unfixed leadwork to front parapet gutter

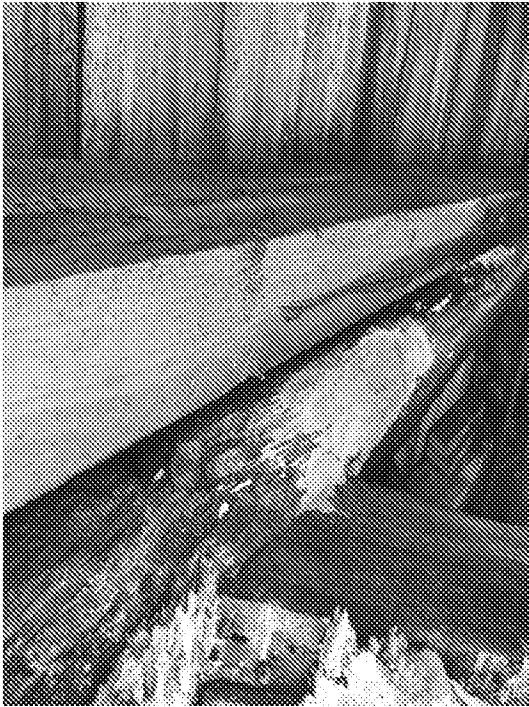
09

Photograph 9 – Wet rot to main roof rafters

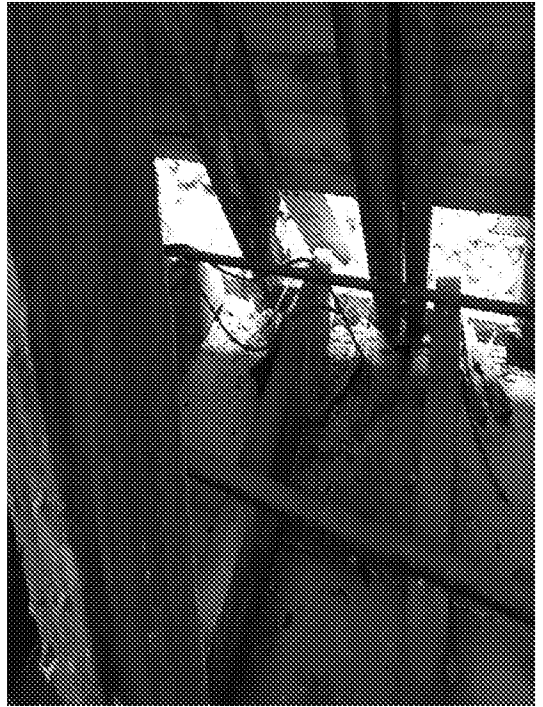
Photograph 10 – Decay to parapet gutter with missing leadwork

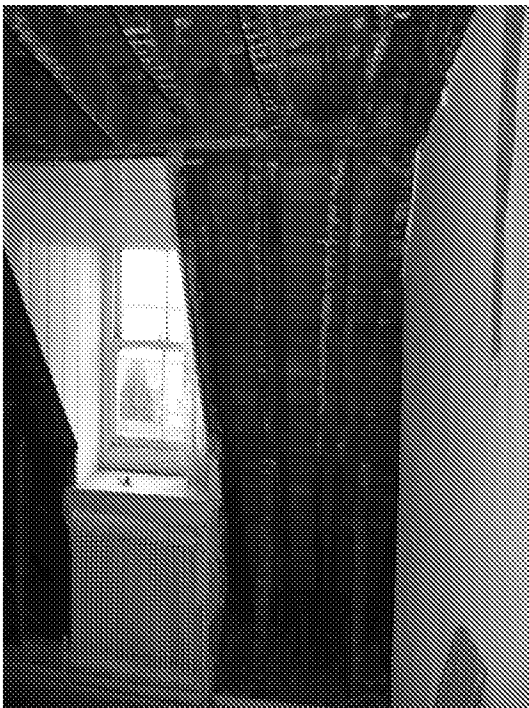
The water ingress also passed through the third floor to the ceiling below on the second floor. This resulted in a large section of the hard boarded ceiling to the sloping soffits of the third floor becoming detached. Complete removal of this ceiling became necessary.

Photograph 11 – Lath and plaster removed following structural repairs to roof timbers circa 1960

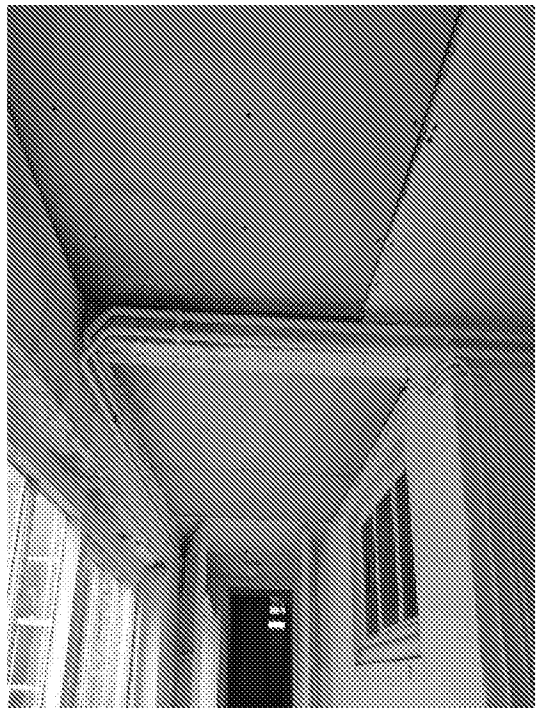
Photograph 12 – Leaks to existing ceilings which have been replaced with plasterboard

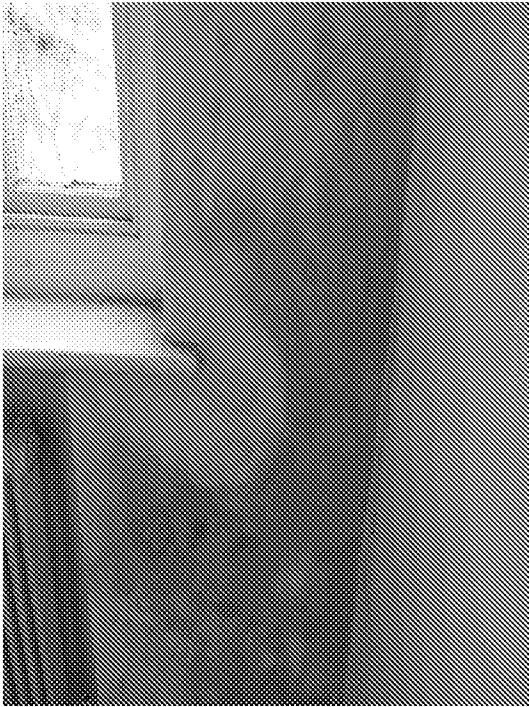
Areas of damp effected wall plaster had been identified to several areas due to a number of defects, and previous repairs with inappropriate materials (carlite plaster). This is summarized as follows:-

Photograph 13 – Carlite plaster and leaks from rainwater goods

It is proposed that these areas be tanked with Triton TT55 cementitious tanking having a finishing coat of plaster. All in accordance with the specialist report prepared by Planet Preservation Ltd (attached hereto). This will prevent further moisture absorption to the internal fabric, and allow moisture evaporation through the external fabric.

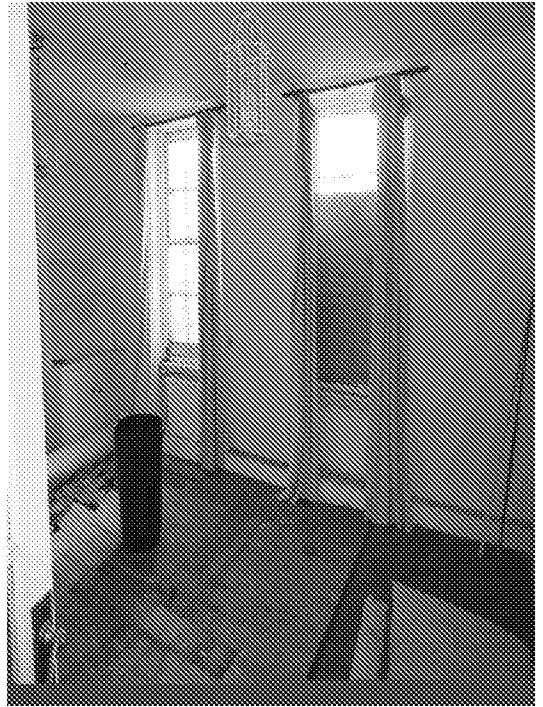
The second floor ceiling is of plasterboard construction. A drainage hole was formed in the plasterboard and the water collected in a dustbin below.

Photograph 14 – Leaks to ceiling of second floor from roof at third floor.

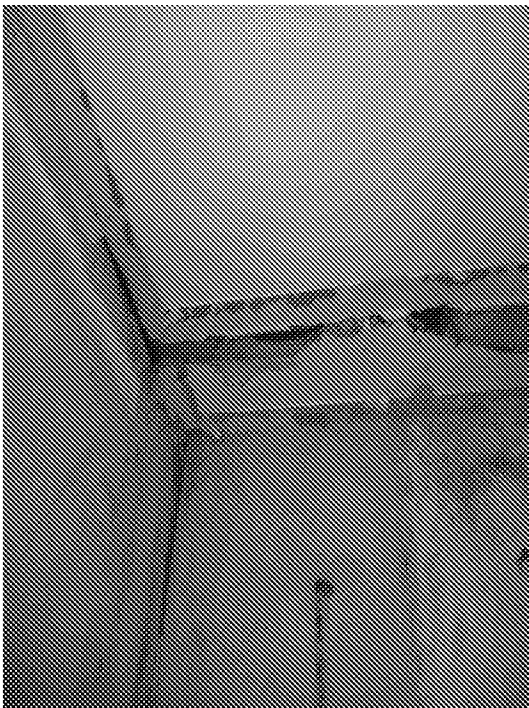
Photograph 15 – Plasterboard ceiling installed previously

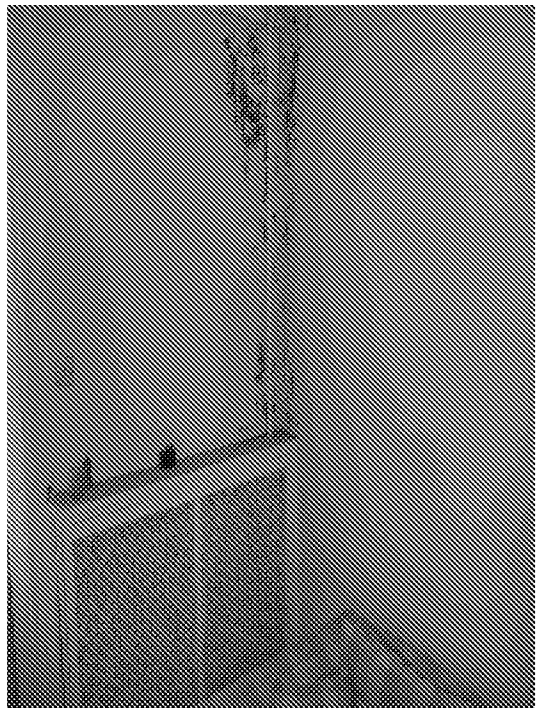
First Floor – damp ingress to the external wall plaster of the rear room and front room. In both these places, the water ingress was found to have been caused by defective rainwater goods and incorrect plaster repairs which had absorbed the moisture.

Photograph 16 – Dampness at first floor level

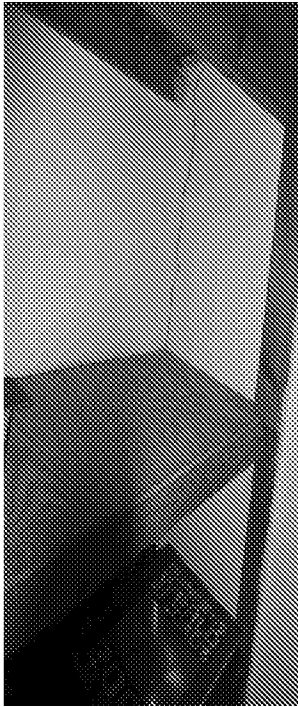
Photograph 17 – A crack to first floor rear wall

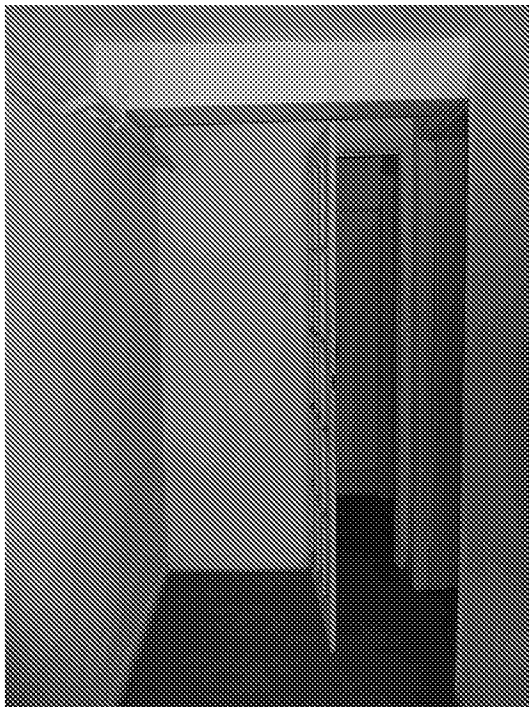
Photograph 19 – Rising damp to basement spine wall

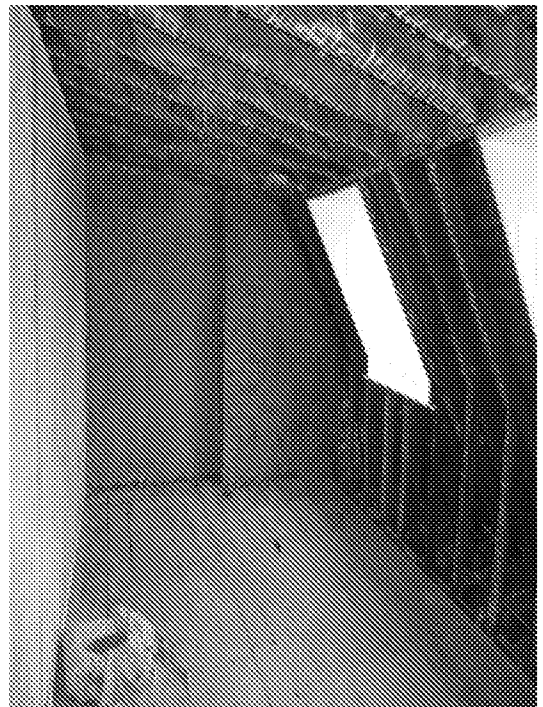
Third Floor – chimney breast and section of the party wall being damp affected due to defective flashings, and previous replastering in “Carlite”.

Photograph 20 – Plaster tanking repairs to third floor front room

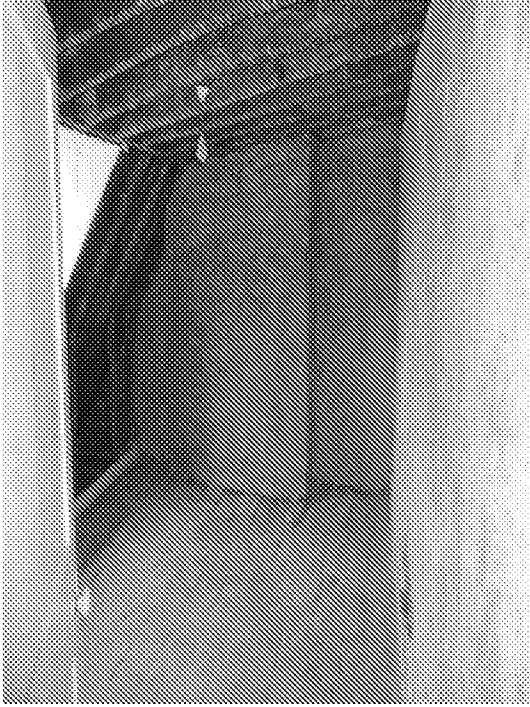
Photograph 21 – Plaster tanking repairs to third floor rear room

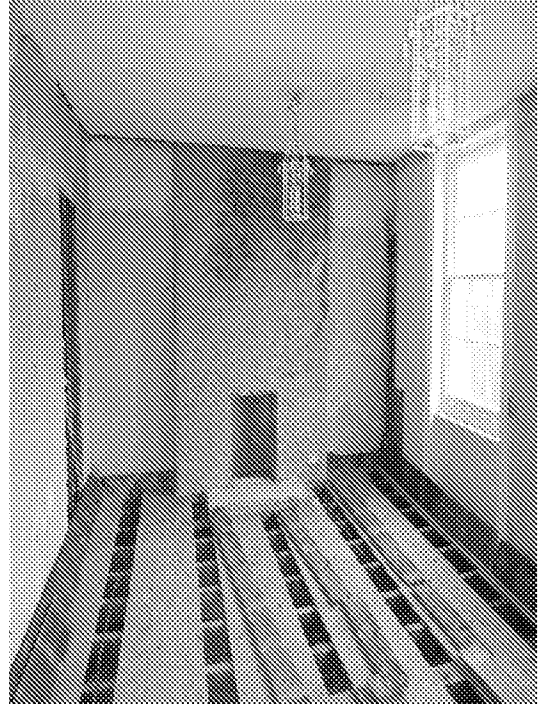
Second Floor – damp ingress through chimney breast and to rear wall of half landing. Again, previous repairs with Carlite plaster were found to exist.

Photograph 22 – Plaster repairs to second floor front room

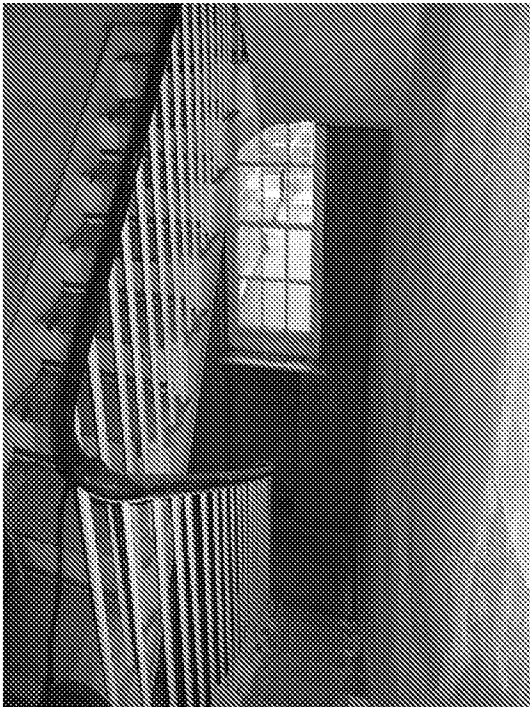
Photograph 23 – Plaster tanking repairs to first floor half landing

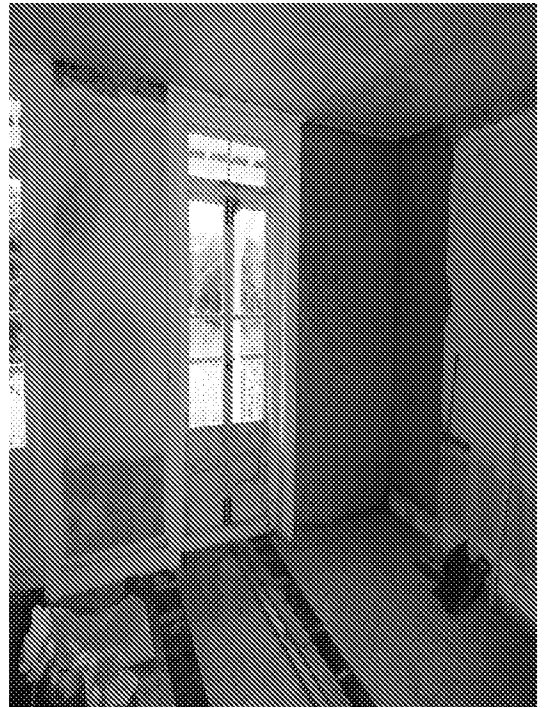
Photograph 24 – Plaster tanking repairs to first floor front room

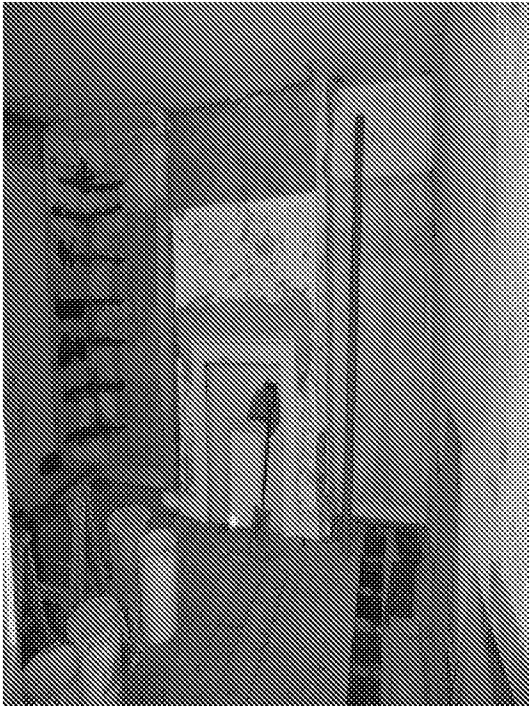
A small crack of approximately 5mm wide was noted to the junction of the rear wall at first floor level. From inspection of the external wall, this was not found to be excessively bulged or bowed and, this cracking was considered to be within acceptable tolerances. However, stainless steel “Helifix” ties have been installed to prevent further movement. These repairs are to have localised plaster repairs on completion.

Photograph 25 – Structural repairs to first floor rear wall

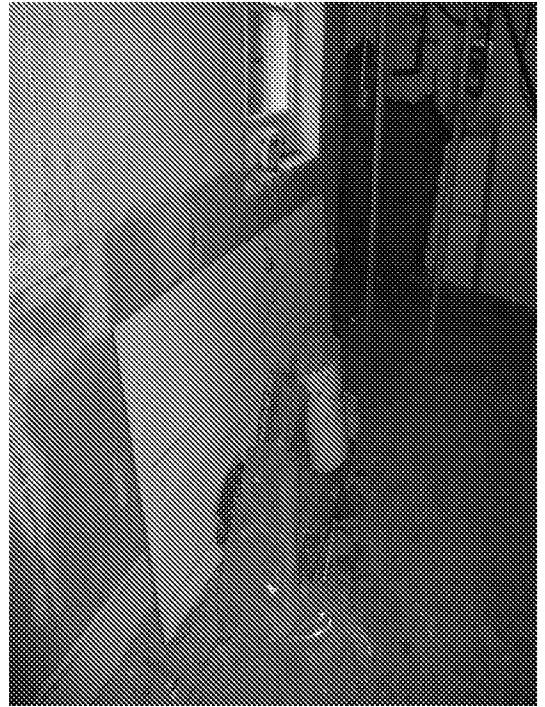
Basement – the following removal of wallpaper, it was noted that previous damp proof treatment had been carried out to the front main wall. However, rising damp was present to the spine wall, and sections of the party wall between the chimney breasts. A small area of rising dampness was also present to the left hand side of the front entrance door.

Photograph 26 – Existing previous damp proof treatment to front main wall of basement

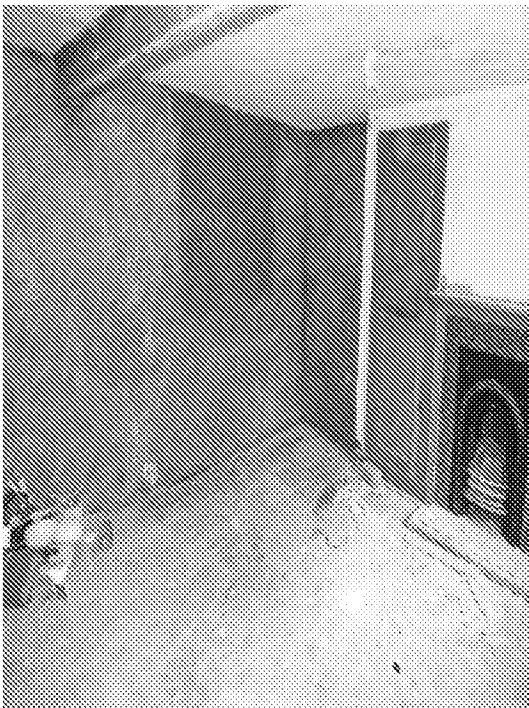
Photograph 27 – Plaster tanking repairs to spine wall of basement

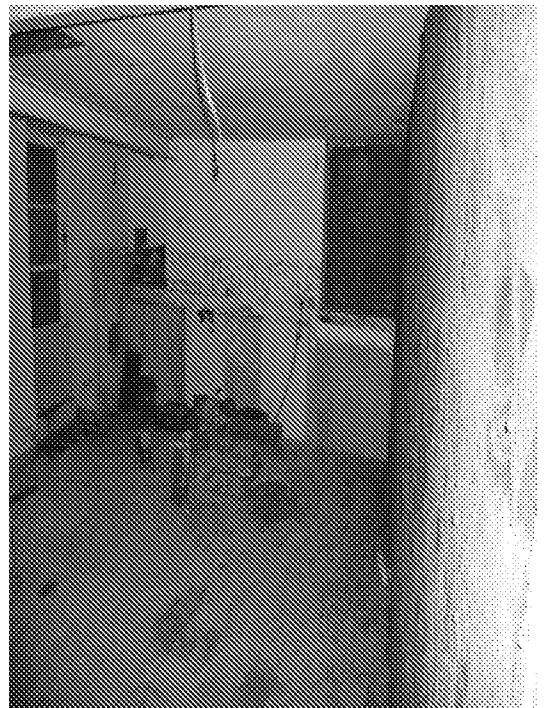
Photograph 28 – Plaster repairs to spine wall of basement rear room
